# **Hazardous Materials Investigation**

## **4206 Commerce Circle, Victoria, BC**

### **BC Transit – Handy Dart**

Island EHS Project #63922

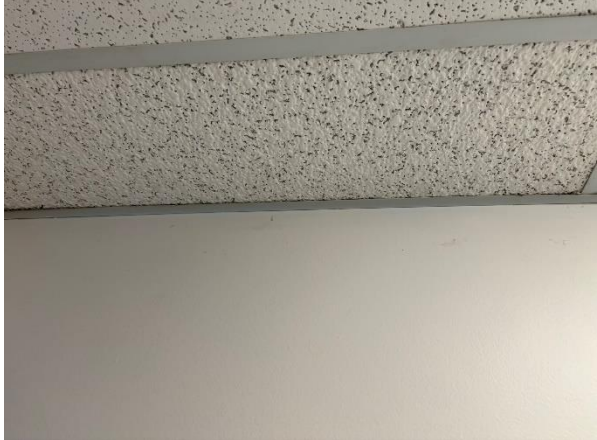
| Sample: | 63922-1 | Sample: | 63922-2 |

| Location: | Hallway | Location: | Lunchroom |
| Description: | Acoustic Ceiling Tile 1 | Description: | Acoustic Ceiling Tile 1 |
| Asbestos: | None Detected | Asbestos: | None Detected |

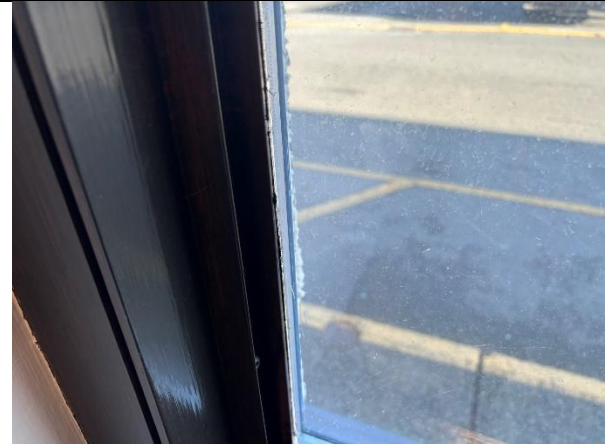
| Sample: | 63922-17 | Sample: | 63922-18 |

| Location: | Lunchroom | Location: | Office |
| Description: | Window Putty | Description: | Window Putty |
| Asbestos: | 1% Chrysotile | Asbestos: | None Detected |

| Material | Description | Location and Quantity Estimates | Recommendation |
|---|---|---|---|
| Asbestos | Window Putty | All windows throughout | Moderate risk asbestos abatement work procedures |

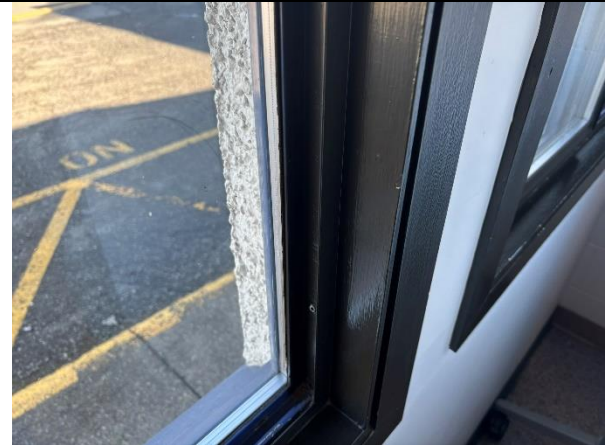
| Sample: | 63922-19 | Sample: | 63922-20 |

| Location: | Lunchroom | Location: | Lunchroom – Behind Lockers |
| Description: | Window Putty | Description: | Mastic |
| Asbestos: | 1% Chrysotile | Asbestos: | None Detected |
