# Hazardous Materials Investigation

## 4210 Commerce Circle, Victoria, BC

Island EHS Project #63921

Original issue date April 2025  
Revised July 2025 (Rev01)  
September 2025 (Rev02)

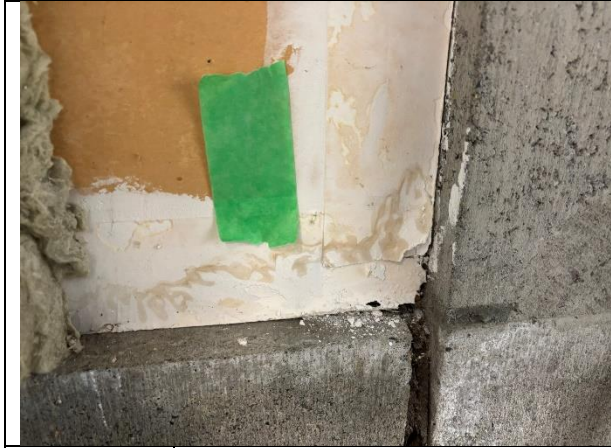
Sample: 63921-1  
 Location: Electrical Room  
 Description: Drywall Joint Compound  
 Asbestos: None Detected

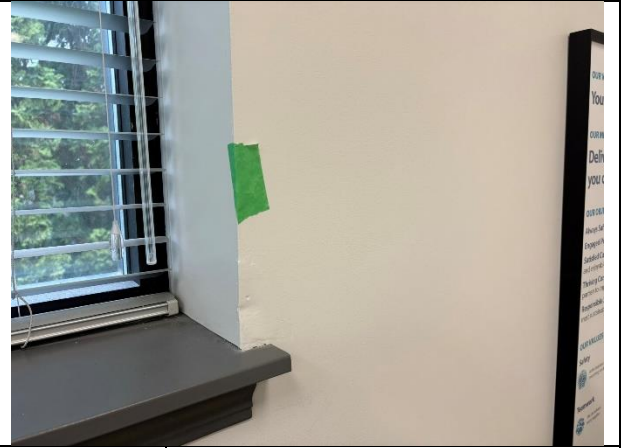
Sample: 63921-2  
 Location: Safety Demonstration Room  
 Description: Drywall Joint Compound  
 Asbestos: None Detected

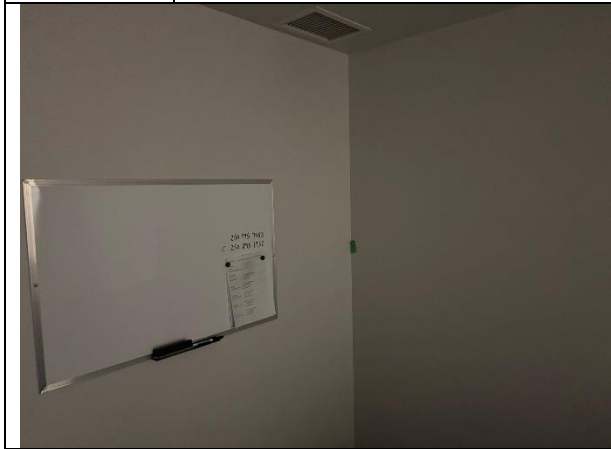
Sample: 63921-3  
 Location: Office 3  
 Description: Drywall Joint Compound  
 Asbestos: None Detected

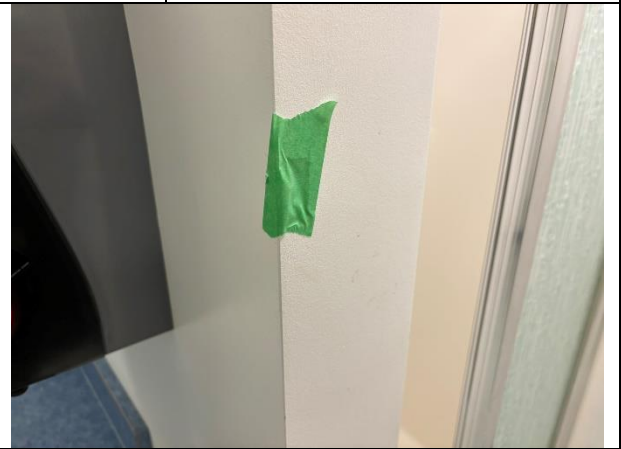
Sample: 63921-4  
 Location: Women's Washroom  
 Description: Drywall Joint Compound  
 Asbestos: None Detected

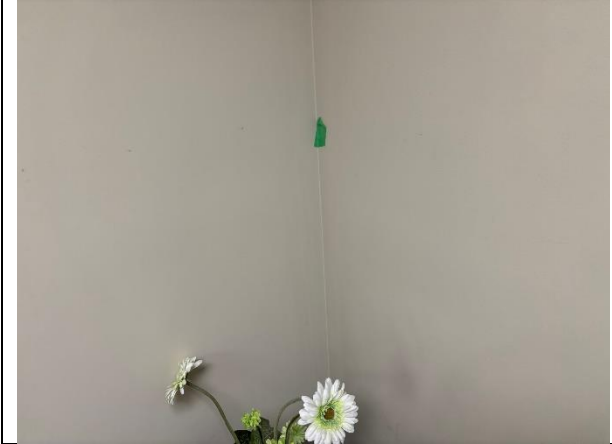
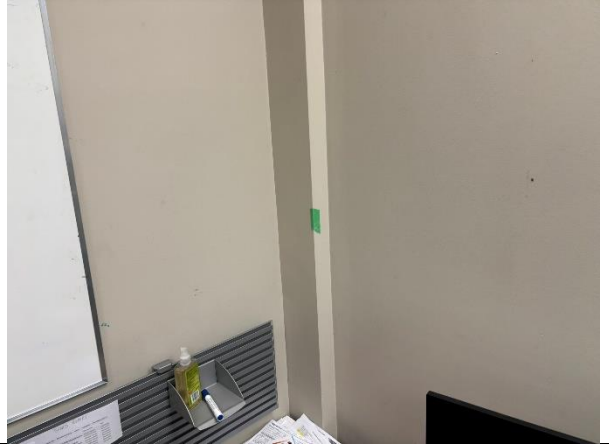
| Sample: | 63921-5 | Sample: | 63921-6 |
| Location: | Reception | Location: | Room 104 |
| Description: | Drywall Joint Compound | Description: | Drywall Joint Compound |
| Asbestos: | None Detected | Asbestos: | None Detected |

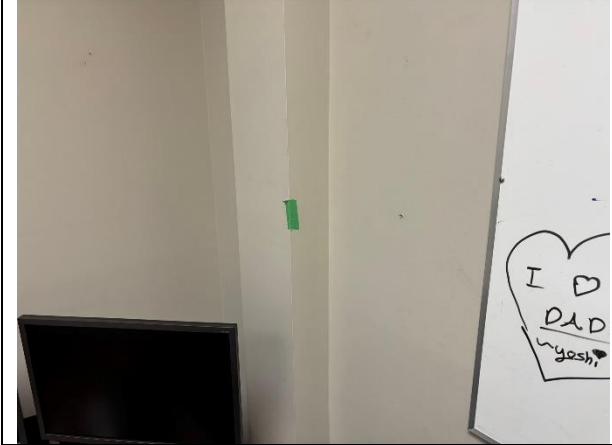
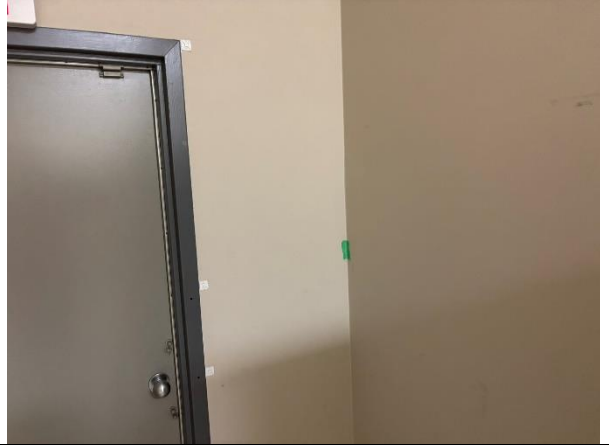
| Sample: | 63921-7 | Sample: | 63921-8 |
| Location: | Room 107 | Location: | Fire Exit Adjacent to Room 105 |
| Description: | Drywall Joint Compound | Description: | Drywall Joint Compound |
| Asbestos: | None Detected | Asbestos: | None Detected |

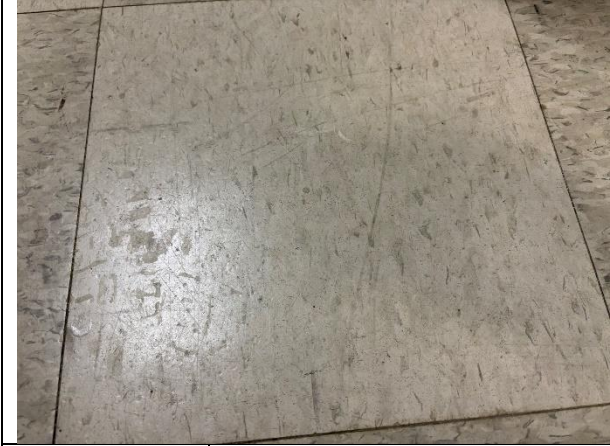
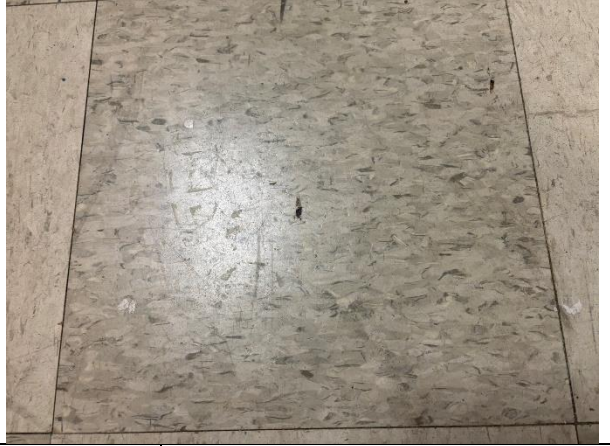
| Sample: | 63921-13 | Sample: | 63921-14 |
| Location: | IT Room | Location: | IT Room |
| Description: | Vinyl Floor Tile | Description: | Vinyl Floor Tile |
| Asbestos: | None Detected | Asbestos: | None Detected |

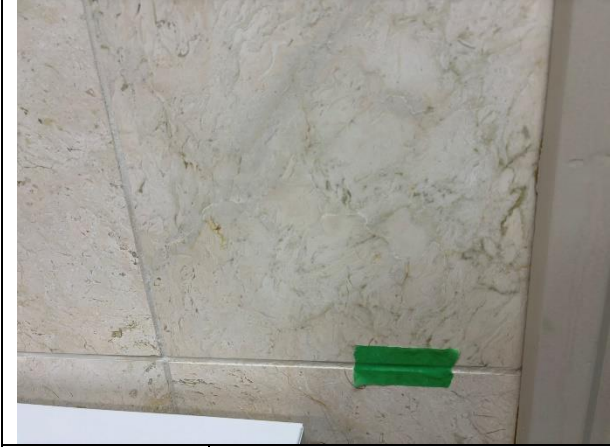
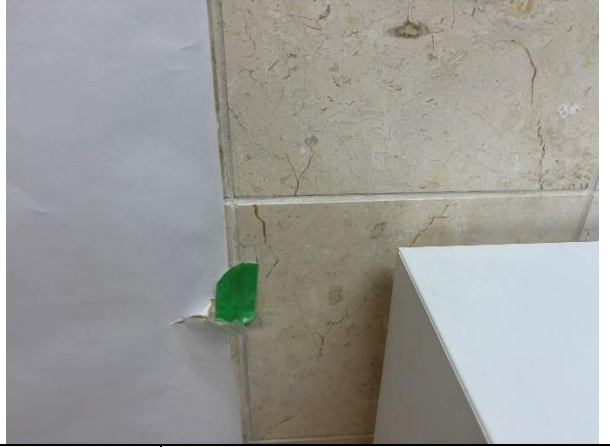
| Sample: | 63921-15 | Sample: | 63921-16 |
| Location: | Room 102 | Location: | Room 102 |
| Description: | Grout | Description: | Grout |
| Asbestos: | None Detected | Asbestos: | None Detected |

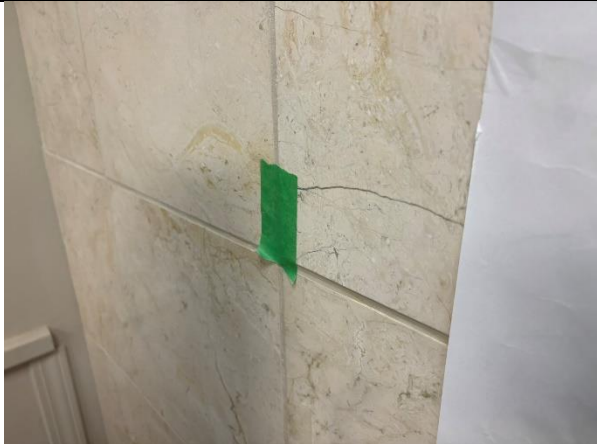
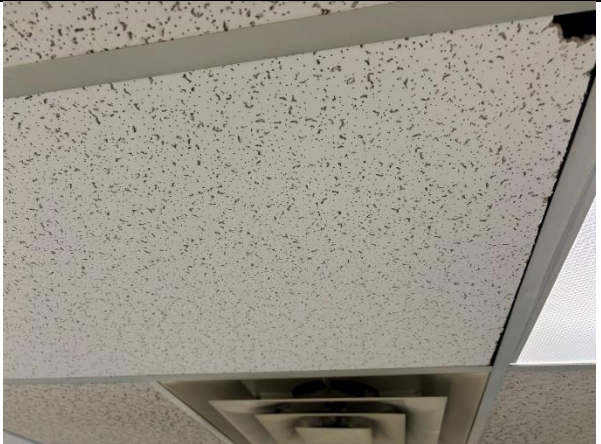
| Sample: | 63921-17 | Sample: | 63921-18 |
| Location: | Room 102 | Location: | Room 106 |
| Description: | Grout | Description: | Acoustic Ceiling Tile 1 |
| Asbestos: | None Detected | Asbestos: | None Detected |

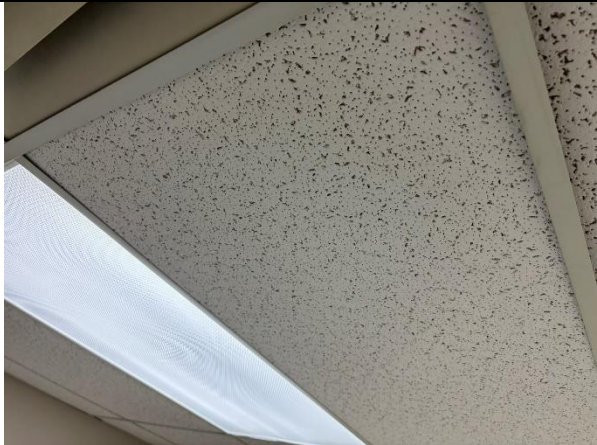
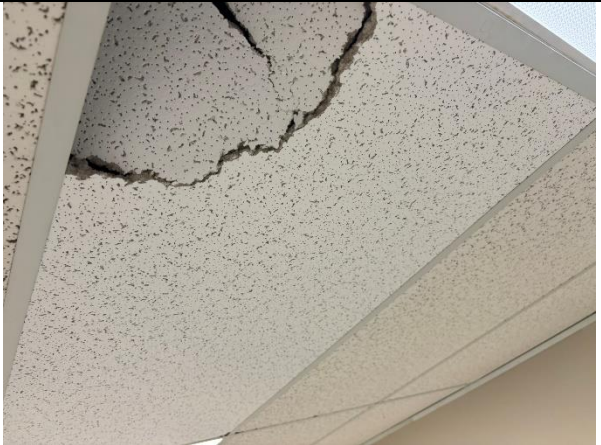
| Sample: | 63921-19 | Sample: | 63921-20 |
| Location: | Room 109 | Location: | Hallway Adjacent to Room 105 |
| Description: | Acoustic Ceiling Tile 1 | Description: | Acoustic Ceiling Tile 1 |
| Asbestos: | None Detected | Asbestos: | None Detected |

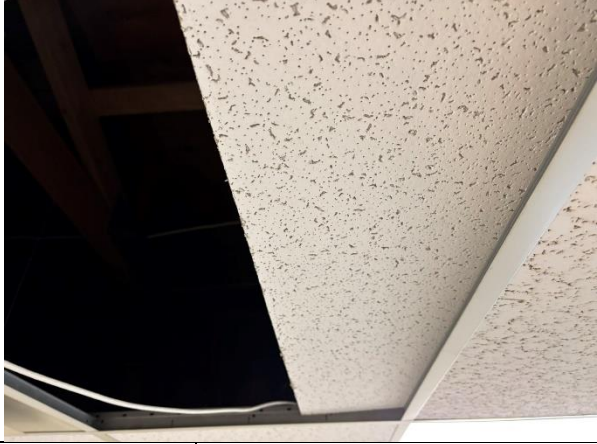
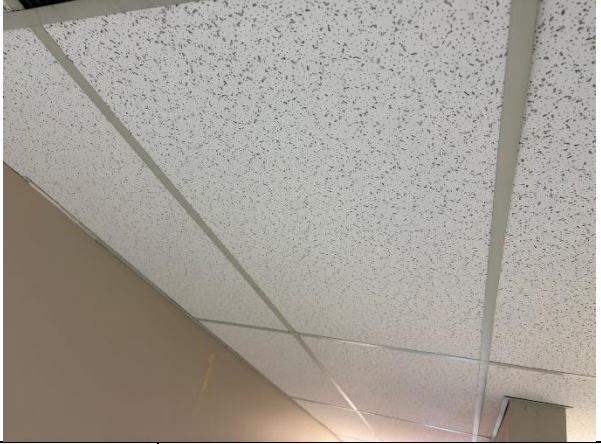
| Sample: | 63921-21 | Sample: | 63921-22 |
| Location: | Reception | Location: | Hallway Adjacent to Kitchen |
| Description: | Acoustic Ceiling Tile 1 | Description: | Acoustic Ceiling Tile 1 |
| Asbestos: | None Detected | Asbestos: | None Detected |

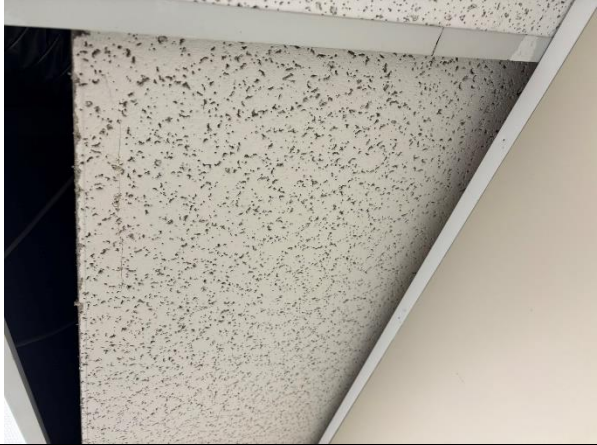
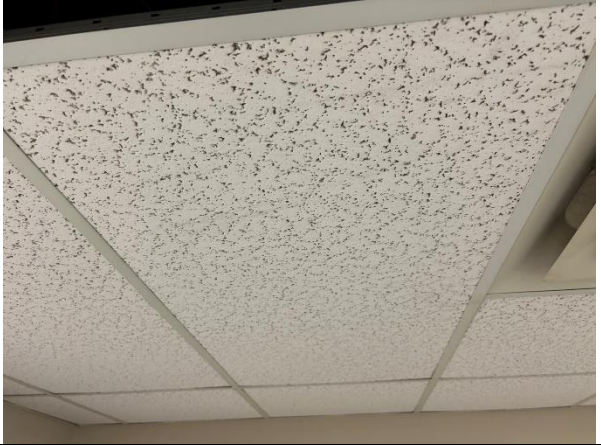
| Sample: | 63921-23 | Sample: | 63921-24 |
| Location: | Room 106 | Location: | Room 109 |
| Description: | Acoustic Ceiling Tile 2 | Description: | Acoustic Ceiling Tile 2 |
| Asbestos: | None Detected | Asbestos: | None Detected |

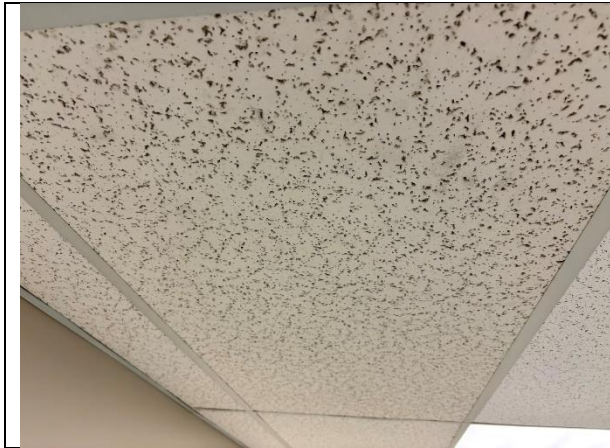
| Sample: | 63921-25 |
| Location: | Hallway Adjacent to Room 105 |
| Description: | Acoustic Ceiling Tile 2 |
| Asbestos: | None Detected |

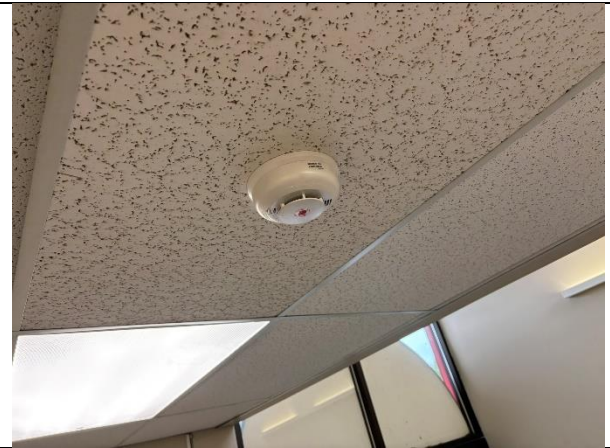
| Sample: | 63921-26 |
| Location: | Reception |
| Description: | Acoustic Ceiling Tile 2 |
| Asbestos: | None Detected |

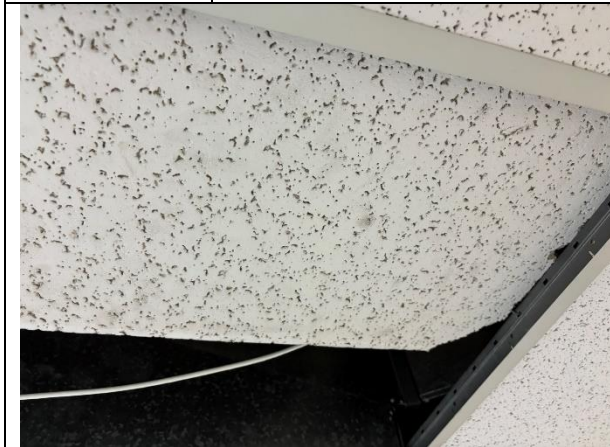
| Sample: | 63921-27 |
| Location: | Hallway Adjacent to Kitchen |
| Description: | Acoustic Ceiling Tile 2 |
| Asbestos: | None Detected |

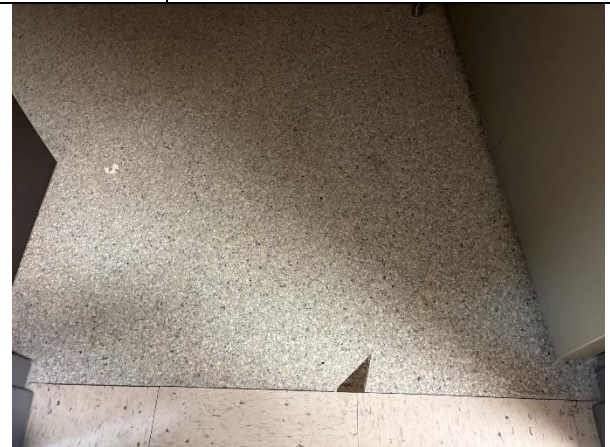
| Sample: | 63921-28 |
| Location: | Men's Washroom |
| Description: | Vinyl Sheet Floor |
| Asbestos: | None Detected |

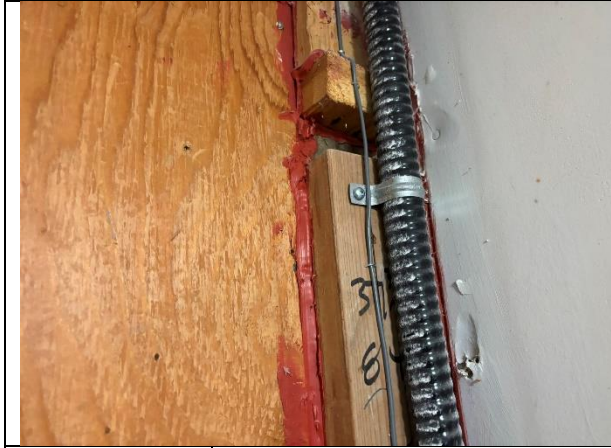
Sample: 63921-29  
 Location: Electrical Room  
 Description: Firestop – Red  
 Asbestos: None Detected

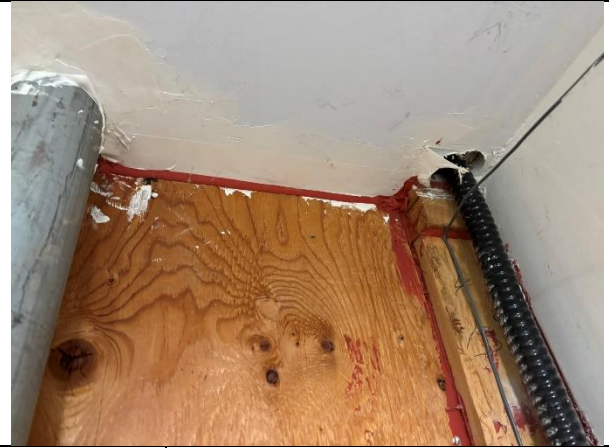
Sample: 63921-30  
 Location: Electrical Room  
 Description: Firestop – Red  
 Asbestos: None Detected

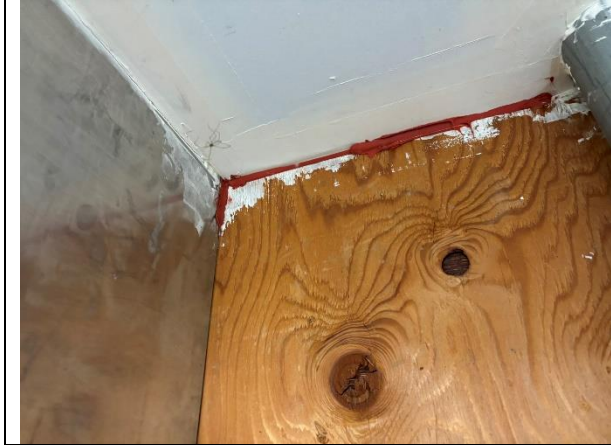
Sample: 63921-31  
 Location: Electrical Room  
 Description: Firestop – Red  
 Asbestos: None Detected

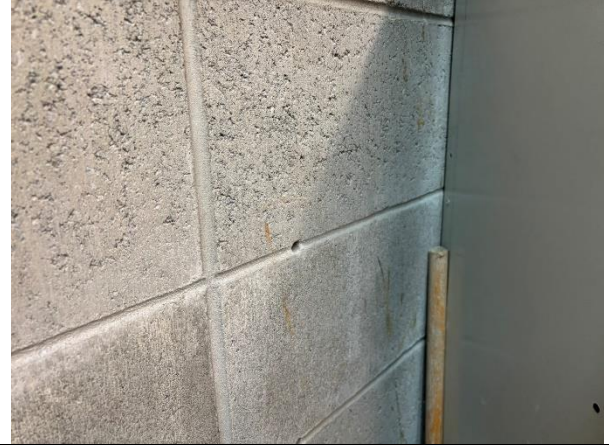
Sample: 63921-32  
 Location: Loading Dock  
 Description: Concrete Block Mortar  
 Asbestos: None Detected

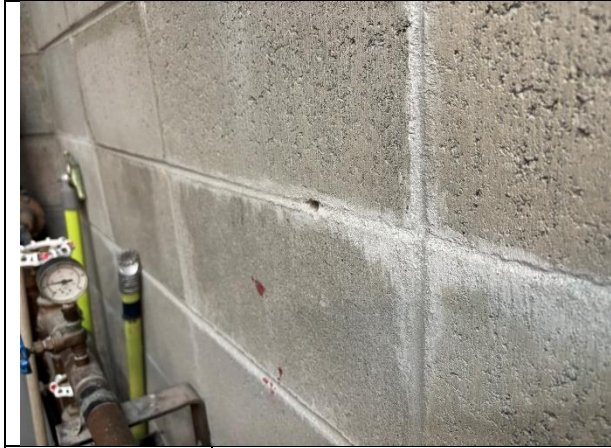
Sample: 63921-33  
 Location: Loading Dock  
 Description: Concrete Block Mortar  
 Asbestos: None Detected

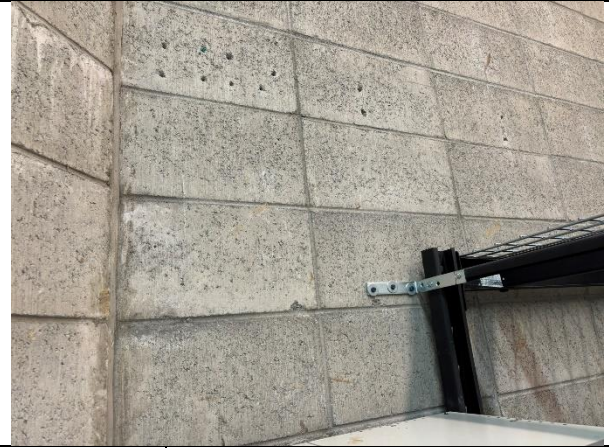
Sample: 63921-34  
 Location: Loading Dock  
 Description: Concrete Block Mortar  
 Asbestos: None Detected

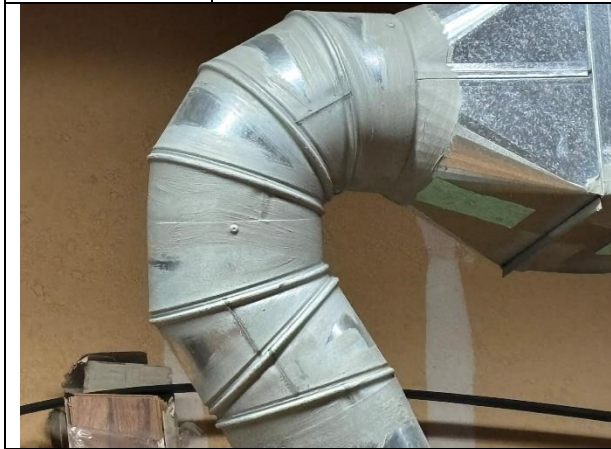
Sample: 63921-35  
 Location: Mezzanine  
 Description: Duct Mastic – Grey  
 Asbestos: None Detected

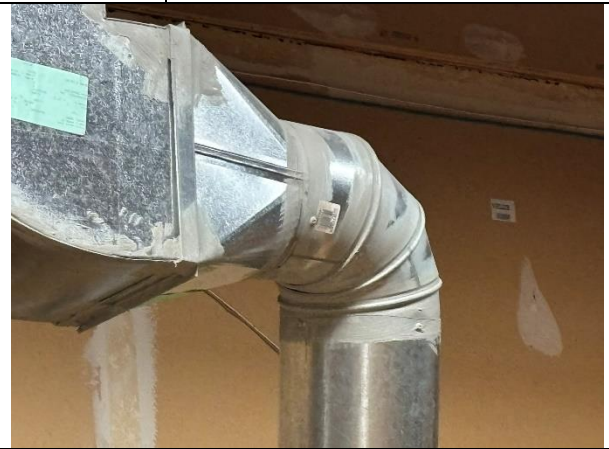
Sample: 63921-36  
 Location: Mezzanine  
 Description: Duct Mastic – Grey  
 Asbestos: None Detected

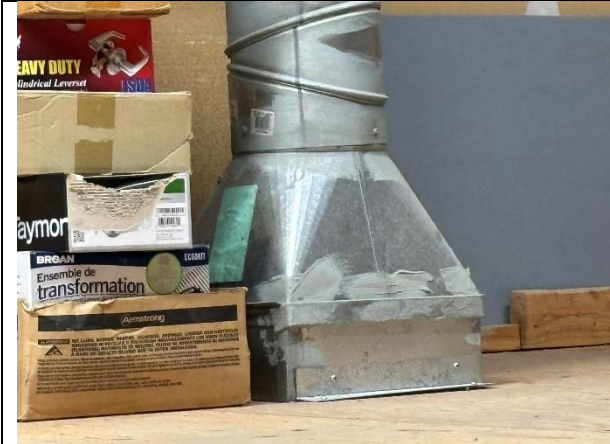
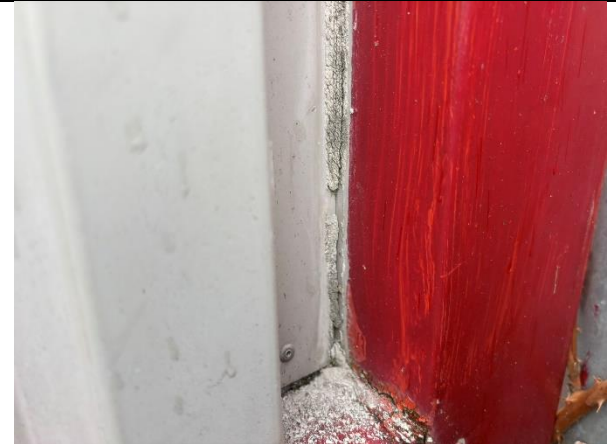
| Sample: | 63921-37 | Sample: | 63921-38 |
| Location: | Mezzanine | Location: | Exterior – Metal Siding |
| Description: | Duct Mastic – Grey | Description: | Caulking – Grey |
| Asbestos: | None Detected | Asbestos: | None Detected |

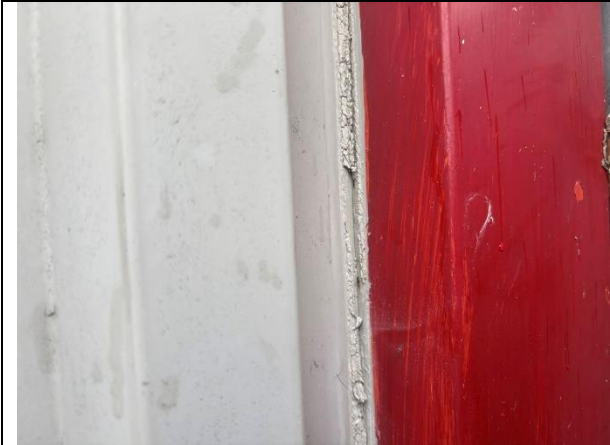
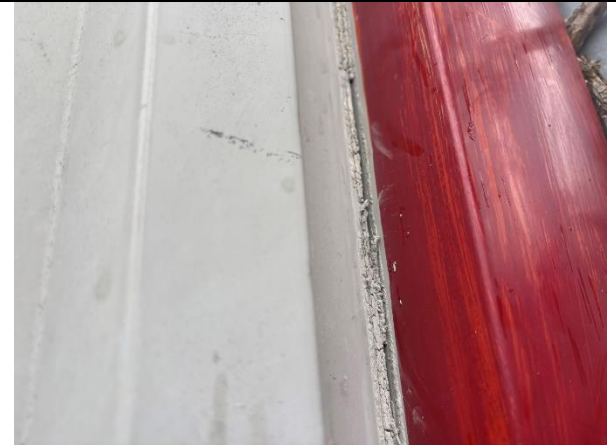
| Sample: | 63921-39 | Sample: | 63921-40 |
| Location: | Exterior – Metal Siding | Location: | Exterior – Metal Siding |
| Description: | Caulking – Grey | Description: | Caulking – Grey |
| Asbestos: | None Detected | Asbestos: | None Detected |

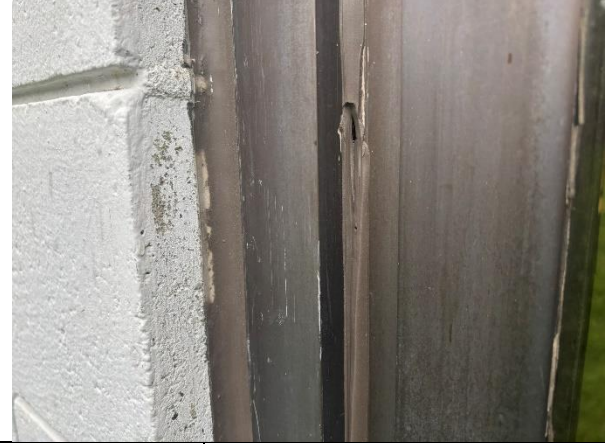
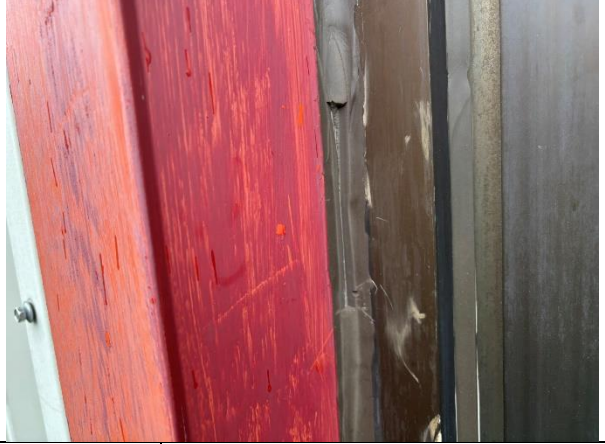
| Sample: | 63921-41 | Sample: | 63921-42 |
| Location: | Exterior – Windows | Location: | Exterior – Windows |
| Description: | Caulking – Brown | Description: | Caulking – Brown |
| Asbestos: | None Detected | Asbestos: | None Detected |

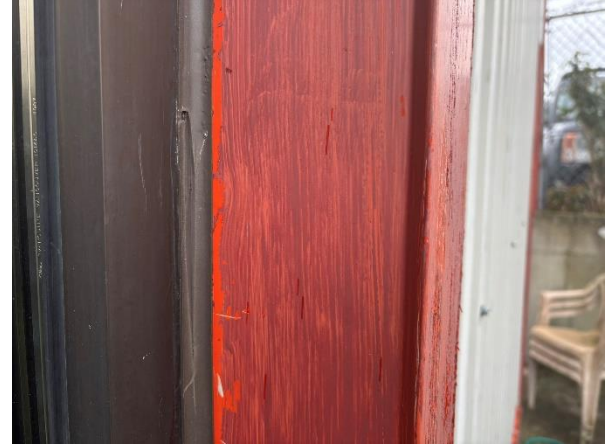
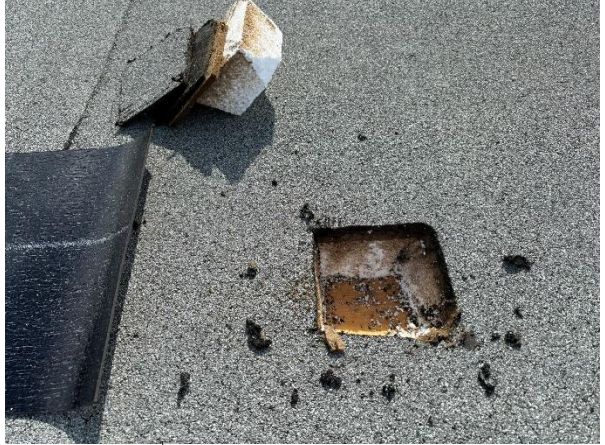
| Sample: | 63921-43 | Sample: | 63921-44 |
| Location: | Exterior - Windows | Location: | Roof |
| Description: | Caulking – Brown | Description: | Torch-on Asphalt |
| Asbestos: | None Detected | Asbestos: | None detected |

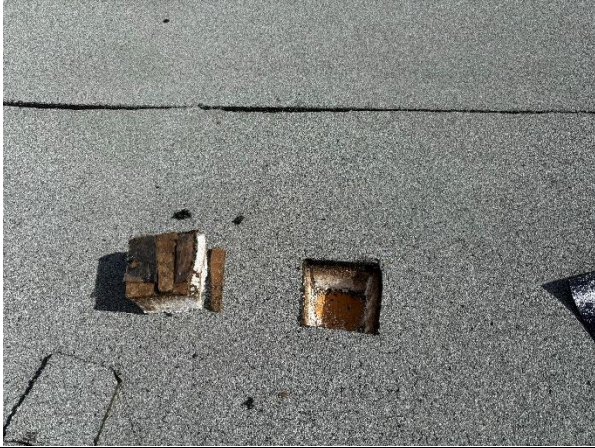
| Sample: | 63921-45 |
| Location: | Roof |
| Description: | Torch-on Asphalt |
| Asbestos: | None Detected |

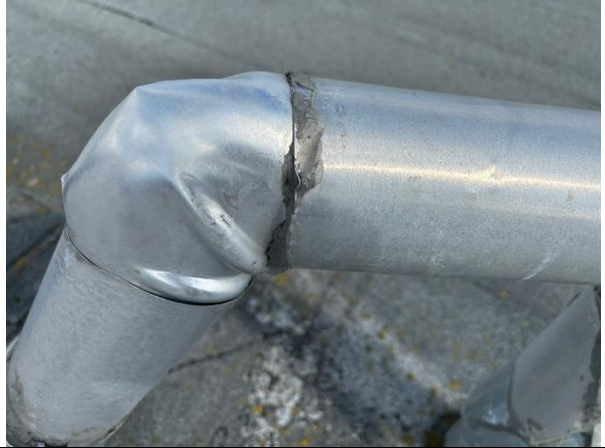
| Sample: | 63921-46 |
| Location: | Roof |
| Description: | Duct Mastic – Grey |
| Asbestos: | None Detected |

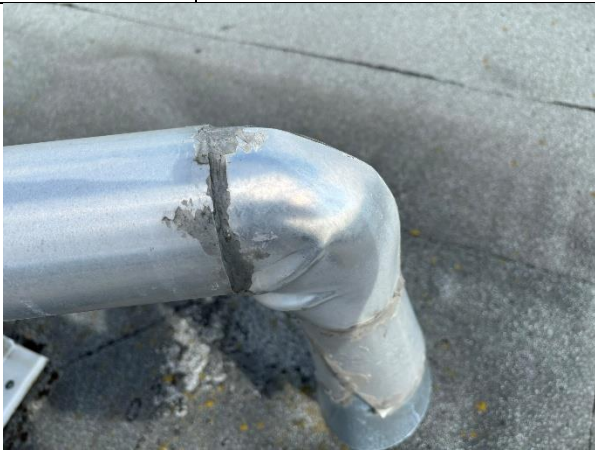
| Sample: | 63921-47 |
| Location: | Roof |
| Description: | Duct Mastic – Grey |
| Asbestos: | None Detected |

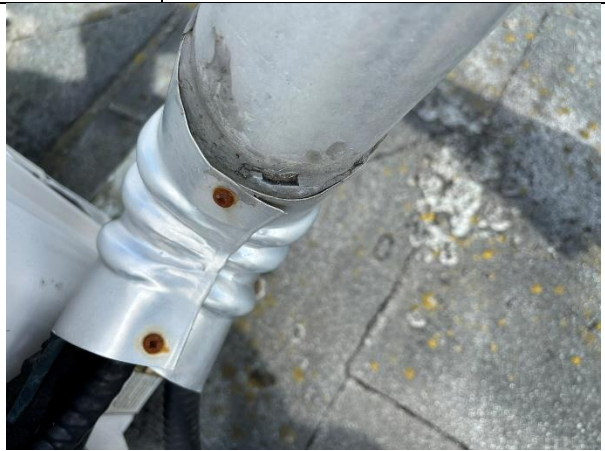
| Sample: | 63921-48 |
| Location: | Roof |
| Description: | Duct Mastic – Grey |
| Asbestos: | None Detected |

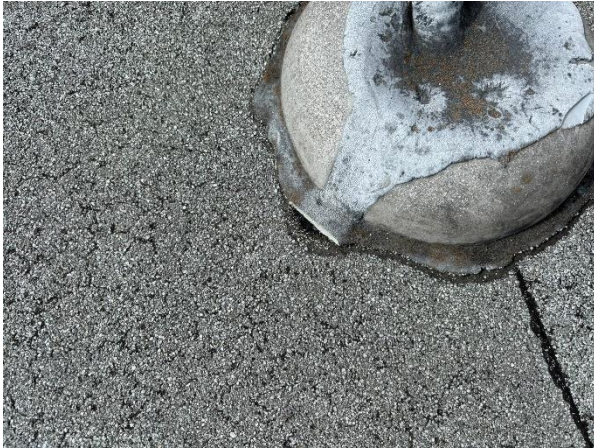
| Sample: | 63921-49 |
| Location: | Roof |
| Description: | Sealant |
| Asbestos: | None Detected |

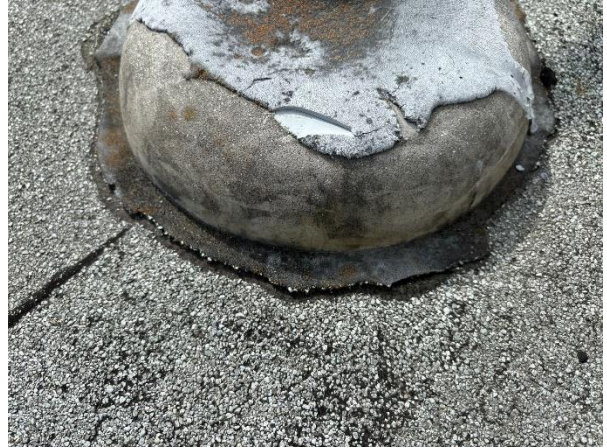
| Sample: | 63921-50 |
| Location: | Roof |
| Description: | Sealant |
| Asbestos: | None Detected |
