# **Hazardous Materials Investigation**

## **4212 Commerce Circle, Victoria, BC**

Island EHS Project #63920 (Rev02)

Original issue date April 2025  
Revised June 2025 (Rev01)  
September 2025 (Rev02)

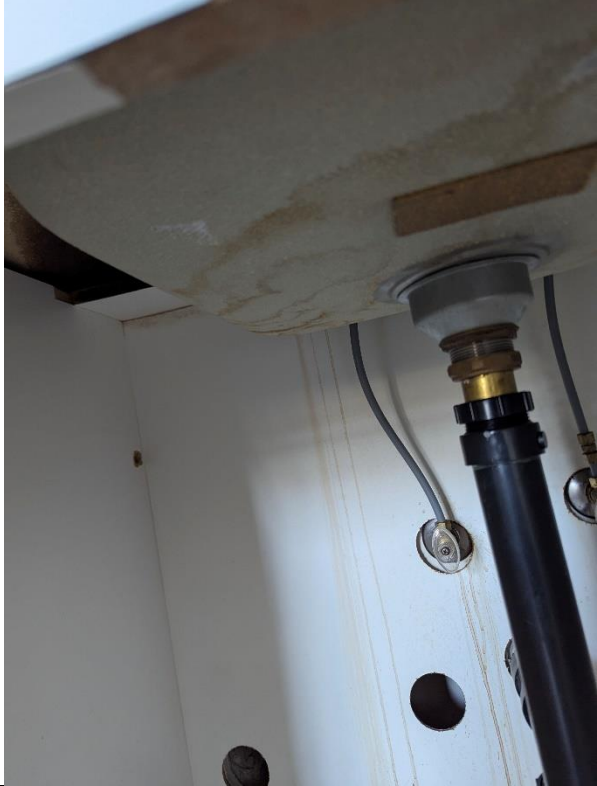
| Sample: | 63920-21 | Sample: | 63920-22 |

| Location: | 2 <sup>nd</sup> Floor – Break Room, Sink | Location: | 2 <sup>nd</sup> Floor |
| Description: | Mastic | Description: | Vinyl Sheet Flooring |
| Asbestos: | None Detected | Asbestos: | None Detected |

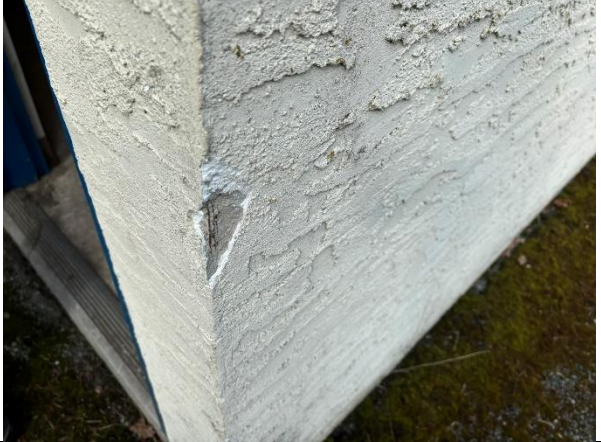
| Sample: | 63920-45 | Sample: | 63920-46 |

| Material | Description | Location and Quantity Estimates | Recommendation |
|---|---|---|---|
| Asbestos | Sink Mastic | 1 sink in the 2 <sup>nd</sup> floor staff room | <b>Moderate risk asbestos abatement work procedures</b><br><br>If unidentified materials are encountered, work must stop until the material is identified and assessed |

| Location: | Mezzanine – Break Room, Sink | Location: | Exterior |
| Description: | Mastic | Description: | Stucco |
| Asbestos: | <b>Chrysotile 1%</b> | Asbestos: | None Detected |
