**Demolition Hazardous Materials  
Investigation  
4212 Glanford Avenue, Victoria, BC**

Island EHS Project #63919

Original Issue Date April 2025  
Revision Date September 2025

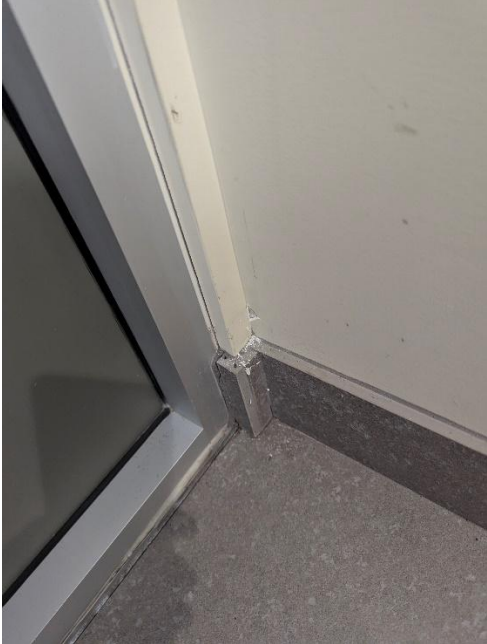
| <p>Sample: 63919-1<br/>Location: Reception<br/>Description: Drywall Joint Compound<br/>Asbestos: None Detected</p> | <p>Sample: 63919-2<br/>Location: Mudroom<br/>Description: Drywall Joint Compound<br/>Asbestos: None Detected</p> |

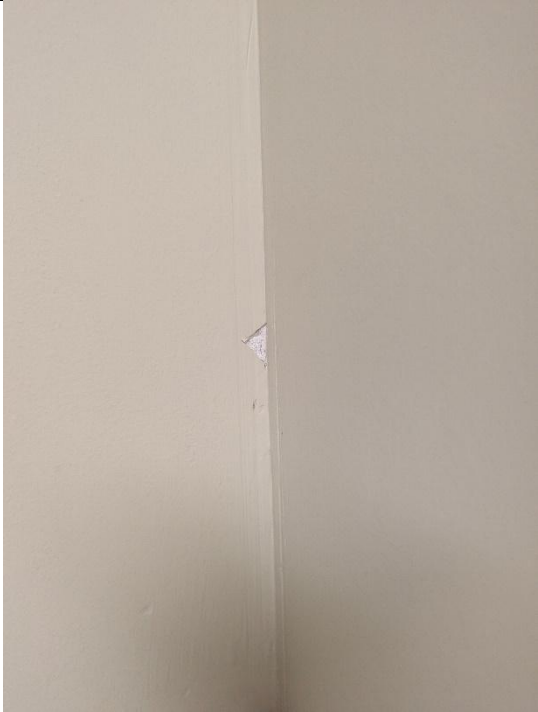
| <p>Sample: 63919-3<br/>Location: File Room<br/>Description: Drywall Joint Compound<br/>Asbestos: None Detected</p> | <p>Sample: 63919-4<br/>Location: Board Room<br/>Description: Drywall Joint Compound<br/>Asbestos: None Detected</p> |

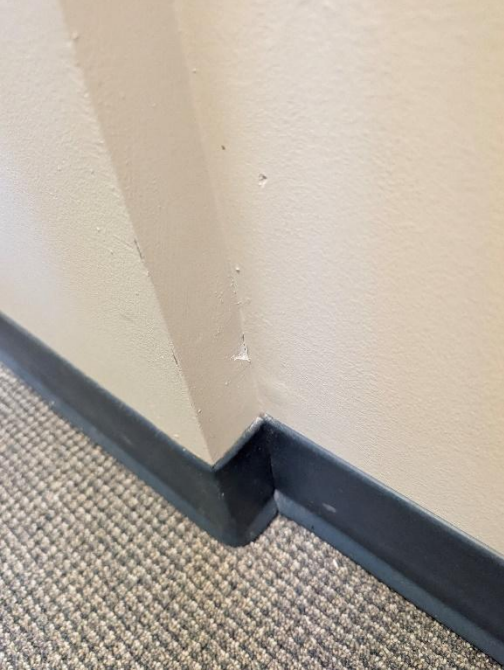
| Sample: | 63919-5 | Sample: | 63919-6 |
| Location: | General Manager's Office | Location: | Senior Field Tech Office |
| Description: | Drywall Joint Compound | Description: | Drywall Joint Compound |
| Asbestos: | None Detected | Asbestos: | None Detected |

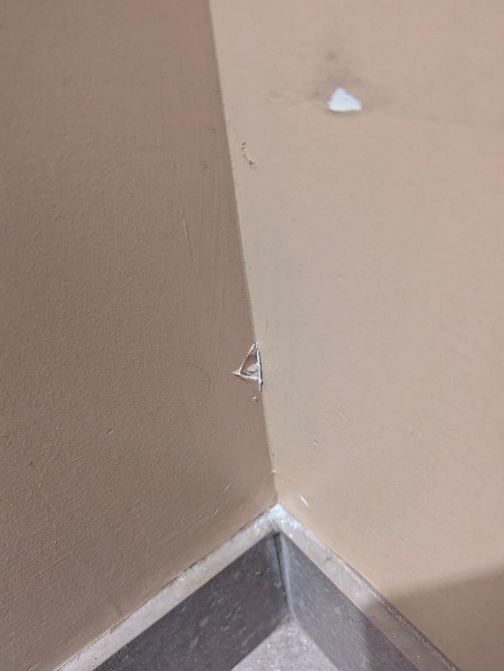
| Sample: | 63919-7 | Sample: | 63919-8 |
| Location: | Client Washroom | Location: | Mud Room |
| Description: | Drywall Joint Compound | Description: | Acoustic Ceiling Tile |
| Asbestos: | None Detected | Asbestos: | None Detected |

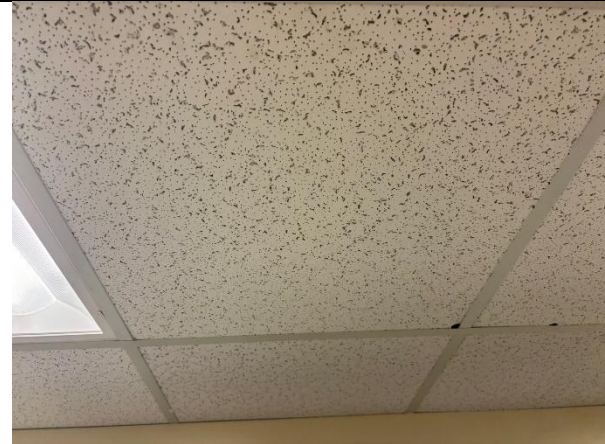
| Sample: | 63919-9 | Sample: | 63919-10 |
| Location: | Surveying File Room | Location: | Senior Field Tech Office |
| Description: | Acoustic Ceiling Tile | Description: | Acoustic Ceiling Tile |
| Asbestos: | None Detected | Asbestos: | None Detected |

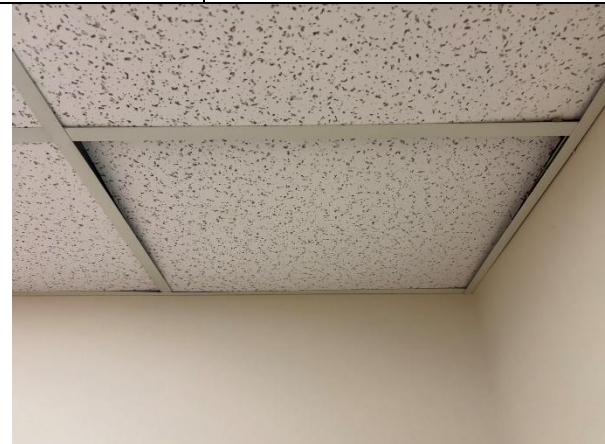
| Sample: | 63919-11 | Sample: | 63919-12 |
| Location: | Boardroom | Location: | General Manager's Office |
| Description: | Acoustic Ceiling Tile | Description: | Acoustic Ceiling Tile |
| Asbestos: | None Detected | Asbestos: | None Detected |

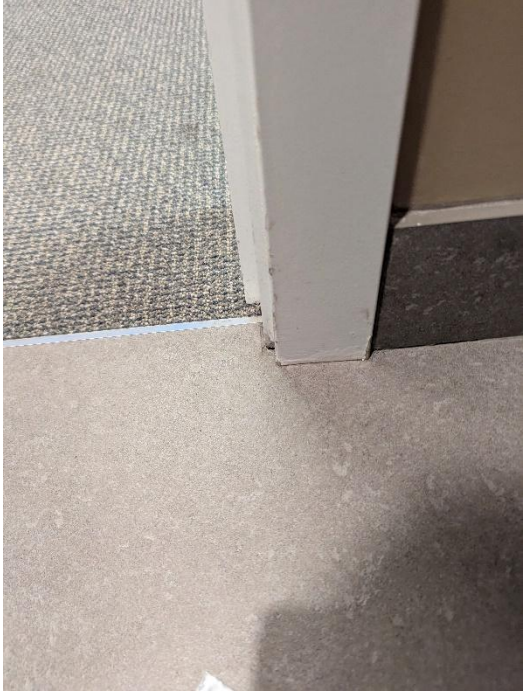
| Sample: | 63919-13 | Sample: | 63919-14 |
| Location: | Client Washroom | Location: | Reception |
| Description: | Grout | Description: | Grout |
| Asbestos: | None Detected | Asbestos: | None Detected |

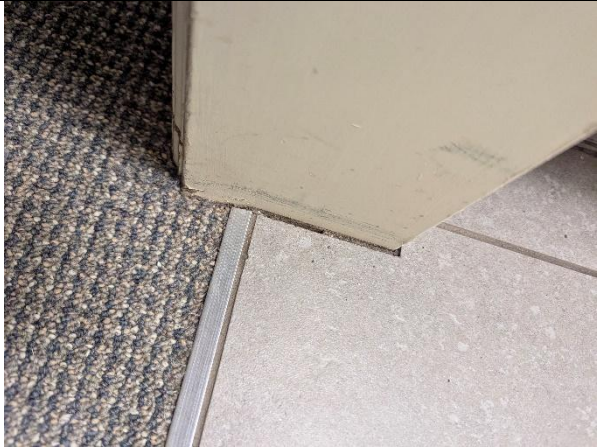
| Sample: | 63919-15 | Sample: | 63919-16 |
| Location: | Kitchen | Location: | Mudroom |
| Description: | Grout | Description: | Vinyl Sheet Floor |
| Asbestos: | None Detected | Asbestos: | None Detected |

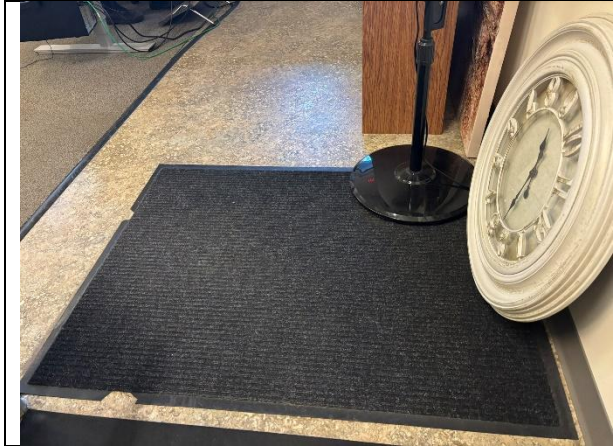
| Sample: | 63919-17 |

| Location: | Engineering/Survey Workstations |
| Description: | Vinyl Sheet Floor |
| Asbestos: | None Detected |

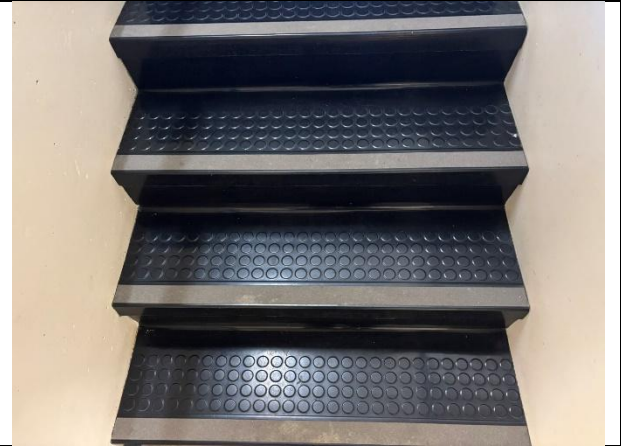
| Sample: | 63919-18 |

| Location: | Engineering/Survey Workstations |
| Description: | Stair Tread |
| Asbestos: | None Detected |

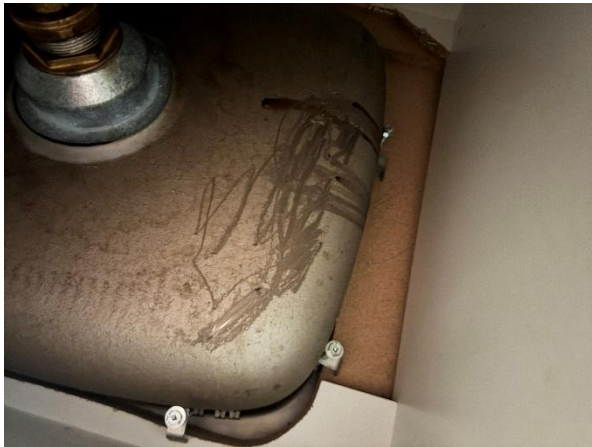
| Sample: | 63919-19 |

| Material | Description | Location and Quantity Estimates | Recommendation |
|---|---|---|---|
| Asbestos | Sink Insulation | 2 sinks in the centre storage bay | Moderate risk asbestos abatement work procedures<br><br>Further inspection and destructive testing required prior to demolition |

| Location: | Kitchen Area |
| Description: | Sink Insulation |
| Asbestos: | 4% Chrysotile |

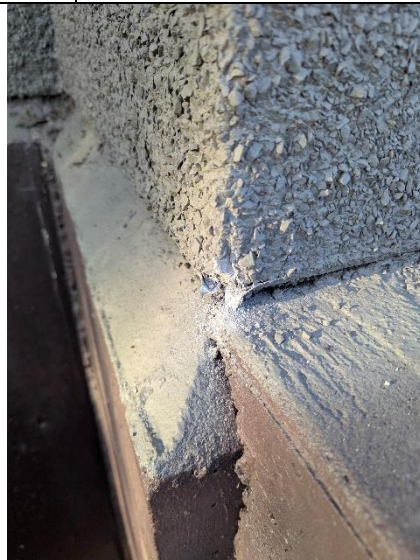
| Sample: | 63919-20 |

| Location: | Exterior – Siding |
| Description: | Stucco |
| Asbestos: | None Detected |

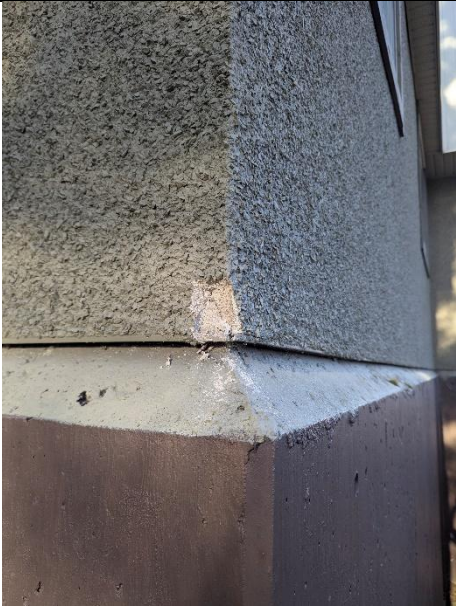
| Sample: | 63919-21 | Sample: | 63919-22 |
| Location: | Exterior – Siding | Location: | Exterior – Siding |
| Description: | Stucco | Description: | Stucco |
| Asbestos: | None Detected | Asbestos: | None Detected |

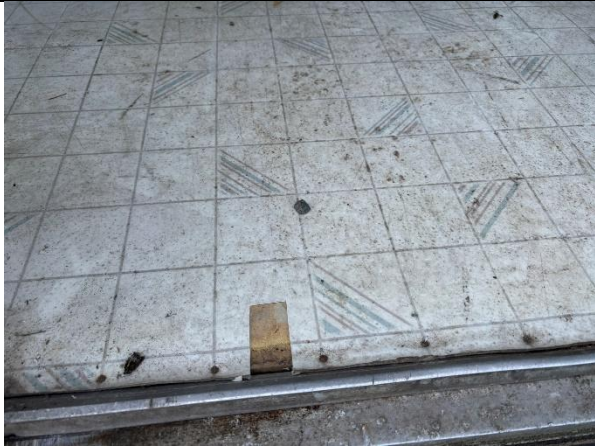
| Sample: | 63919-23 | Sample: | 63919-24 |
| Location: | Portable | Location: | Portable |
| Description: | Vinyl Sheet Floor | Description: | Drywall Joint Compound |
| Asbestos: | None Detected | Asbestos: | None Detected |

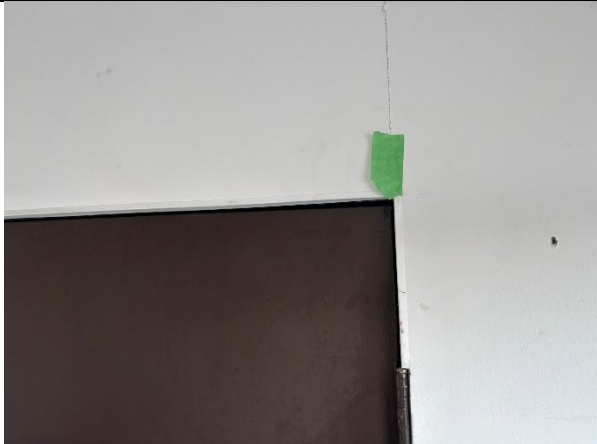
| Sample: | 63919-25 | Sample: | 63919-26 |
| Location: | Portable | Location: | Portable |
| Description: | Drywall Joint Compound | Description: | Drywall Joint Compound |
| Asbestos: | None Detected | Asbestos: | None Detected |

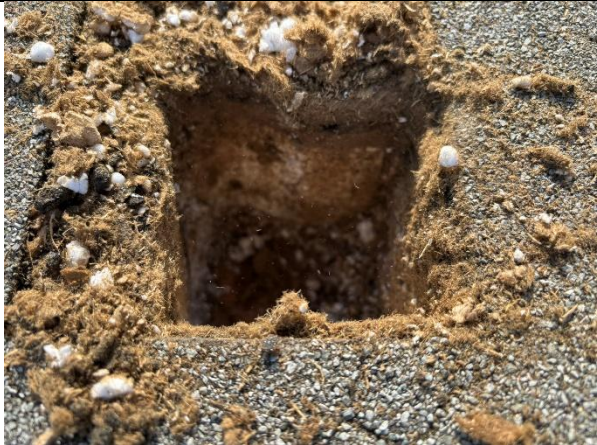
| Sample: | 63919-27 | Sample: | 63919-28 |
| Location: | Roof | Location: | Roof |
| Description: | Torch-on Asphalt | Description: | Torch-on Asphalt |
| Asbestos: | None Detected | Asbestos: | None Detected |

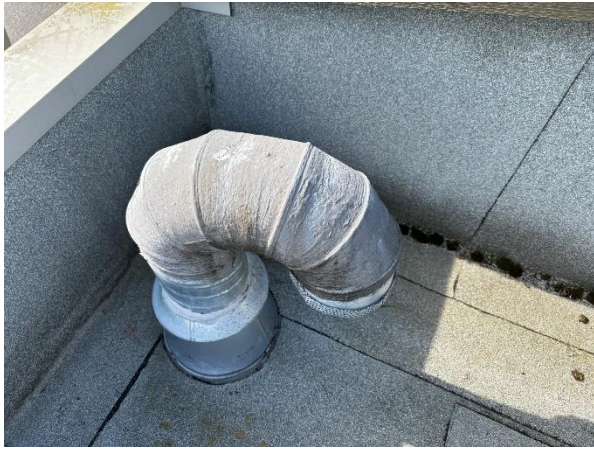
| Sample: | 63919-29 |

| Location: | Roof |
| Description: | Mastic - Grey |
| Asbestos: | None Detected |

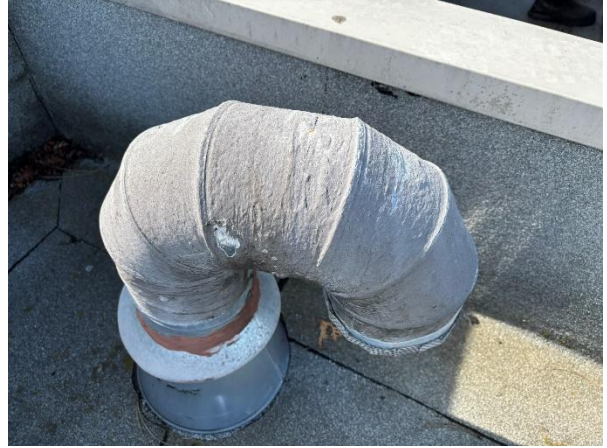
| Sample: | 63919-30 |

| Location: | Roof |
| Description: | Mastic - Grey |
| Asbestos: | None Detected |

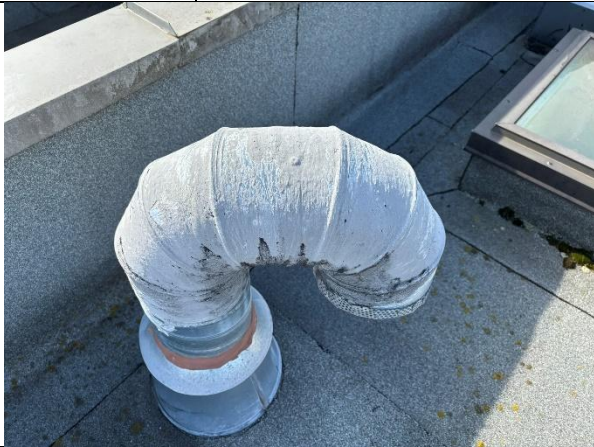
| Sample: | 63919-31 |

| Location: | Roof |
| Description: | Mastic - Grey |
| Asbestos: | None Detected |

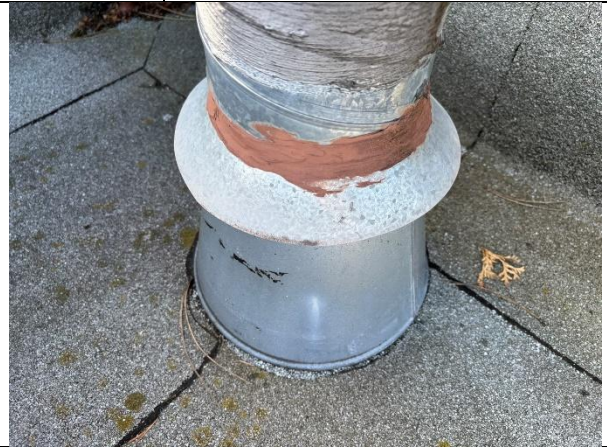
| Sample: | 63919-32 |

| Location: | Roof |
| Description: | Mastic - Brown |
| Asbestos: | None Detected |

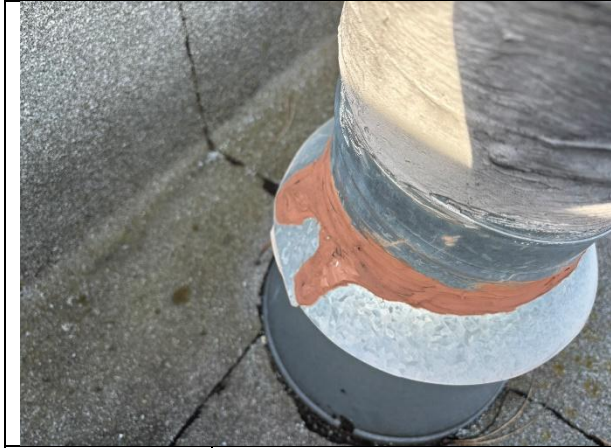
| Sample: | 63919-33 |

| Location: | Roof |
| Description: | Mastic - Brown |
| Asbestos: | None Detected |

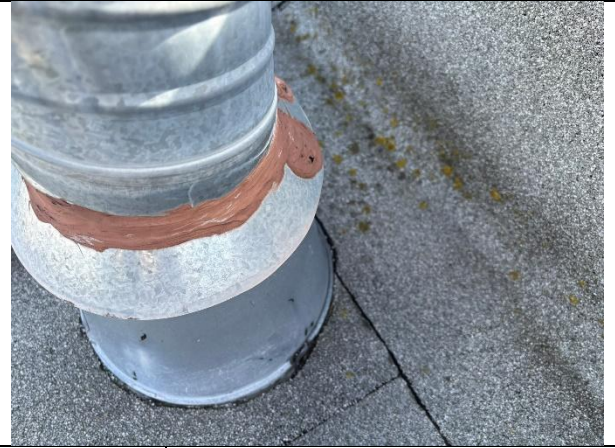
| Sample: | 63919-34 |

| Location: | Roof |
| Description: | Mastic - Brown |
| Asbestos: | None Detected |

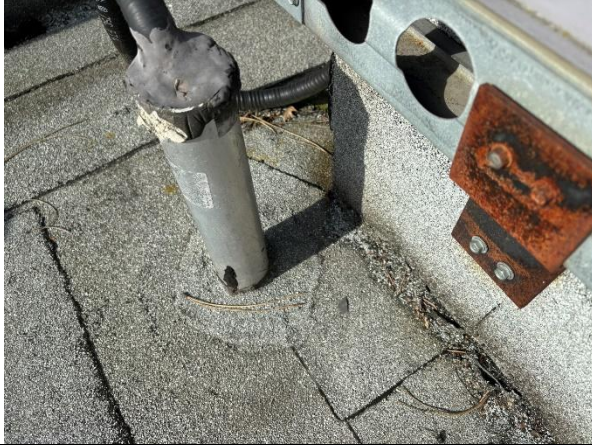
| Sample: | 63919-35 |

| Location: | Roof |
| Description: | Sealant - Black |
| Asbestos: | None Detected |

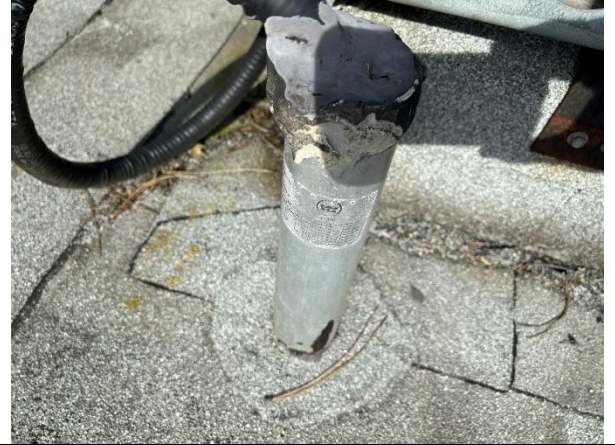
| Sample: | 63919-36 |

| Location: | Roof |
| Description: | Sealant - Black |
| Asbestos: | None Detected |
