# **Hazardous Materials Investigation**

## **4216 Glanford Avenue, Victoria, BC**

Island EHS Project #63918

Original issue date April 2025  
Revised July 2025 (Rev01)  
September 2025 (Rev02)

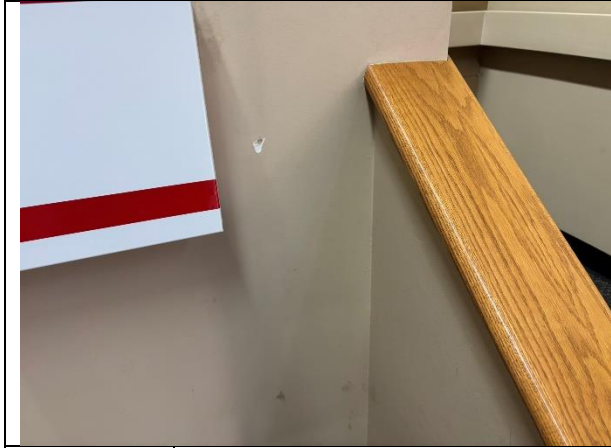
Sample: 63918-1  
 Location: Main Foyer – East End  
 Description: Drywall Joint Filler Compound  
 Asbestos: None Detected

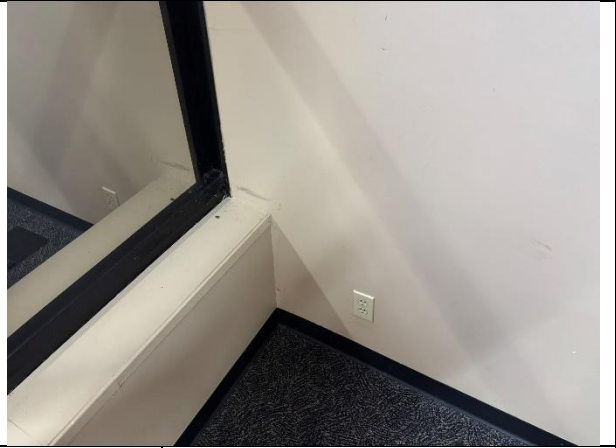
Sample: 63918-2  
 Location: Main Foyer – East End  
 Description: Drywall Joint Filler Compound  
 Asbestos: None Detected

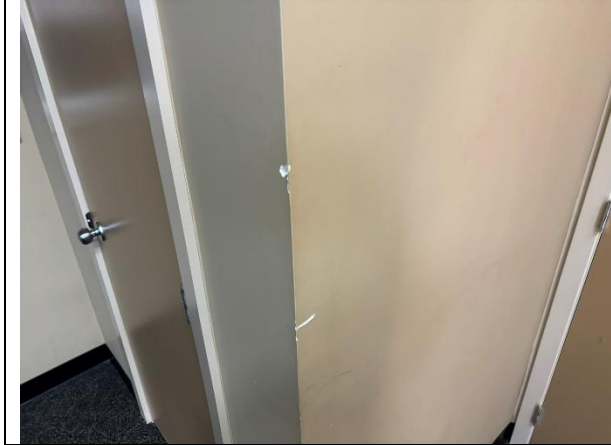
Sample: 63918-3  
 Location: Main Foyer – West End  
 Description: Drywall Joint Filler Compound  
 Asbestos: None Detected

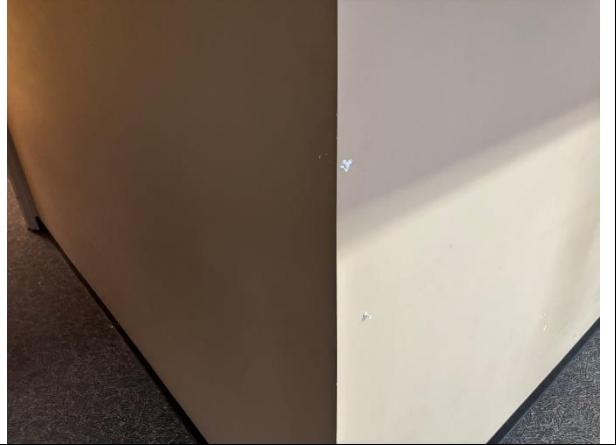
Sample: 63918-4  
 Location: Main Foyer – West End  
 Description: Drywall Joint Filler Compound  
 Asbestos: None Detected

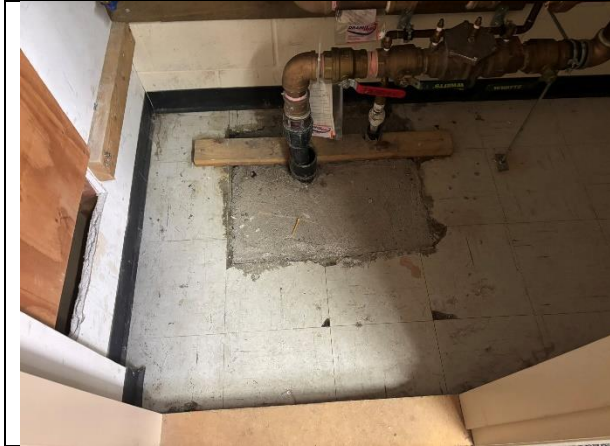
Sample: 63918-5  
 Location: Main Foyer – Under Stairs  
 Description: Floor Tile  
 Asbestos: **1% Chrysotile**

| Material | Description | Location and Quantity Estimates | Recommendation |
|---|---|---|---|
| Asbestos | Floor tile and sink mastic | 1000 square feet of floor tile in the foyer<br>2 sinks in the centre storage bay | Moderate risk asbestos abatement work procedures<br><br>If unidentified materials are encountered, work must stop until the material is identified and assessed |

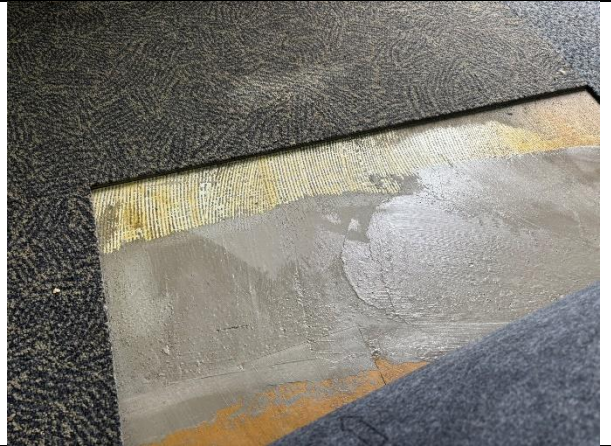
Sample: 63918-6  
 Location: Main Foyer – Under Carpet  
 Description: Floor Tile  
 Asbestos: **1% Chrysotile**

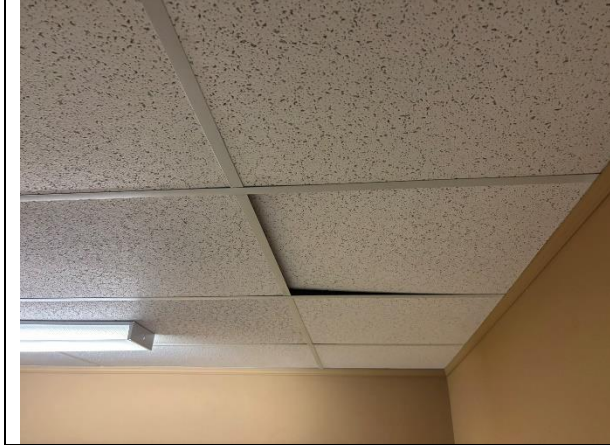
Sample: 63918-7  
 Location: Offices off Main Foyer  
 Description: Lay-in Ceiling Panel  
 Asbestos: None Detected

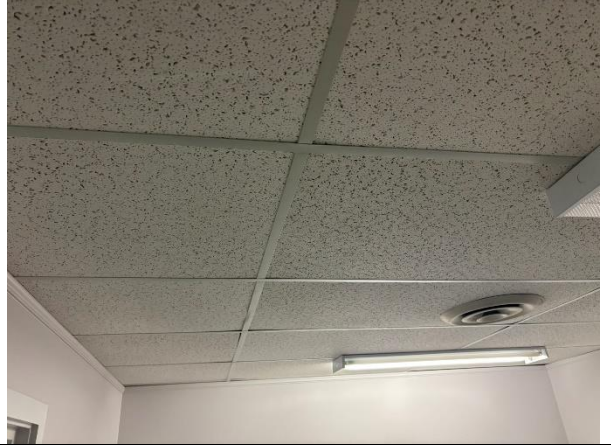
Sample: 63918-8  
 Location: Offices Off Main Foyer  
 Description: Lay-in Ceiling Panel  
 Asbestos: None Detected

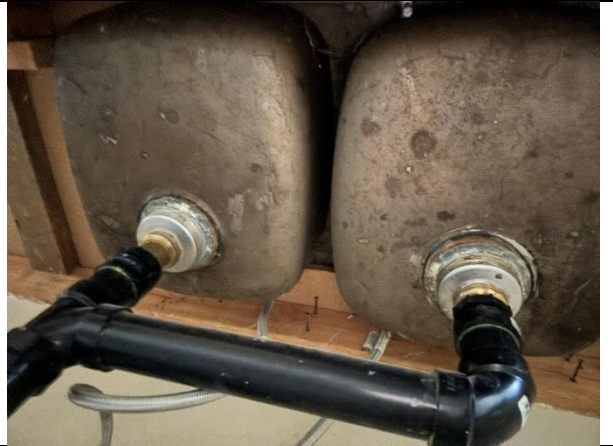
| Sample: | 63918-22 |
| Location: | Cleaning Shop |
| Description: | Sink Mastic |
| Asbestos: | <b>5% Chrysotile</b> |

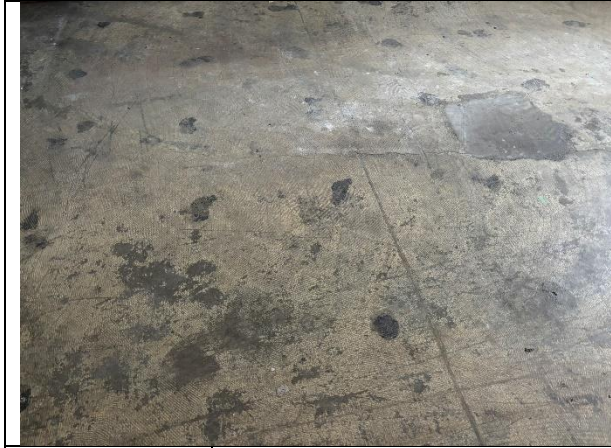
Sample: 63918-53  
 Location: Cleaning Shop on Floor  
 Description: Mastic  
 Asbestos: None Detected

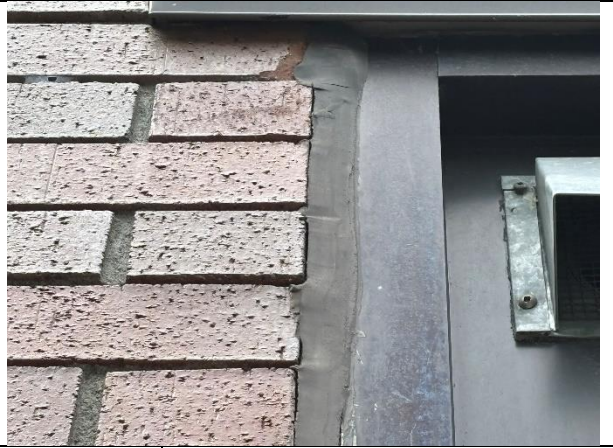
Sample: 63918-54  
 Location: Exterior at Windows  
 Description: Caulking  
 Asbestos: None Detected

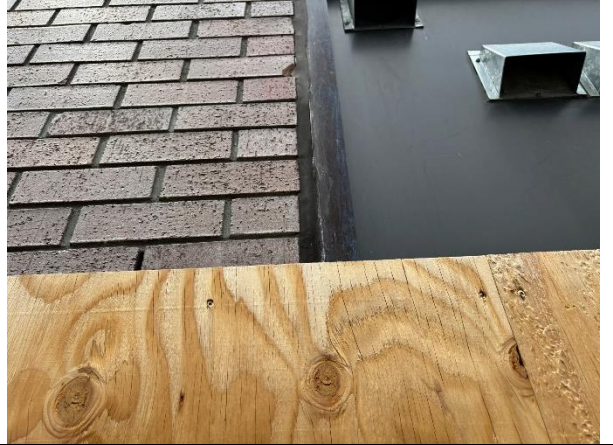
Sample: 63918-56  
 Location: Exterior at Windows  
 Description: Caulking  
 Asbestos: None Detected

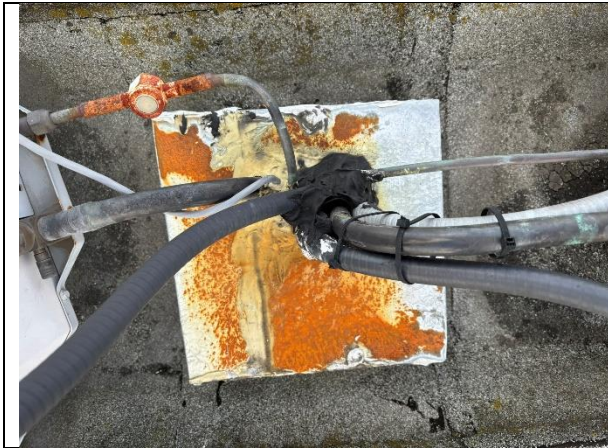
Sample: 63918-61  
 Location: Roof  
 Description: Sealant - black  
 Asbestos: None Detected

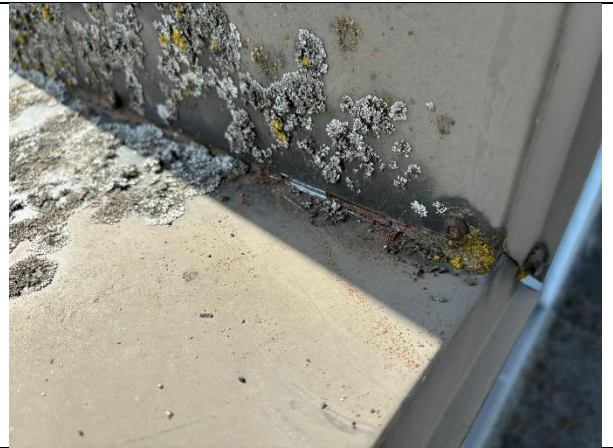
Sample: 63918-62  
 Location: Roof - Flashing  
 Description: Caulking  
 Asbestos: None Detected

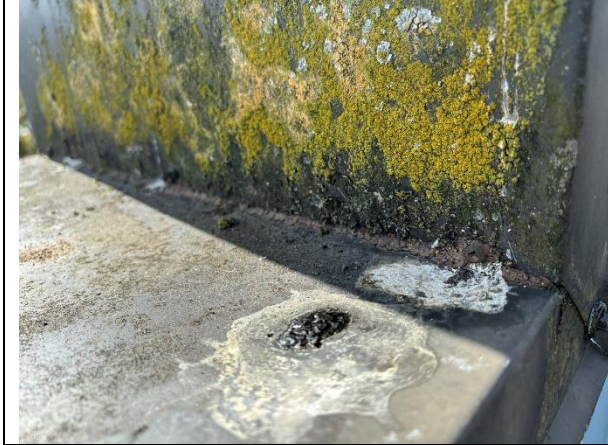
Sample: 63918-63  
 Location: Roof - Flashing  
 Description: Caulking  
 Asbestos: None Detected

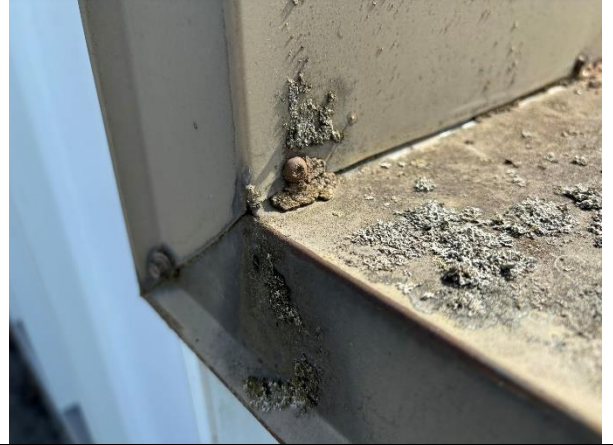
Sample: 63918-64  
 Location: Roof - Flashing  
 Description: Caulking  
 Asbestos: None Detected
