BC TRANSIT

PHASE I ENVIRONMENTAL SITE ASSESSMENT

2401 BURNSIDE ROAD WEST, VIEW ROYAL, BC

SEPTEMBER 14, 2017

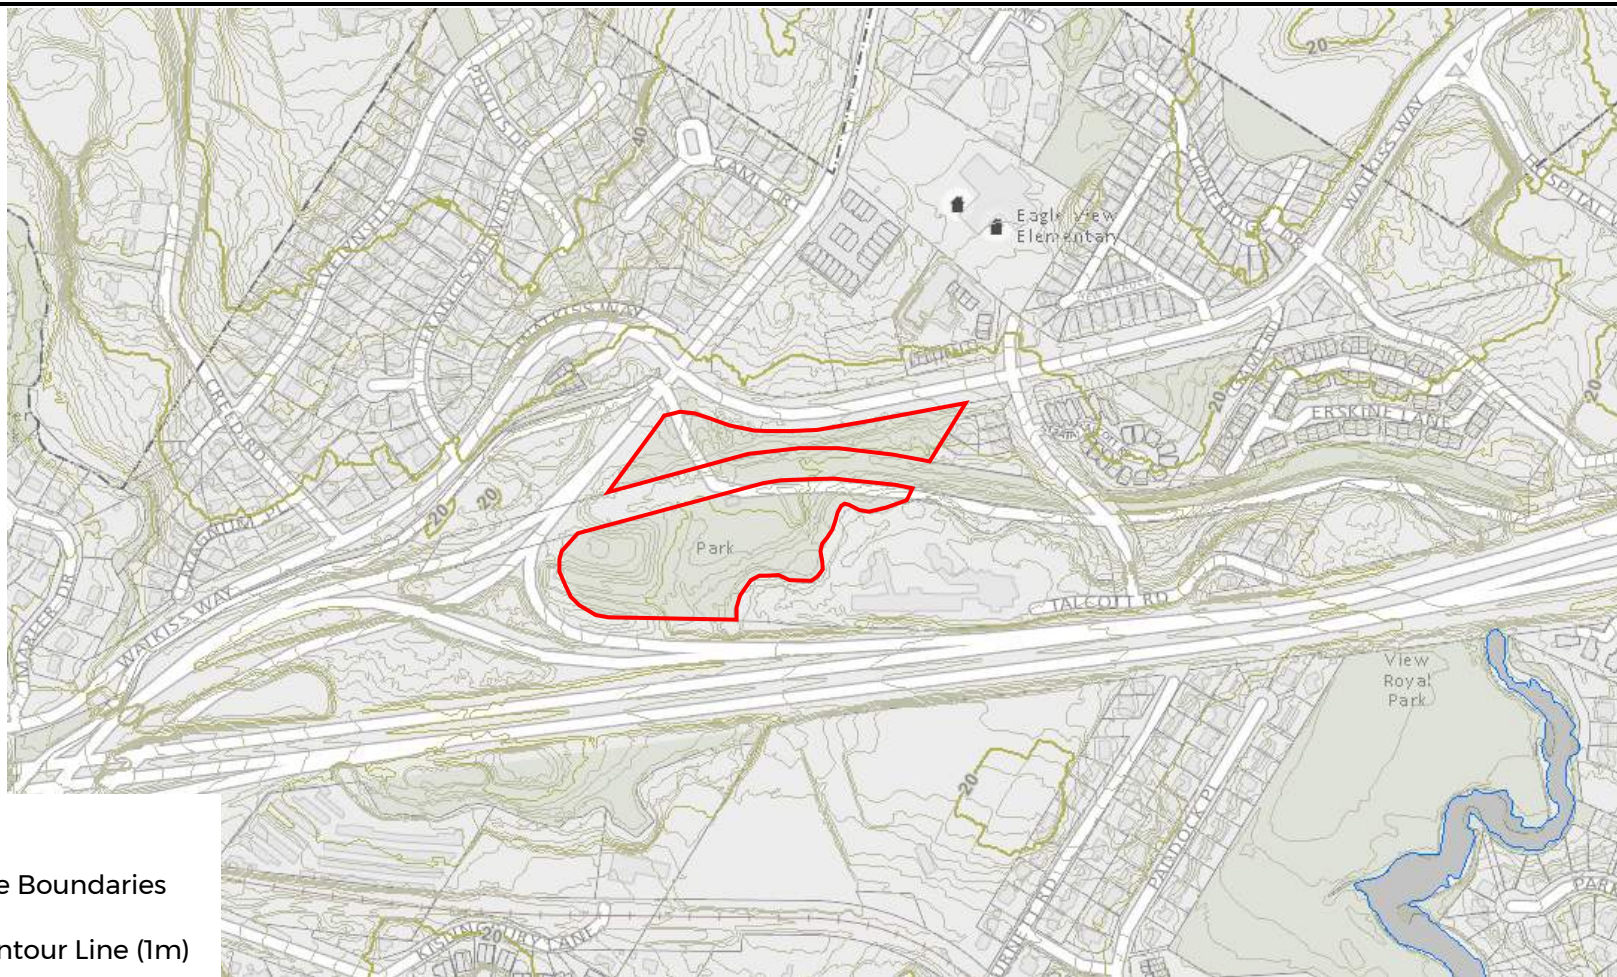
FIGURE NO.: 3	DATE: SEPT 2017	FILE NO.: 169-00385-20	SCALE: NTS	DRAWN BY: CL	REV NO.: 1
------------------	--------------------	---------------------------	---------------	-----------------	---------------

- Site Boundaries
- Contour Line (1m)

PROJECT:	PHASE I ENVIRONMENTAL SITE ASSESSMENT 2401 BURNSIDE ROAD WEST VIEW ROYAL, BC
TITLE:	SITE AND SURROUNDING TOPOGRAPHY
CLIENT:	BC TRANSIT

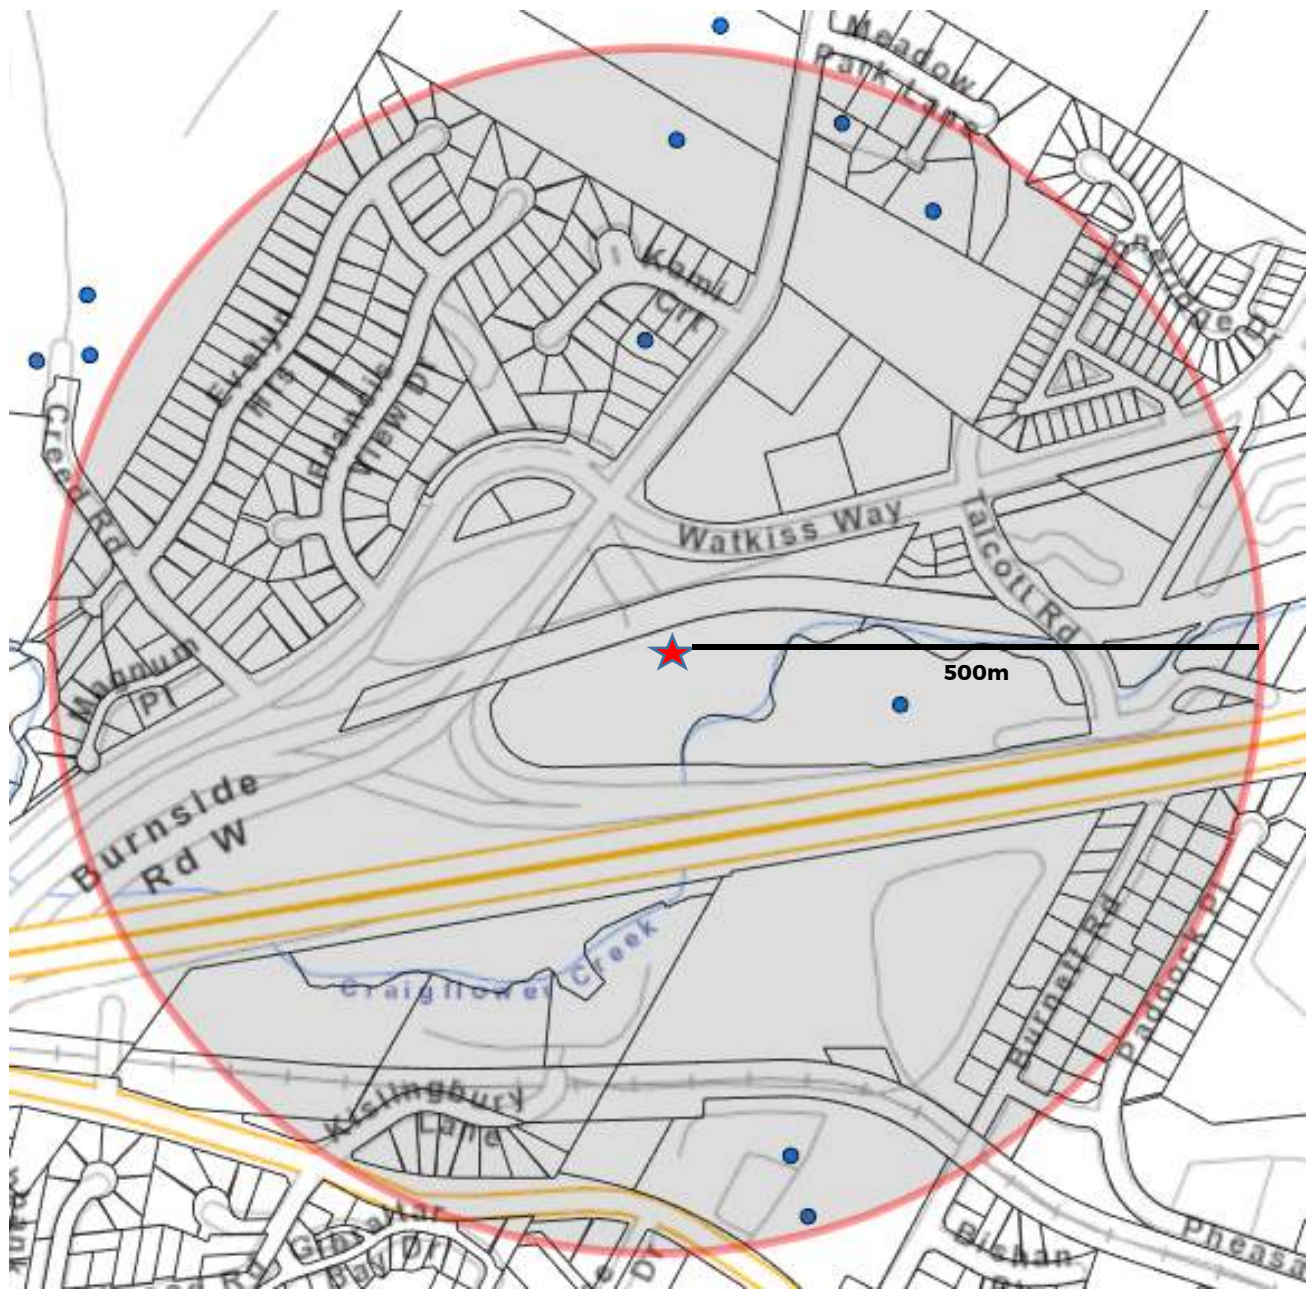
FIGURE NO.:	DATE:	FILE NO.:	SCALE:	DRAWN BY:	REV NO.:
4	SEPT 2017	169-00385-20	NTS	CL	1

PROJECT:				
	PHASE I ENVIRONMENTAL SITE ASSESSMENT 2401 BURNSIDE ROAD WEST VIEW ROYAL, BC				
	TITLE:				
WATER WELL SEARCH RESULTS					
CLIENT:					
BC TRANSIT

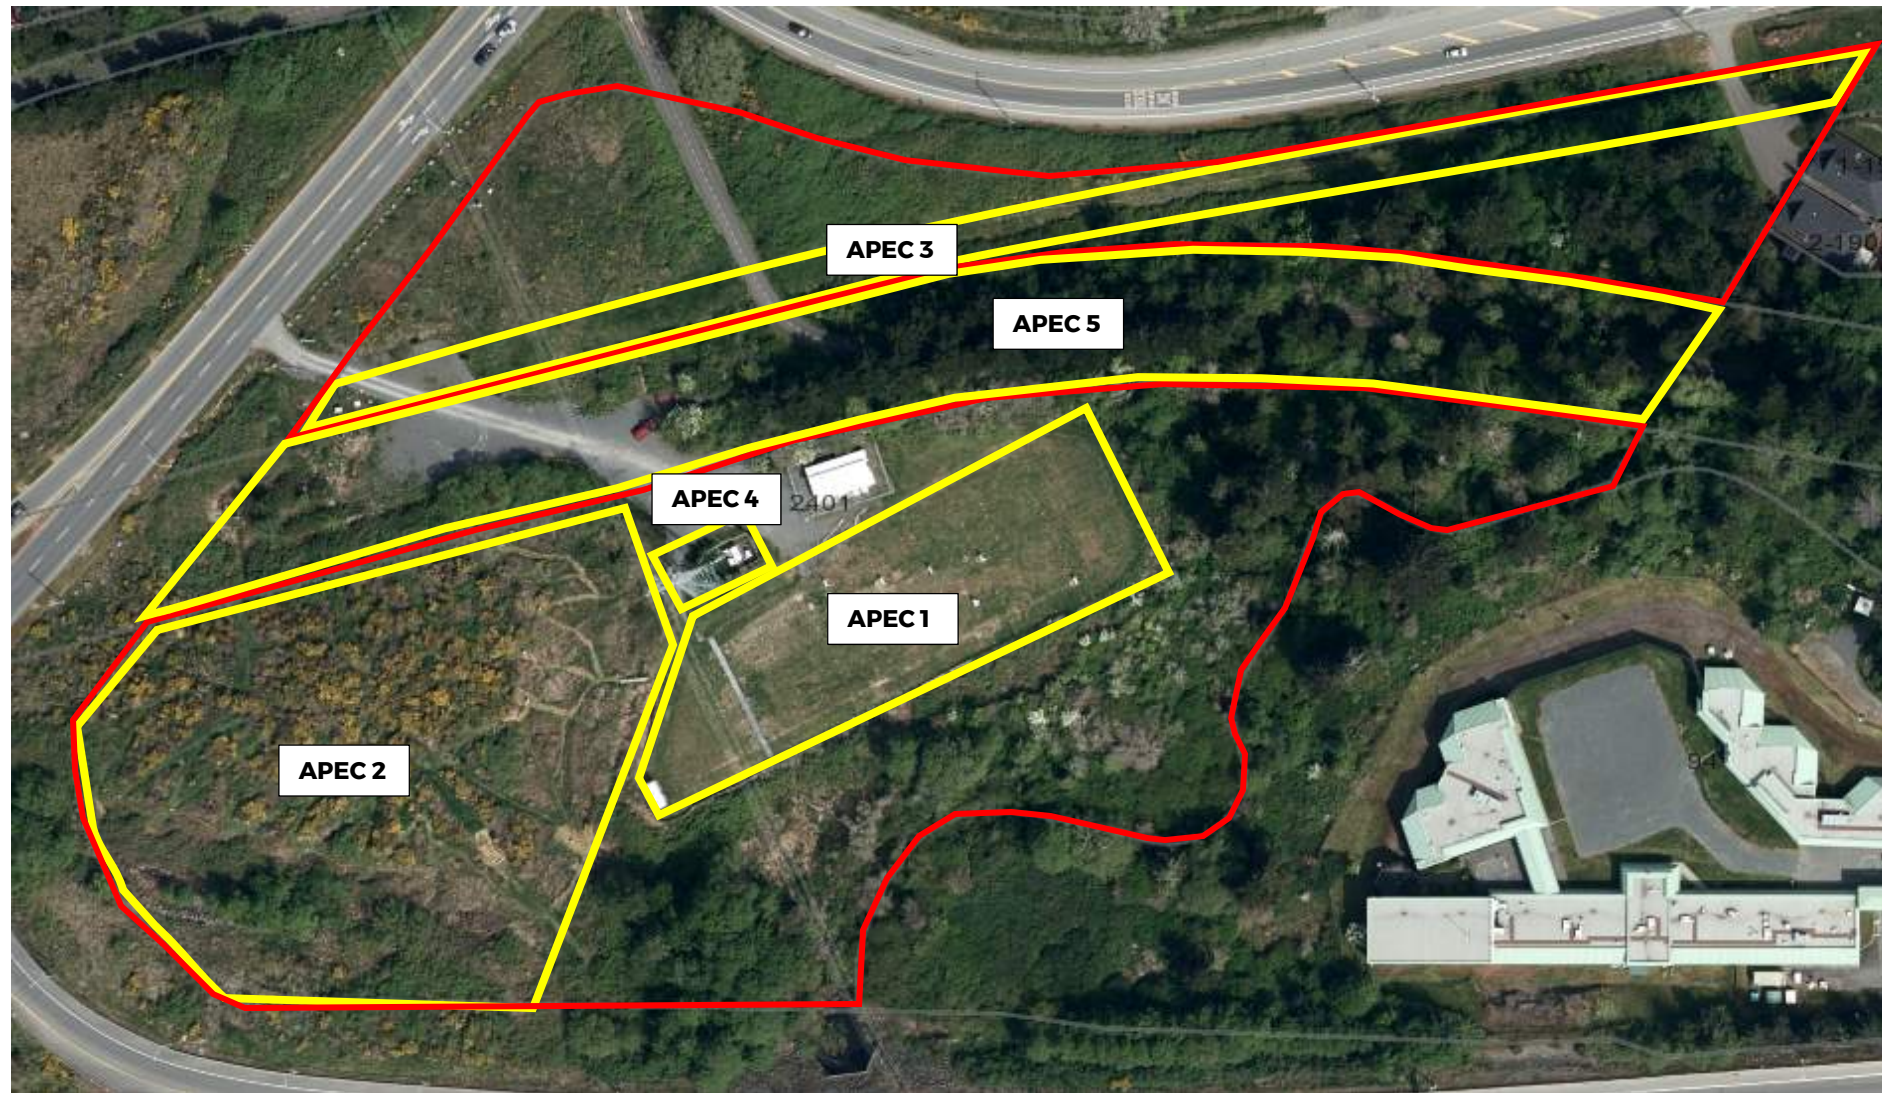
PROJECT: PHASE I ENVIRONMENTAL SITE ASSESSMENT 2401 BURNSIDE ROAD WEST VIEW ROYAL, BC					
	TITLE: APEC LOCATION PLAN					
	CLIENT: BC TRANSIT					
FIGURE NO.: 6	DATE: SEPT 2017	FILE NO.: 169-00385-20	SCALE: NTS	DRAWN BY: CL	REV NO.: 1

Summary of Identified APECs and PCOCs

APEC NO.	APEC DESCRIPTION	RISK RATING*
APEC #1 (on-Site)	Archery range - historical fill placement during construction of the range in 2011.	Moderate
APEC #2 (on-Site)	West end of the Site - area of fill placement and fill material identified during geotechnical investigation.	Moderate
APEC #3 (on-Site)	CRD Statutory Right-of-Ways (SRWs) at the north end of the Site - potential for use of herbicides to keep the SRWs clear of vegetation.	Low to Moderate
APEC #4 (on-Site)	BC Hydro SRW at the centre of the Site - potential for PCBs associated with on-site electrical equipment.	Low to Moderate
APEC #5 (off-Site)	Former CNR and current Ministry of Transportation property bisecting the Site - potential historical use of herbicides and/or petroleum hydrocarbons to keep the rail line clear. Potential for buried rail materials from the former railway.	Low to Moderate

- A sub-surface investigation in the form of a Phase II Environmental Site Assessment is recommended at the Site at this time to assess the identified on and off-Site APECs.
- If any environmentally suspect fill material is encountered onsite during any future redevelopment activities, such fill should be characterized prior to disposal offsite or at a permitted facility.

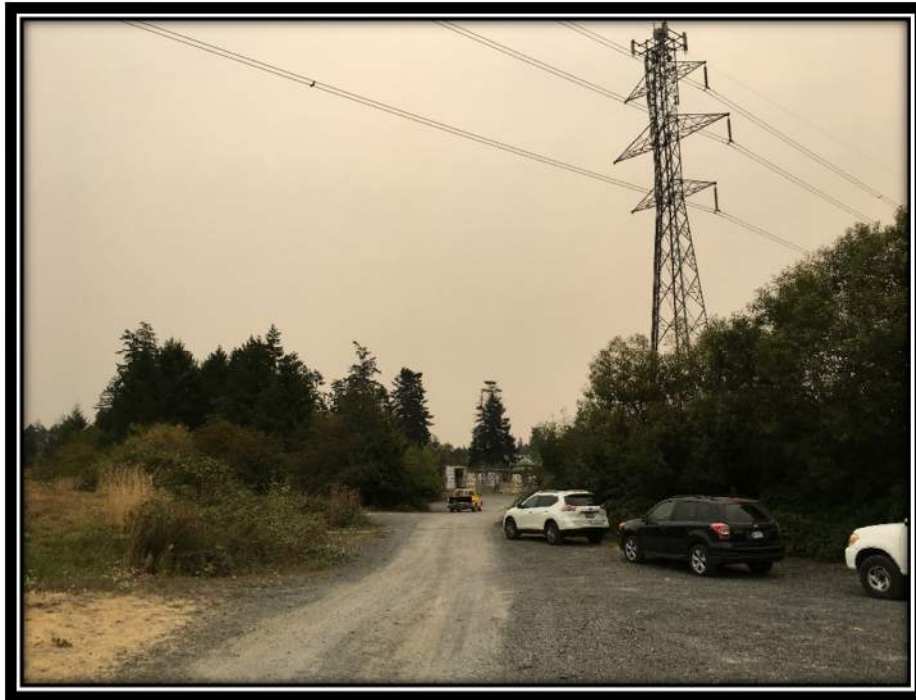
Photograph 1: Photo showing the gravel driveway entrance to the Site. Photo looking southeast.

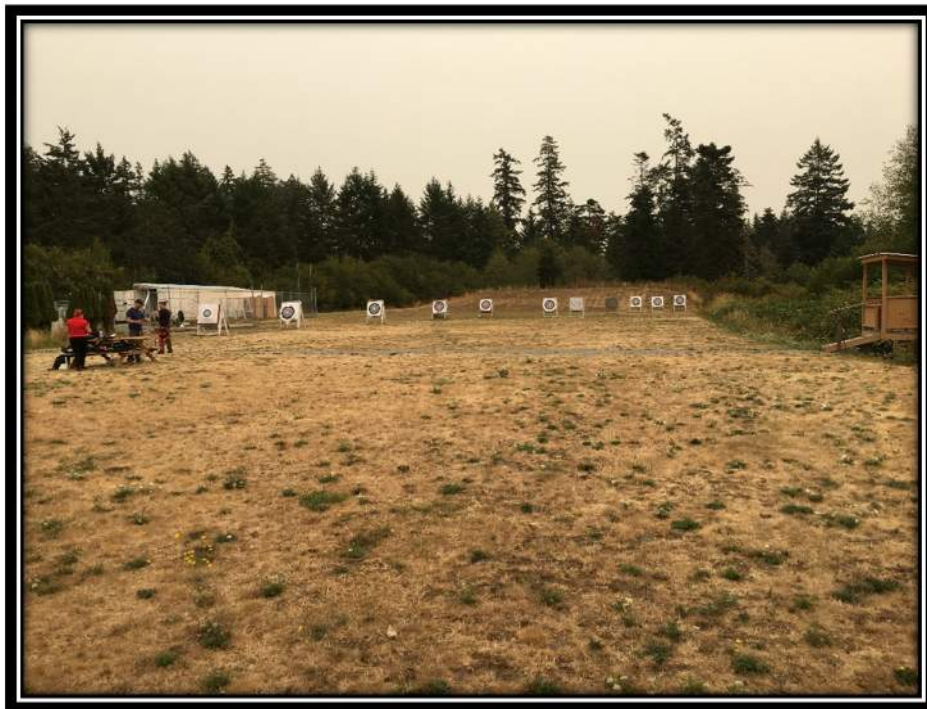
Photograph 2: Photo showing the archery range at the centre of the Site that was levelled with fill circa 2011 (APEC #1). Photo looking northeast.

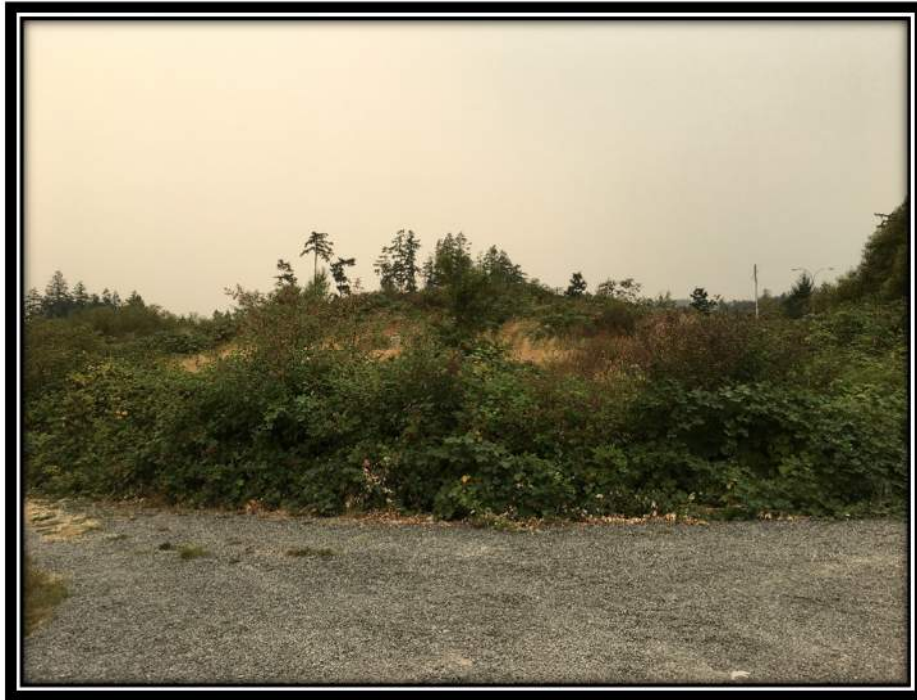
- A preliminary test-pitting investigation was recently completed by WSP's geotechnical division within the proposed development area at the west end of the Site. Fill material was identified in all six test pits, some of which extended beyond 4 meters below the ground surface. No foreign debris, odorous or stained soils or deleterious material was observed in the test pits; however, as this is the primary area for the planned development at the Site, this area is considered an APEC and environmental characterization of this fill material is recommended. The geotechnical report for the Site is being completed under a separate cover.

Photograph 3: Photo showing the west end of the Site where fill material was identified during a geotechnical investigation (APEC #2). Photo looking west.

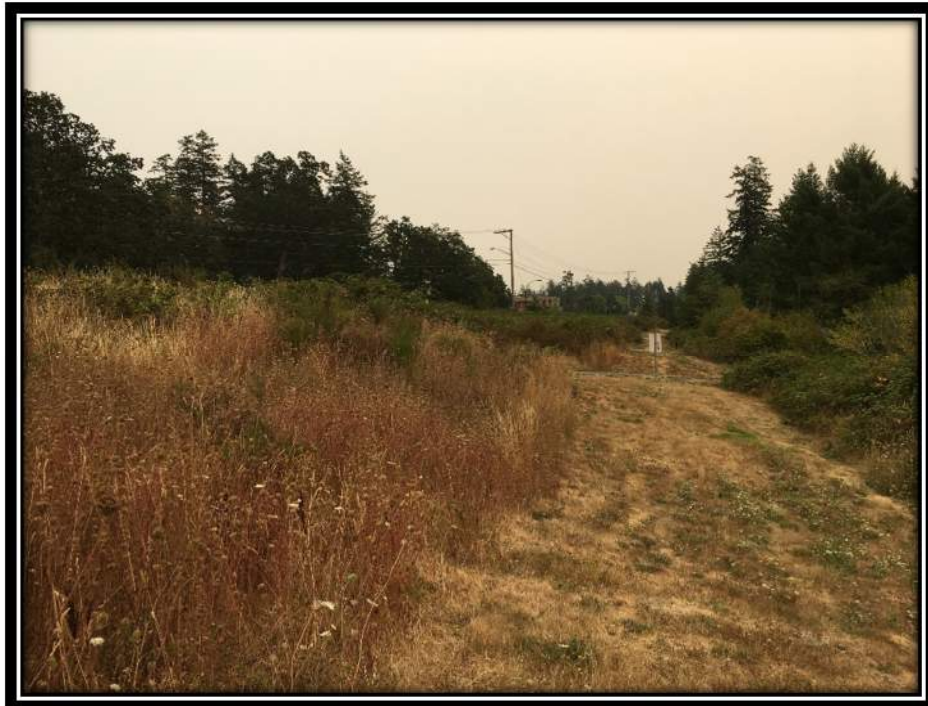
Photograph 4: Photo showing the Statutory Right-of-Way for the CRD water line (APEC #3). Photo looking northeast.

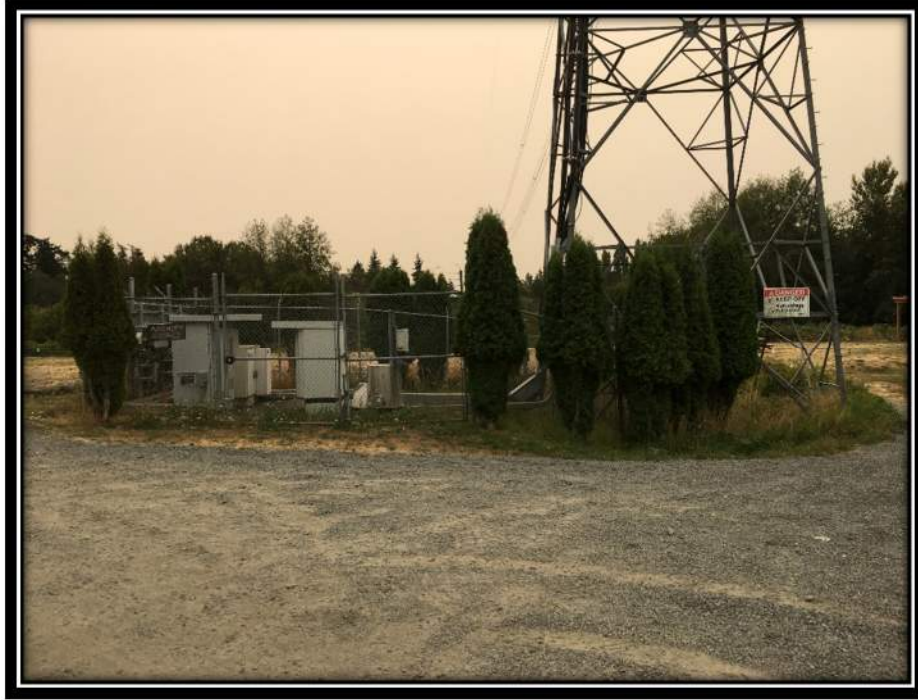
A BC Hydro tower and associated electrical equipment are present at the centre of the Site. No staining was noted in the area of the equipment at the time of the Site visit; however, the fenced hydroelectric area was not accessed during the Site visit and therefore it is inferred that PCB containing equipment may present within the fenced area and is considered a potential APEC at this time.

Photograph 5: Photo showing the base of the BC Hydro Electrical Transmission Tower (APEC #4). Photo looking southeast.

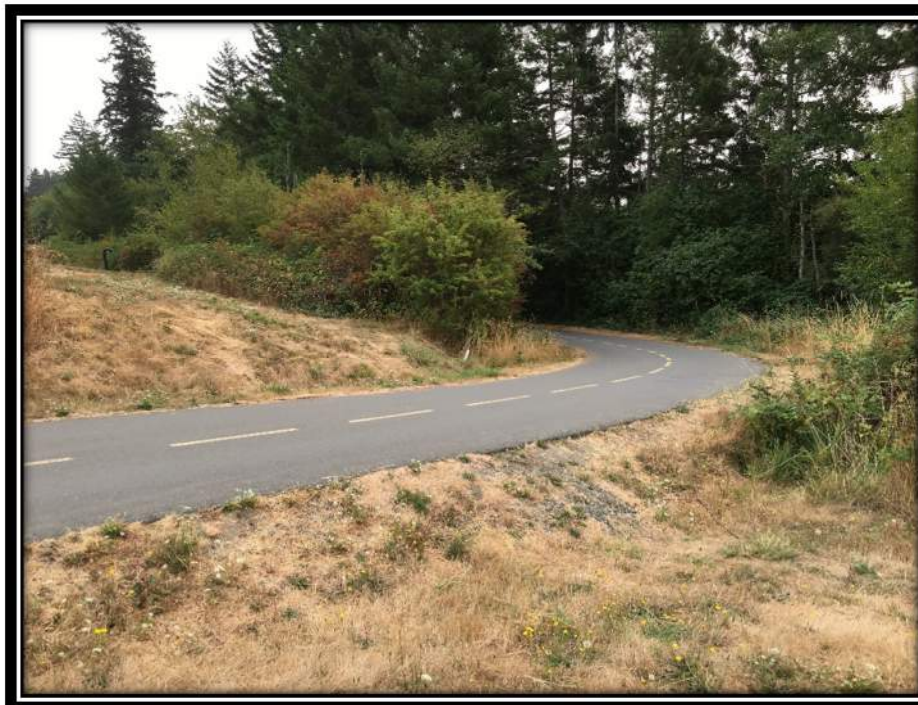
Photograph 6: Photo showing a portion of the former Canadian National Railway, currently the Galloping Goose Trail (APEC #5). Photo looking east.
