**Riparian Areas Protection Regulation: Assessment Report**

The proposed development is the construction of a handyDART bus facility at the Site (the Project). To facilitate construction of the facility, the Project will require the realignment and subsequent infilling of Watercourse 2 which flows through the centre of the property. Construction of the Project will be broken into two stages. The first stage includes installing site access, grading the hill on the west side of the Site, construction of the Watercourse 2 realignment channel including a tie-in to Craigflower Creek, and wick drain installation (Figure 2).

Client/Project/Report  
 BC Transit  
 2401 Burnside Road HandyDART Facility  
 Riparian Areas Regulation Development Permit

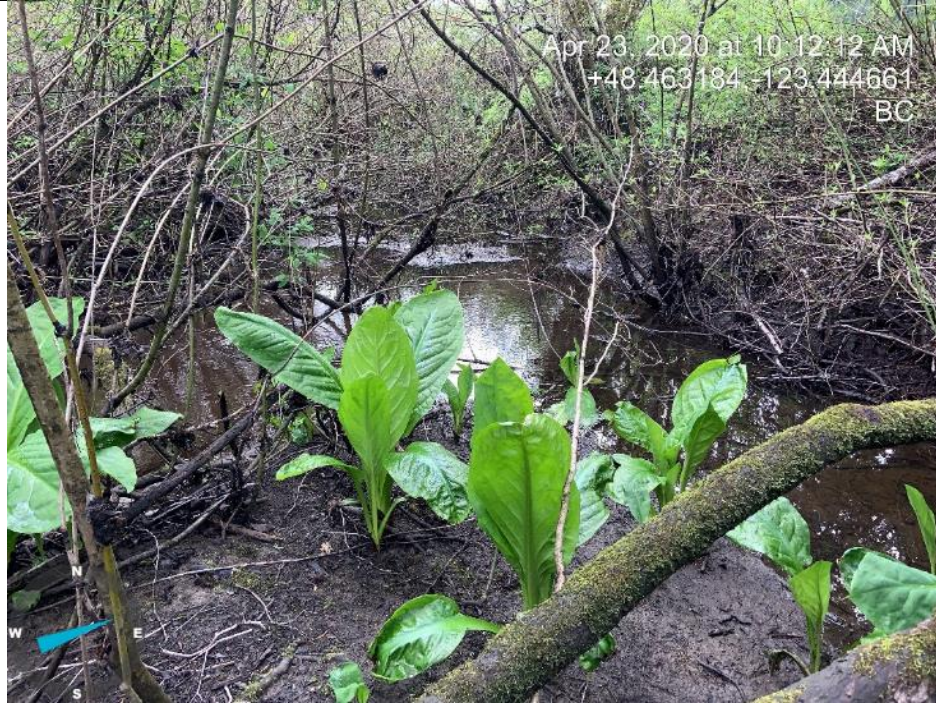
**Photo 1** Typical photo of Craigflower Creek taken at transect 1 looking downstream.

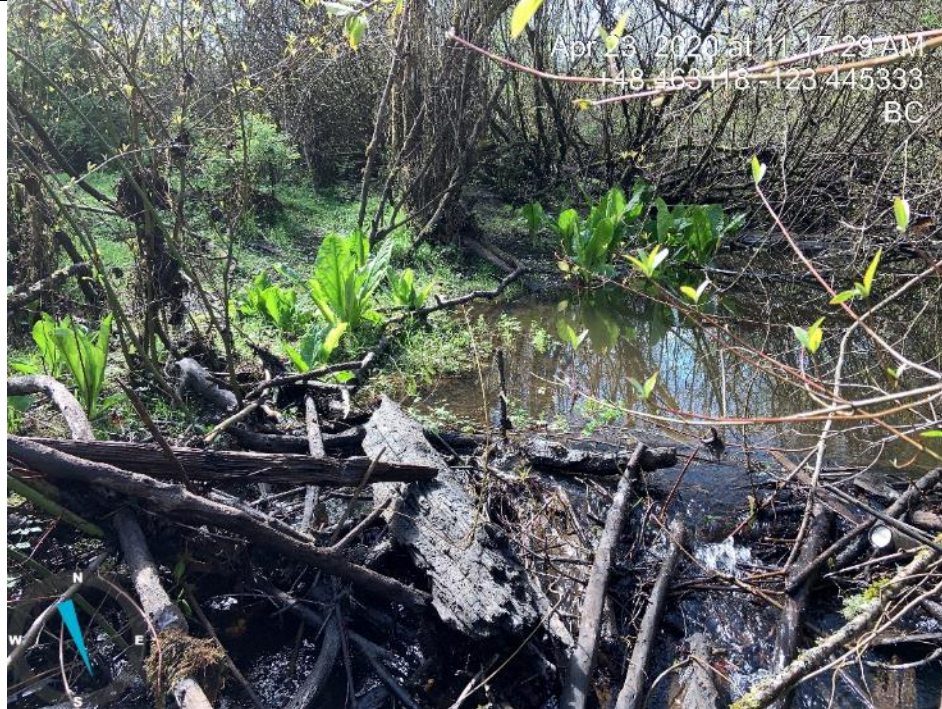
**Photo 2** Typical photo of Craigflower Creek looking upstream.

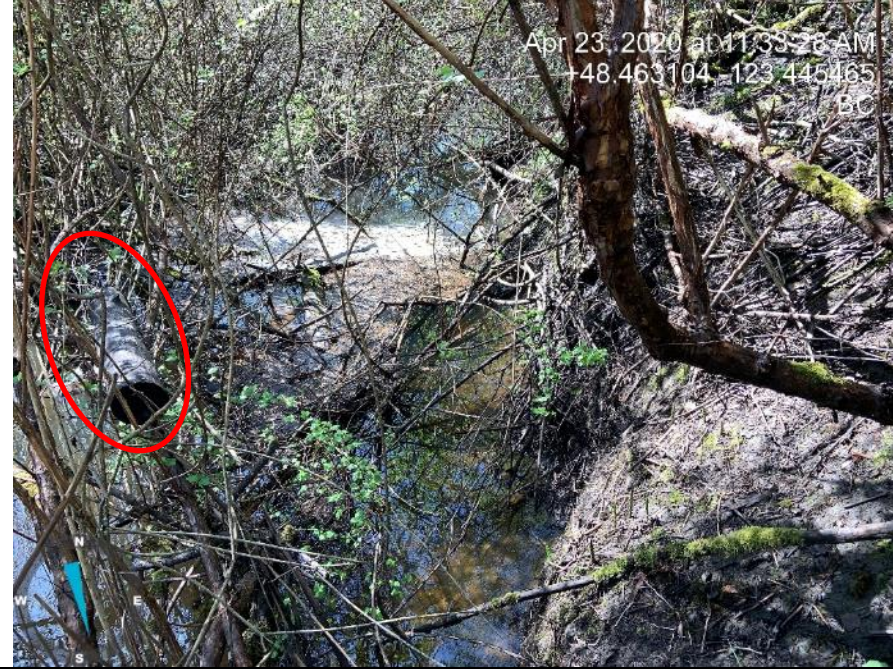
**Photo 3** Craigflower Creek looking upstream. Note log rafted in tree (red circle) indicating creek has very high flow at times.

Stream flows were moderate at the time of assessment, though evidence of flood flows were present throughout the reach in the form of rafting and debris in trees above and beside the channel (Photo 3). Beaver activity was observed in the form of a small dam (Photo 4)

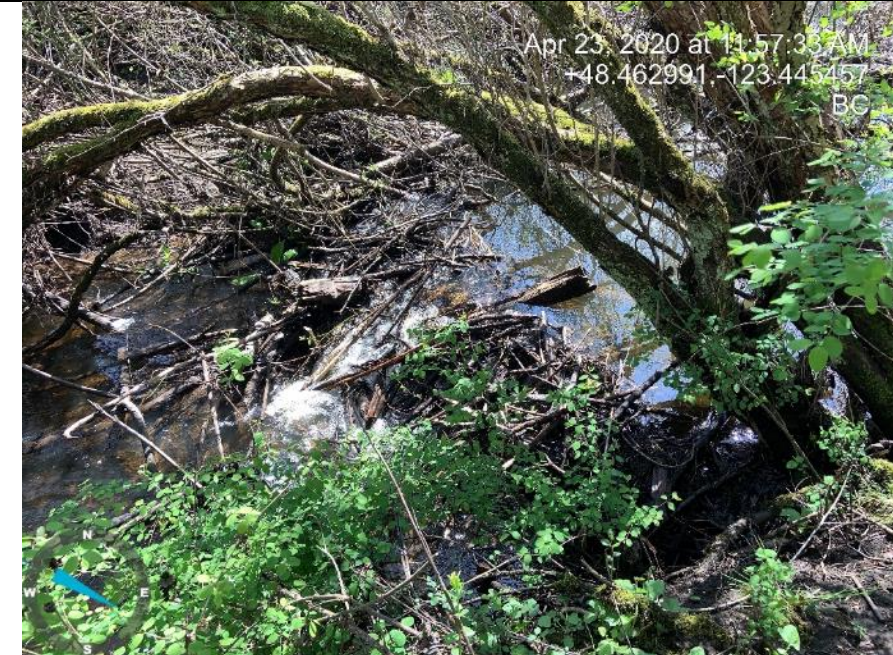
**Photo 4** Beaver dam on Craigflower Creek downstream of Highway 1 culvert.

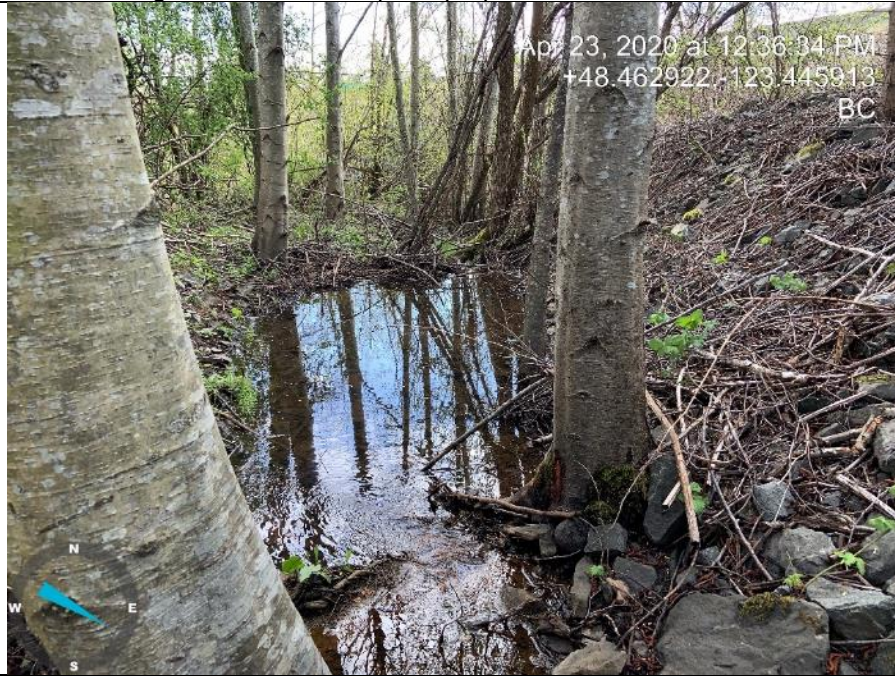
**Photo 7** Downstream, vegetated area of Watercourse 2 looking downstream. Right bank is made up of riprap berm that contains Watercourse 1.

Tree cover was almost exclusively restricted to the downstream 50 m of Watercourse 2 (Photos 7 & 8) and consisted of red alder (*Alnus rubra*), big leaf maple (*Acer macrophyllum*), and limited Douglas-fir. Upstream of this area, vegetation consisted of a narrow band (3-5 m) of Himalayan blackberry and reed canary grass (Photos 9-11). Beyond this strip, vegetation was made up of lawn for the archery range, gravel driveway/walkway, and invasive vegetation.

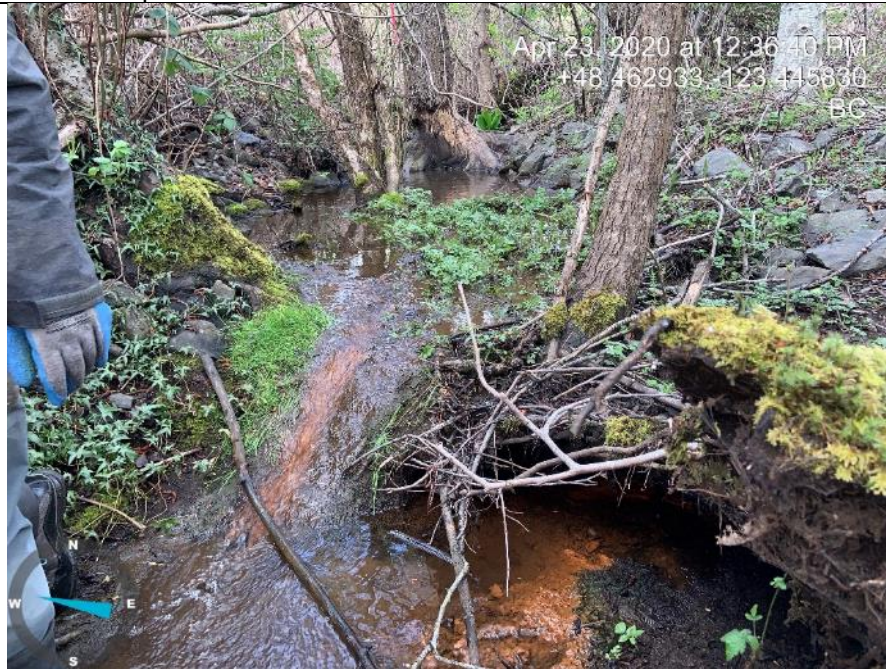
**Photo 8** Downstream, vegetated and natural area of Watercourse 2 looking upstream.

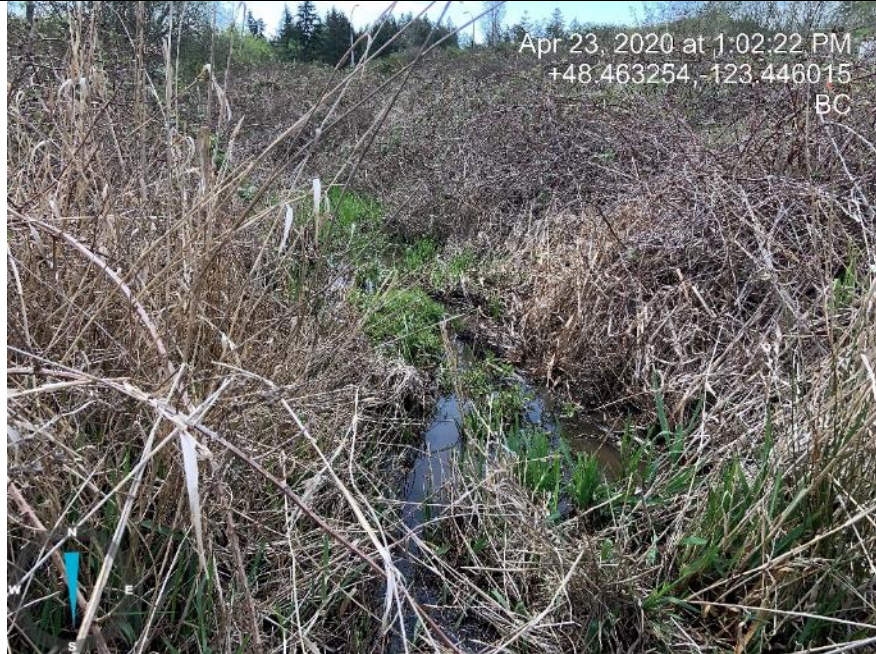
**Photo 9** Watercourse 2 within the archery range, looking upstream. Channel had copious amounts of reed canary grass and banks were covered in Himalayan blackberry.

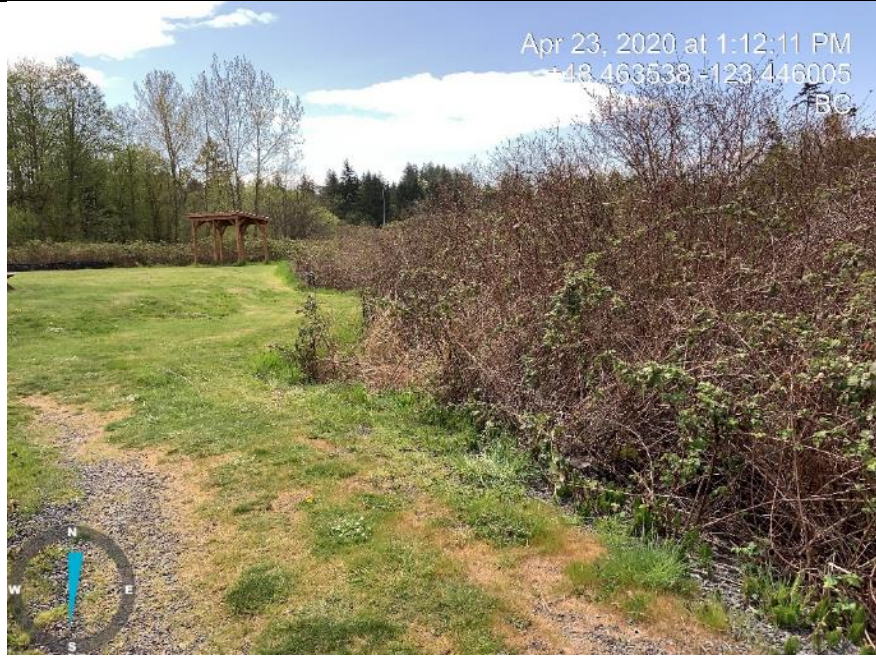
**Photo 10** Watercourse 2 looking downstream from within archery range. Ditch is within area heavily infested with Himalayan blackberry.

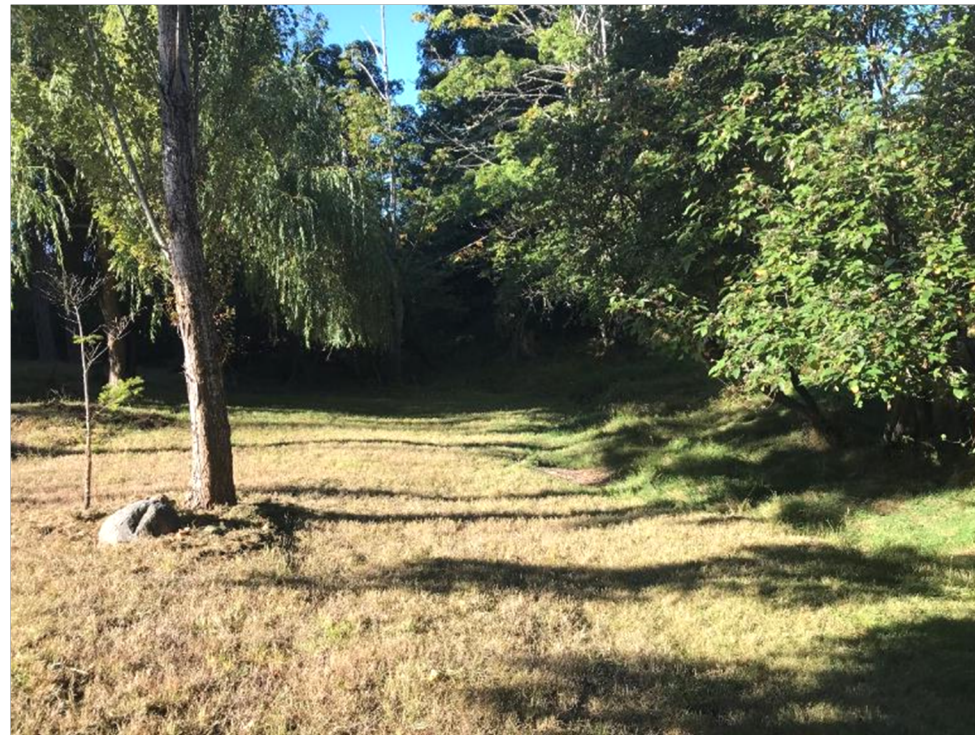
**Photo 12** The watercourse north of Kami Court that provides a seasonal source of water to Watercourse 2. The watercourse was primarily overgrown with grass.

of the Site. Connection between this stream and Watercourse 2 via the stormwater system and ditching network was confirmed through an additional site visit and municipal storm system information. The watercourse north of Kami Court appears to be a natural watercourse. Though most of the watercourse is overgrown with grass (Photo 12), some sections are scoured with gravel and cobble substrate (Photo 13). The property owner indicated the watercourse is seasonal, flowing during winter months. This connection confirms Watercourse 2 is a modified stream.

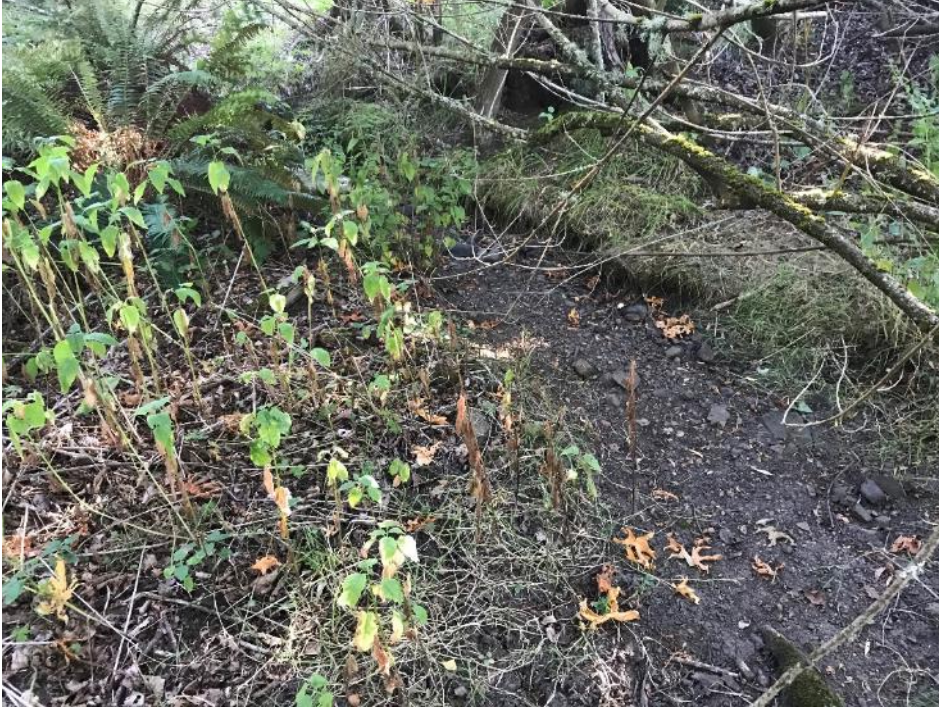
**Photo 13** A portion of scoured channel along the watercourse north of Kami Court that provides a source of water to Watercourse 2.

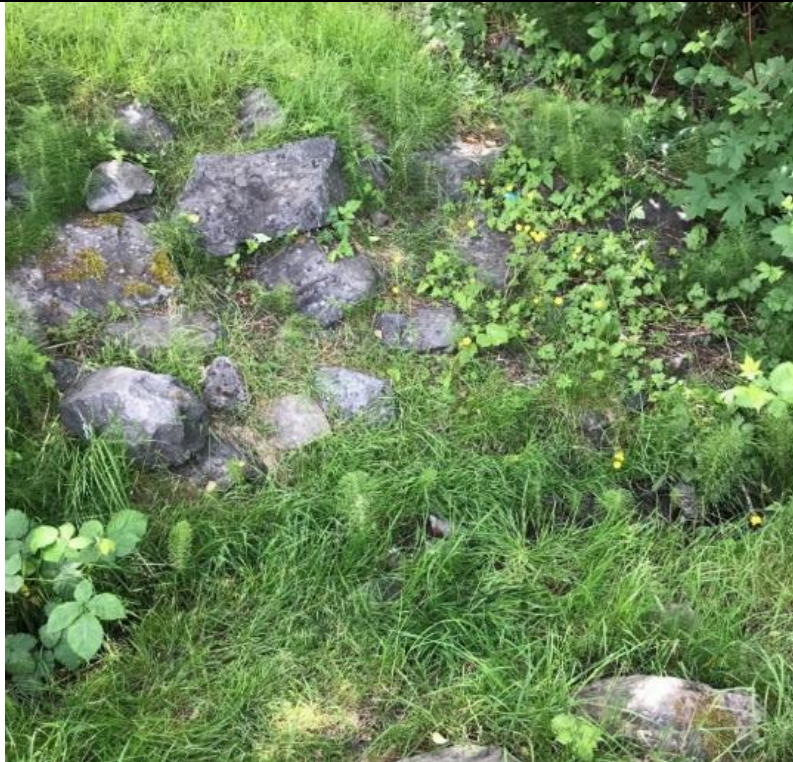
**Photo 14** Watercourse 3 south of Watkiss Way showing rock armouring on banks.

Watercourse 3 was measured at 10 transects over 100 m within the property (on the portion north side of the Galloping Goose) and had an average width of 2.5 m. The first transect was measured directly south of Watkiss Way, immediately downstream of a culvert and a section of rock armoring (Photo 14).

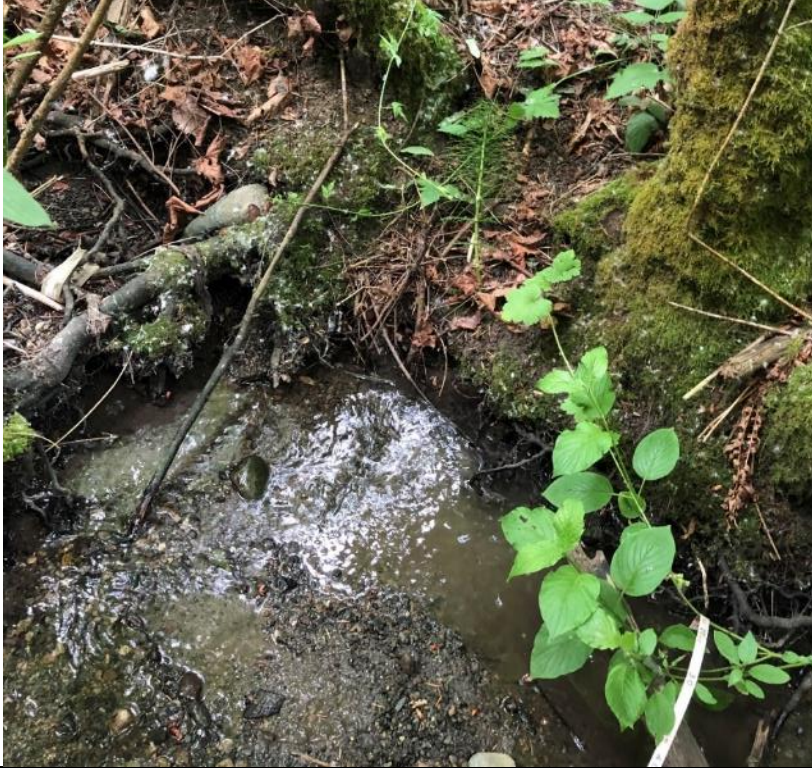
**Photo 15** Watercourse 3 south of Watkiss Way showing area of channelization.

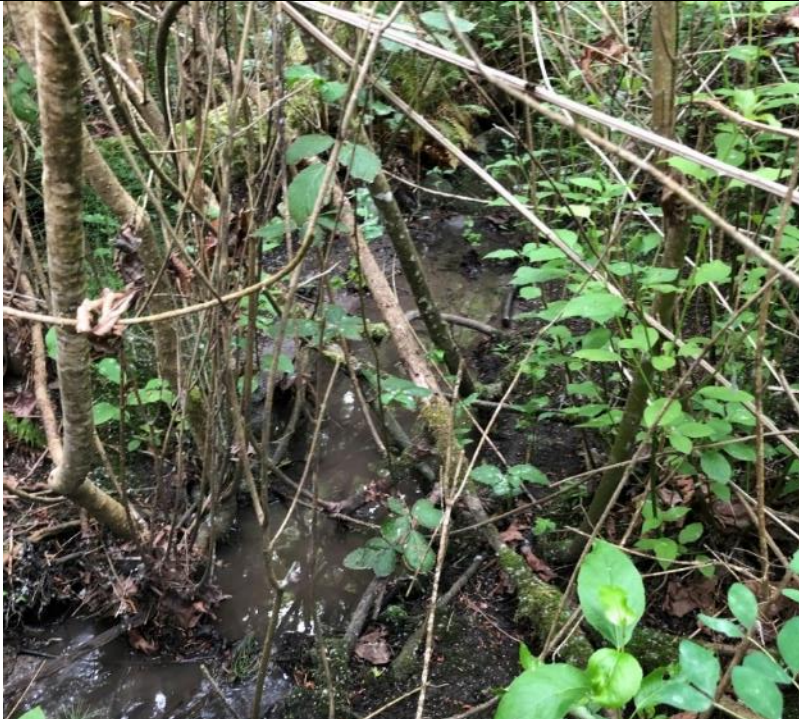
**Photo 16** Watercourse 3 south of Watkiss Way showing wetted areas between deciduous vegetation.

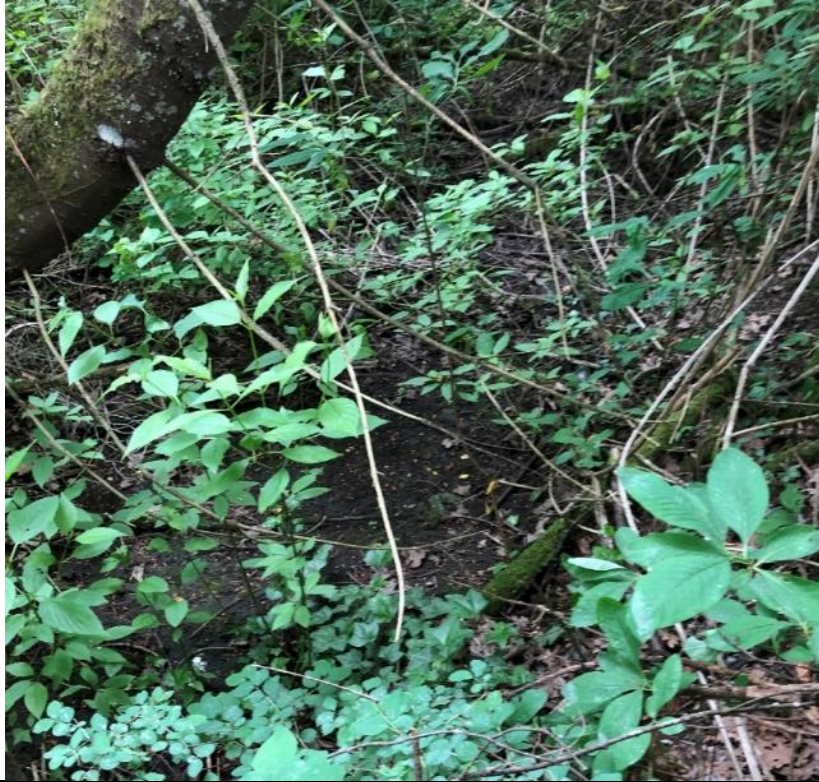
**Photo 17** Watercourse 3 south of Watkiss Way showing dry areas in non-channelized areas.

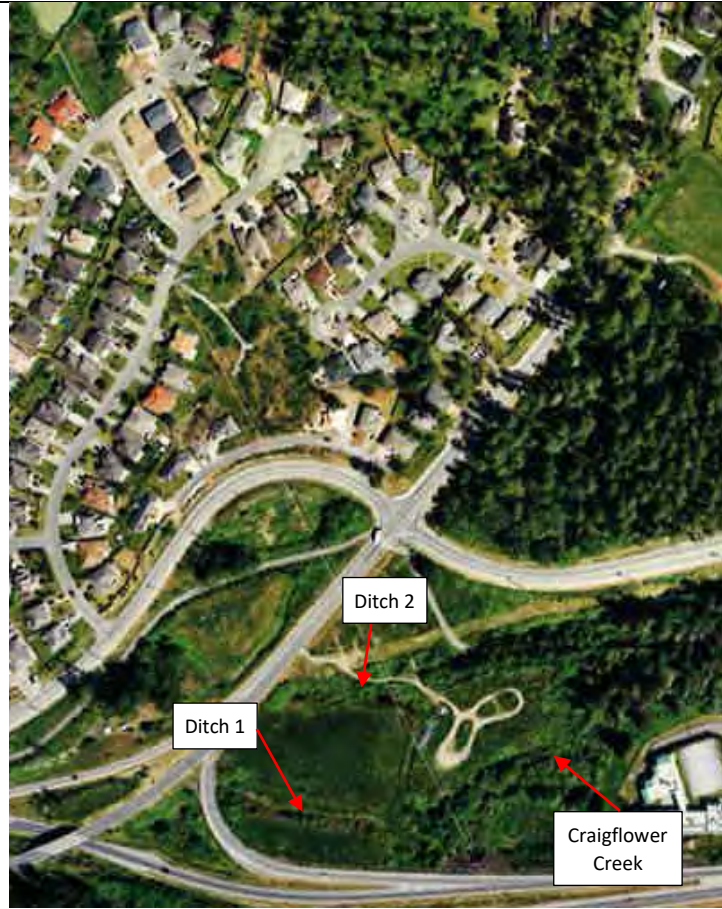
**Air Photo – 2005:** Site conditions after the construction of the Burnside Road offramp from Highway 1.

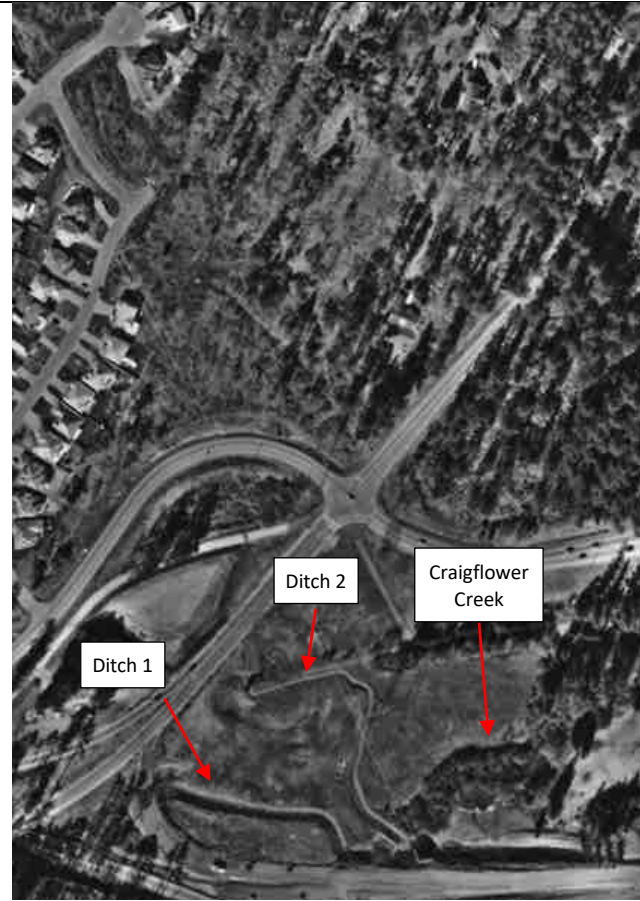
**Air Photo – 1997:** Site conditions during the construction of the Burnside Road offramp from Highway 1. The alignment of Ditch 1 and Ditch 2 are pronounced.

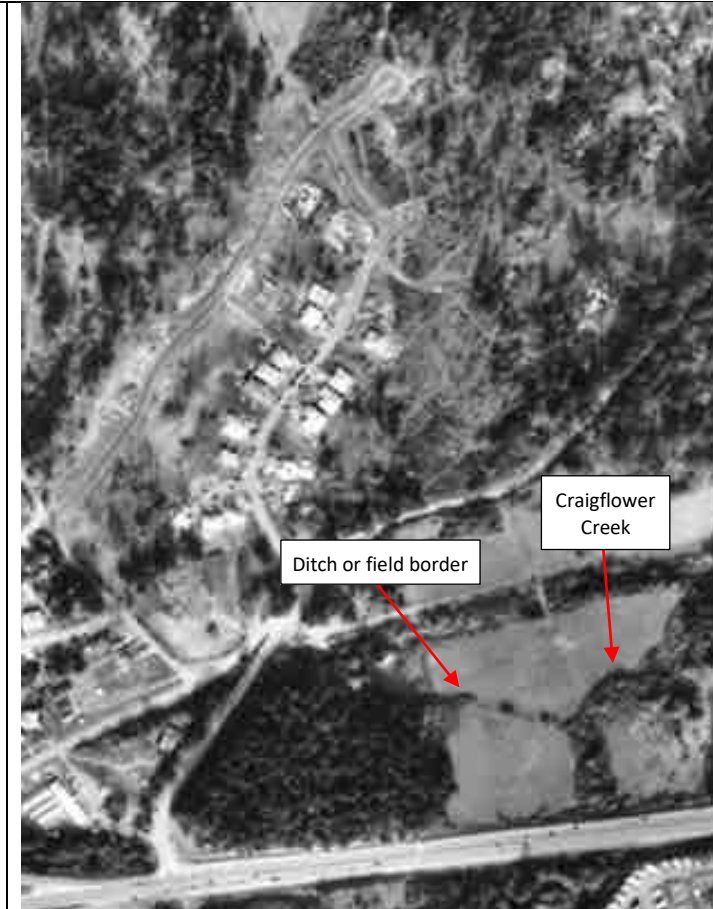
**Air Photo – 1992:** Site conditions prior to the construction of the Burnside Road offramp from Highway 1. Ditch 1 does not appear to be present and a ditch or field border is present in a similar location as Ditch 2 was previously.

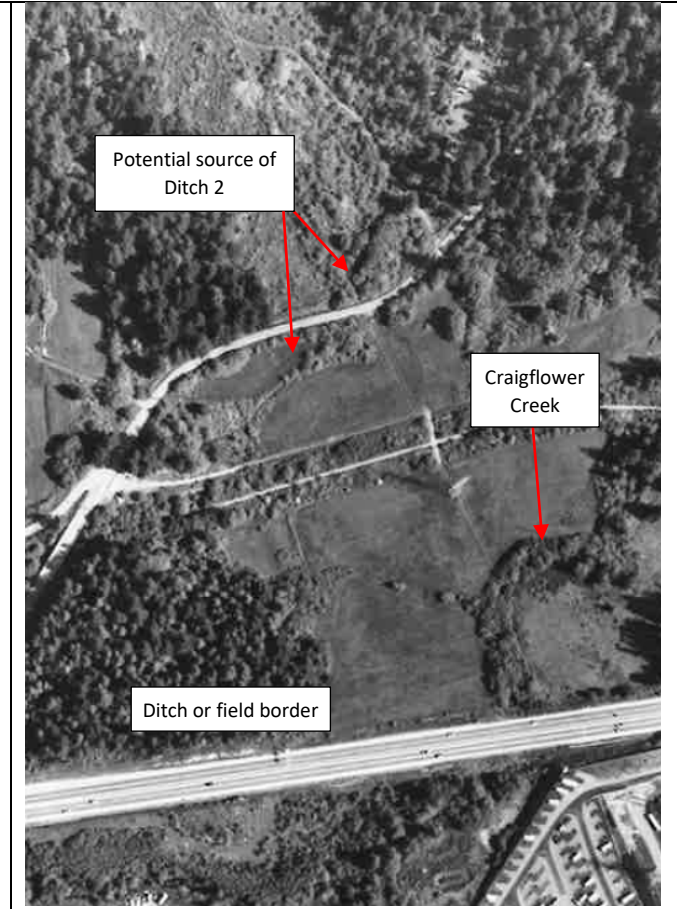
**Air Photo – 1986:** A potential source of water for Ditch 2 may be present in the cleared right-of-way upslope (north) of the property.

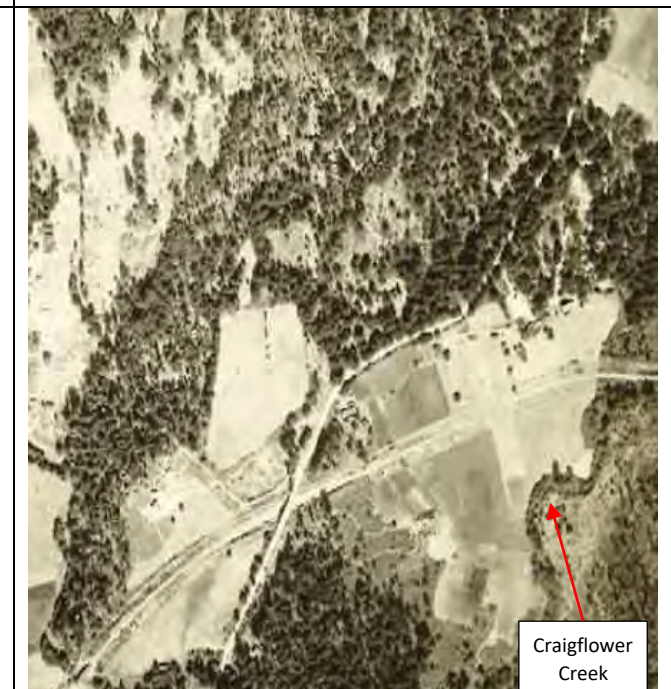
**Air Photo – 1932:** The ditch / field border is no longer visible, though the area is cleared. No watercourses appear to flow into Craigflower Creek

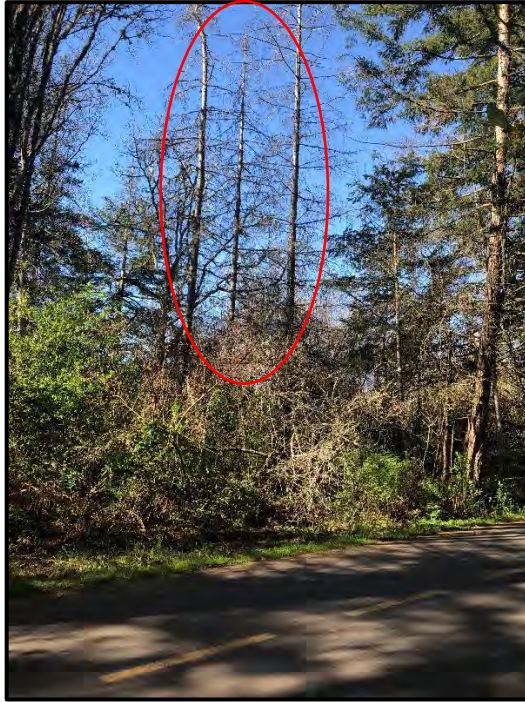
**Figure 1: Subject trees #205-207 circled in red (04/15/2021).**

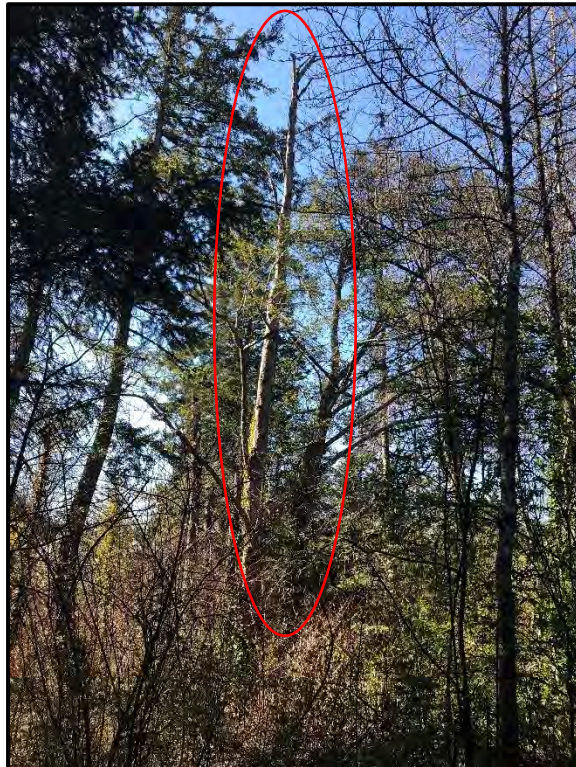
**Figure 2: Subject tree #214 circled in red (04/15/2021).**

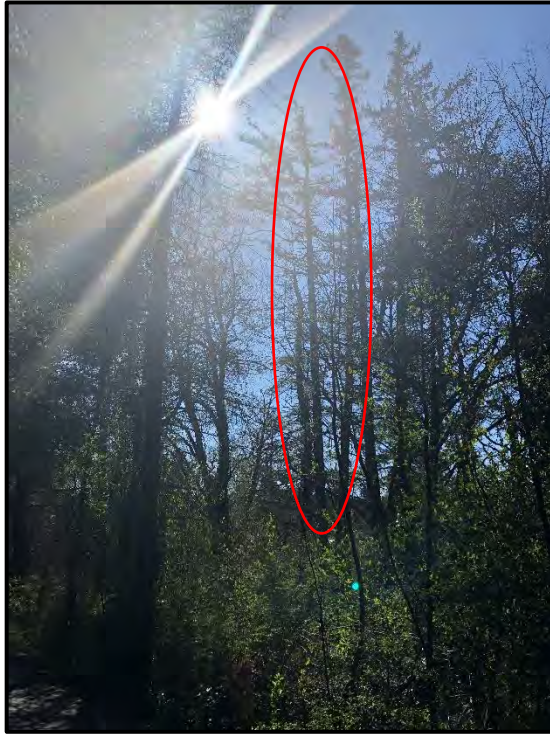
**Figure 3: Subject trees #211-213 circled in red (04/15/2021).**

5. Reduce the heights of declining fir trees #d 211 – 213 to live growth or by approximately 15 percent as to reduce likelihood of impact to trail in the event of a failure.

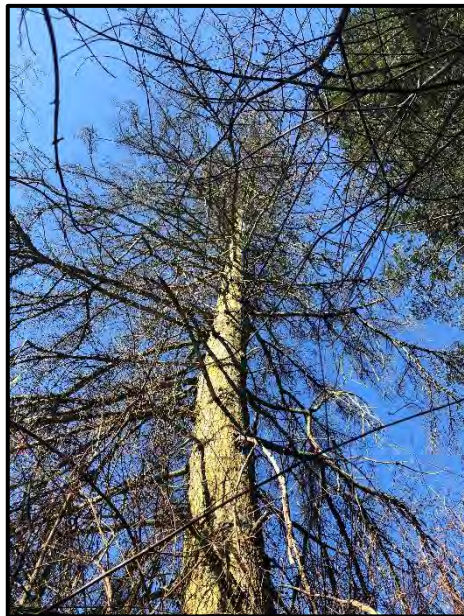
**Figure 4: Subject tree #202 which leans towards project direction (04/15/2021).**

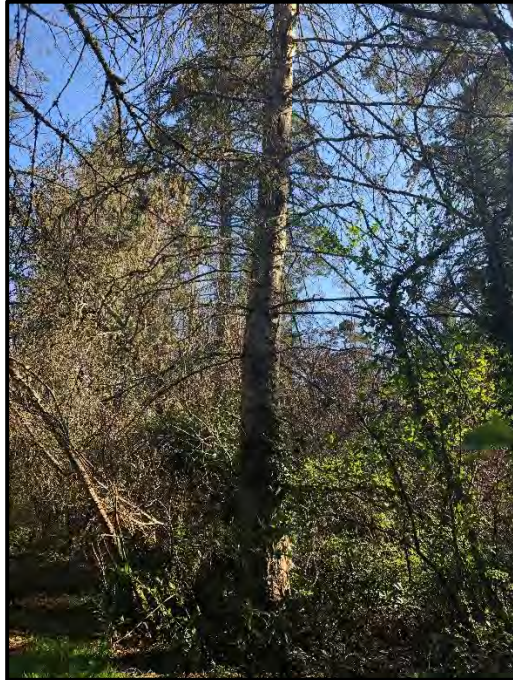
**Figure 5: Subject tree #204 (04/15/2021).**

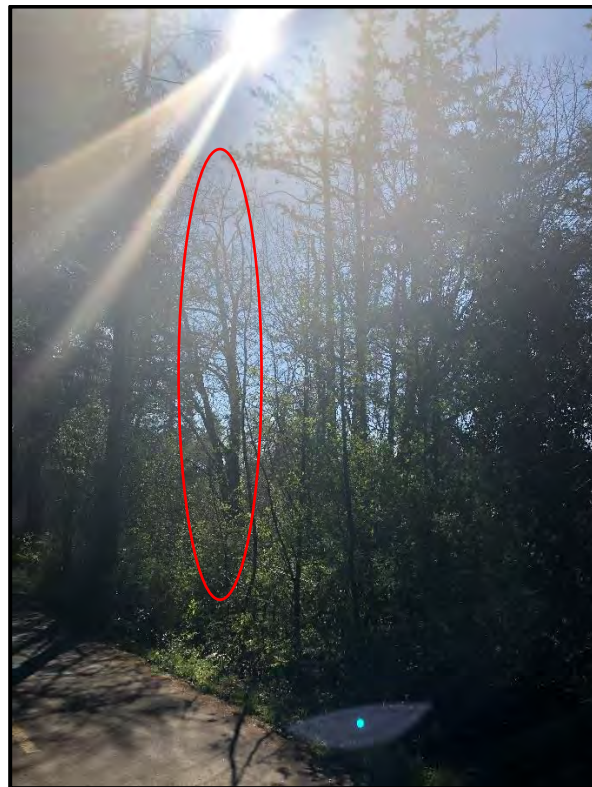
**Figure 6: Subject tree #215 circled in red (04/15/2021).**

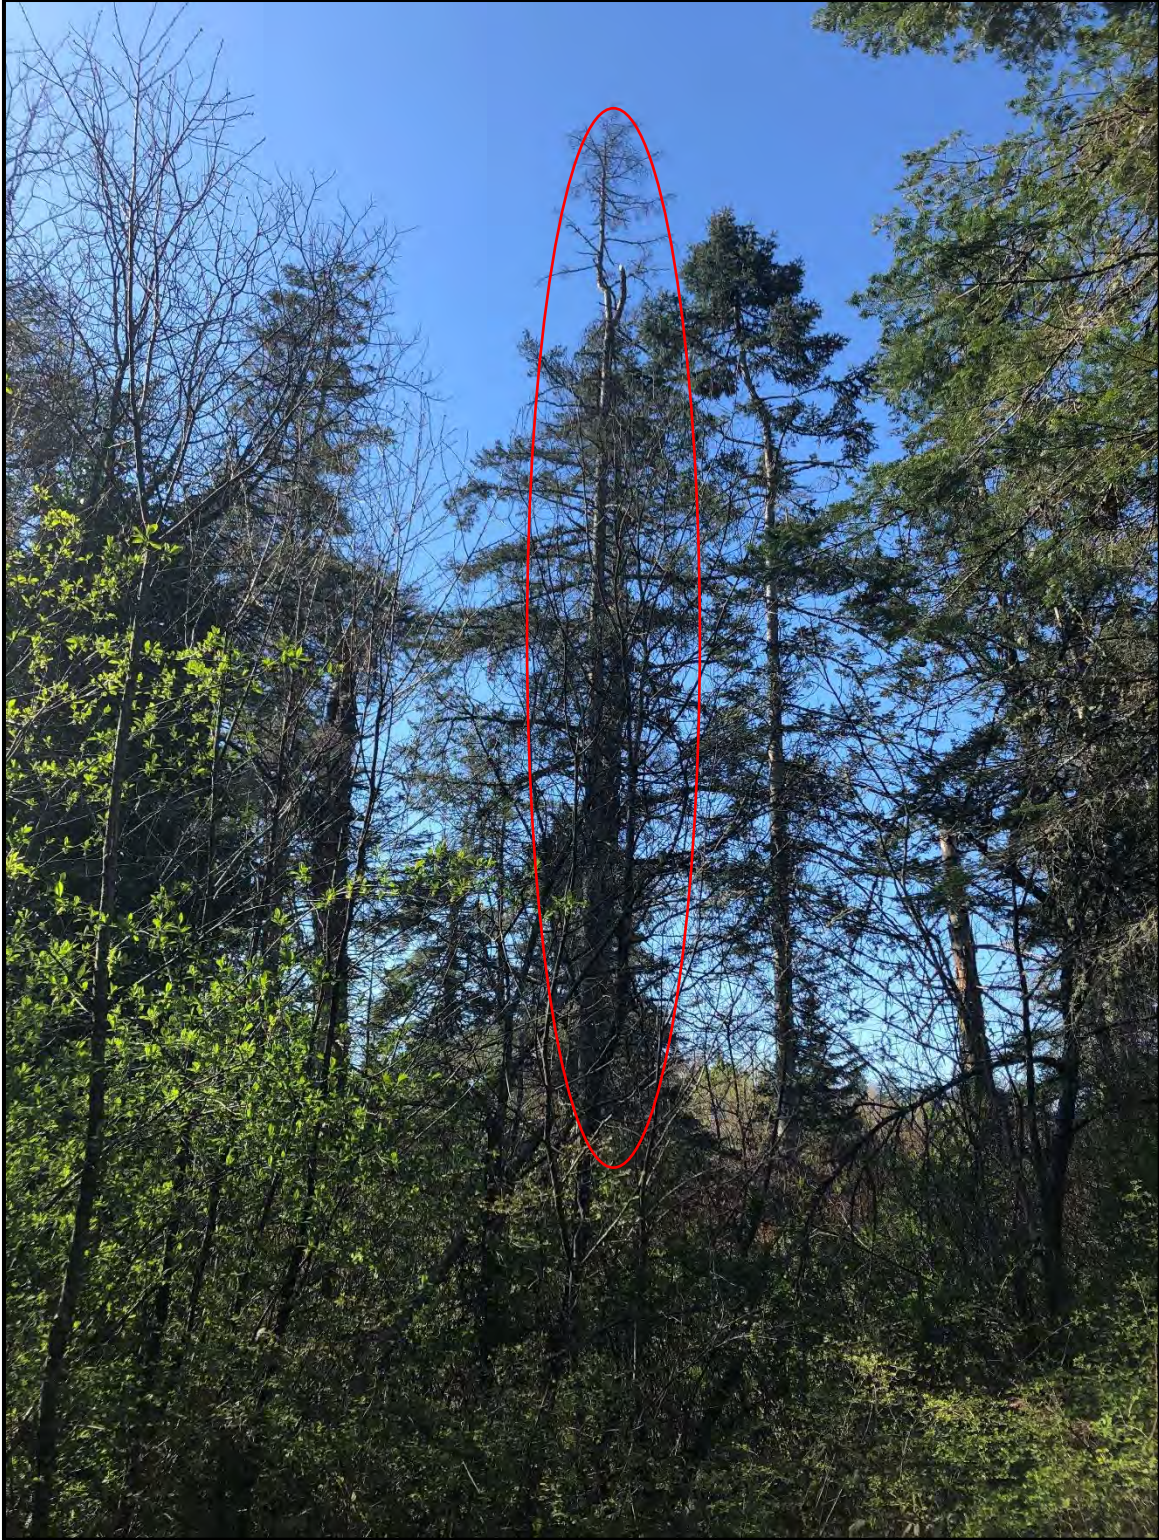
**Figure 7: Subject tree #216 circled in red (04/15/2021).**

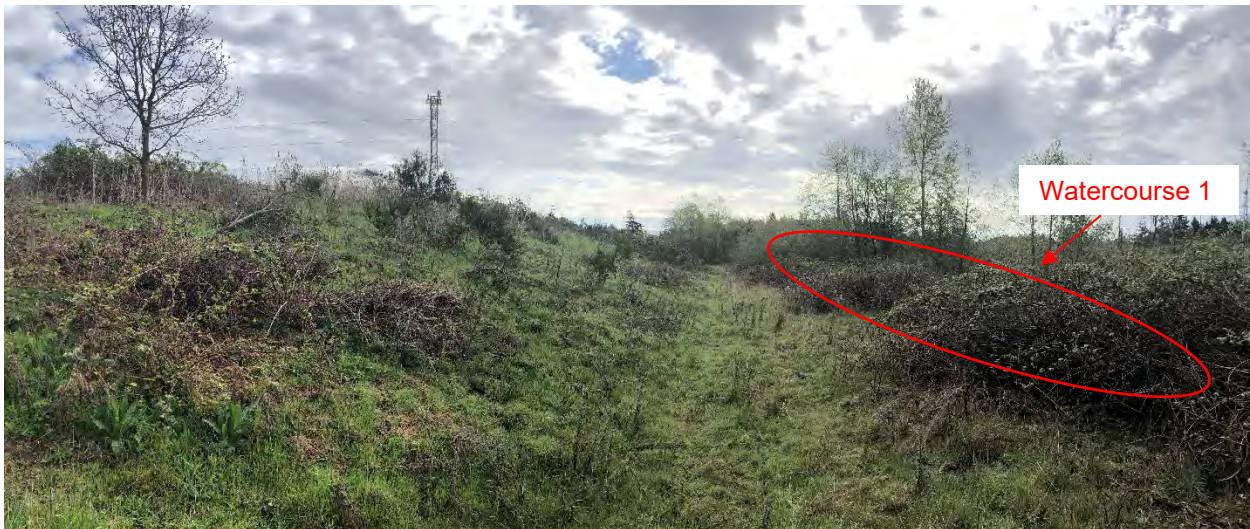
**Figure 1** Looking east with Watercourse 1 on the right side of the image (overgrown with vegetation) and the stockpile on the left side of the image

Watercourse 1 is a vegetated, rip-rap lined drainage channel located at the toe of the stockpile adjacent to the Trans-Canada Highway (refer to Figure 1) and terminates in a pool adjacent to Craigflower Creek. No connectivity, culverts, or water flow were observed that would suggest Watercourse 1 currently connects to Craigflower Creek or Watercourse 2. Further, the 70% design drawings indicate that a new channel would be created approximately 7 m north of the existing channel. As such, the existing channel is isolated and not protected under the *Riparian Areas Regulation*. Therefore, no geotechnical assessment is required at this time for Watercourse 1 in support of the RAR Detailed Assessment Report.

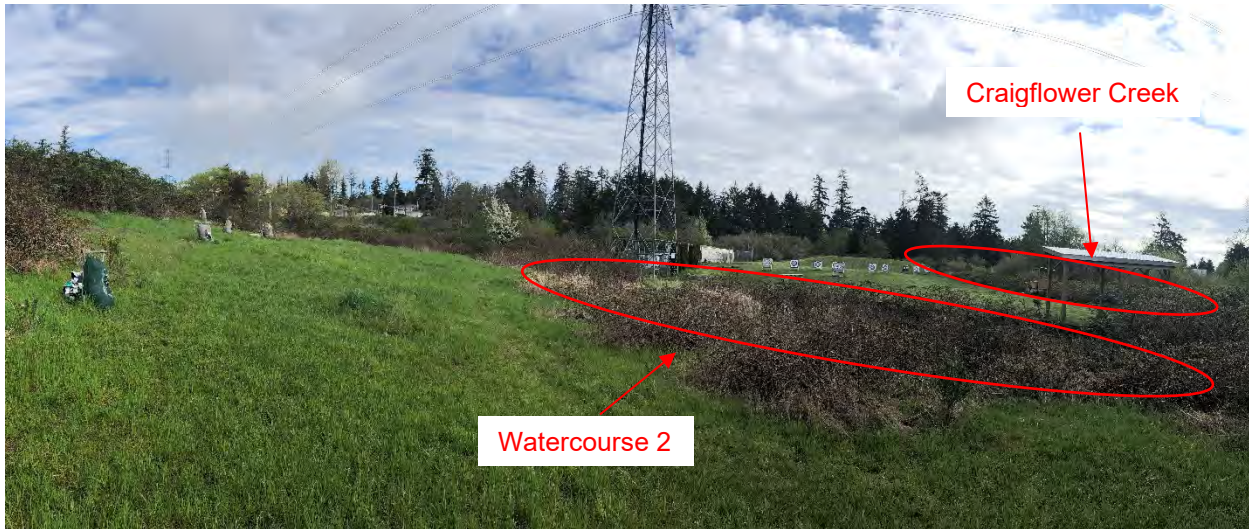
**Figure 2** Looking northeast with 2 in the foreground, and the crest of the slope above Craigflower Creek in the background (both overgrown with vegetation)

Watercourse 2 is a vegetated, rip-rap lined drainage channel that connects to Craigflower Creek at the southeast corner of the site (refer to Figure 2). We understand Watercourse 2 would be infilled, and water diverted into the new channel adjacent to Watercourse 1. Therefore, no geotechnical assessment is required at this time for Watercourse 2 in support of the RAR Detailed Assessment Report.

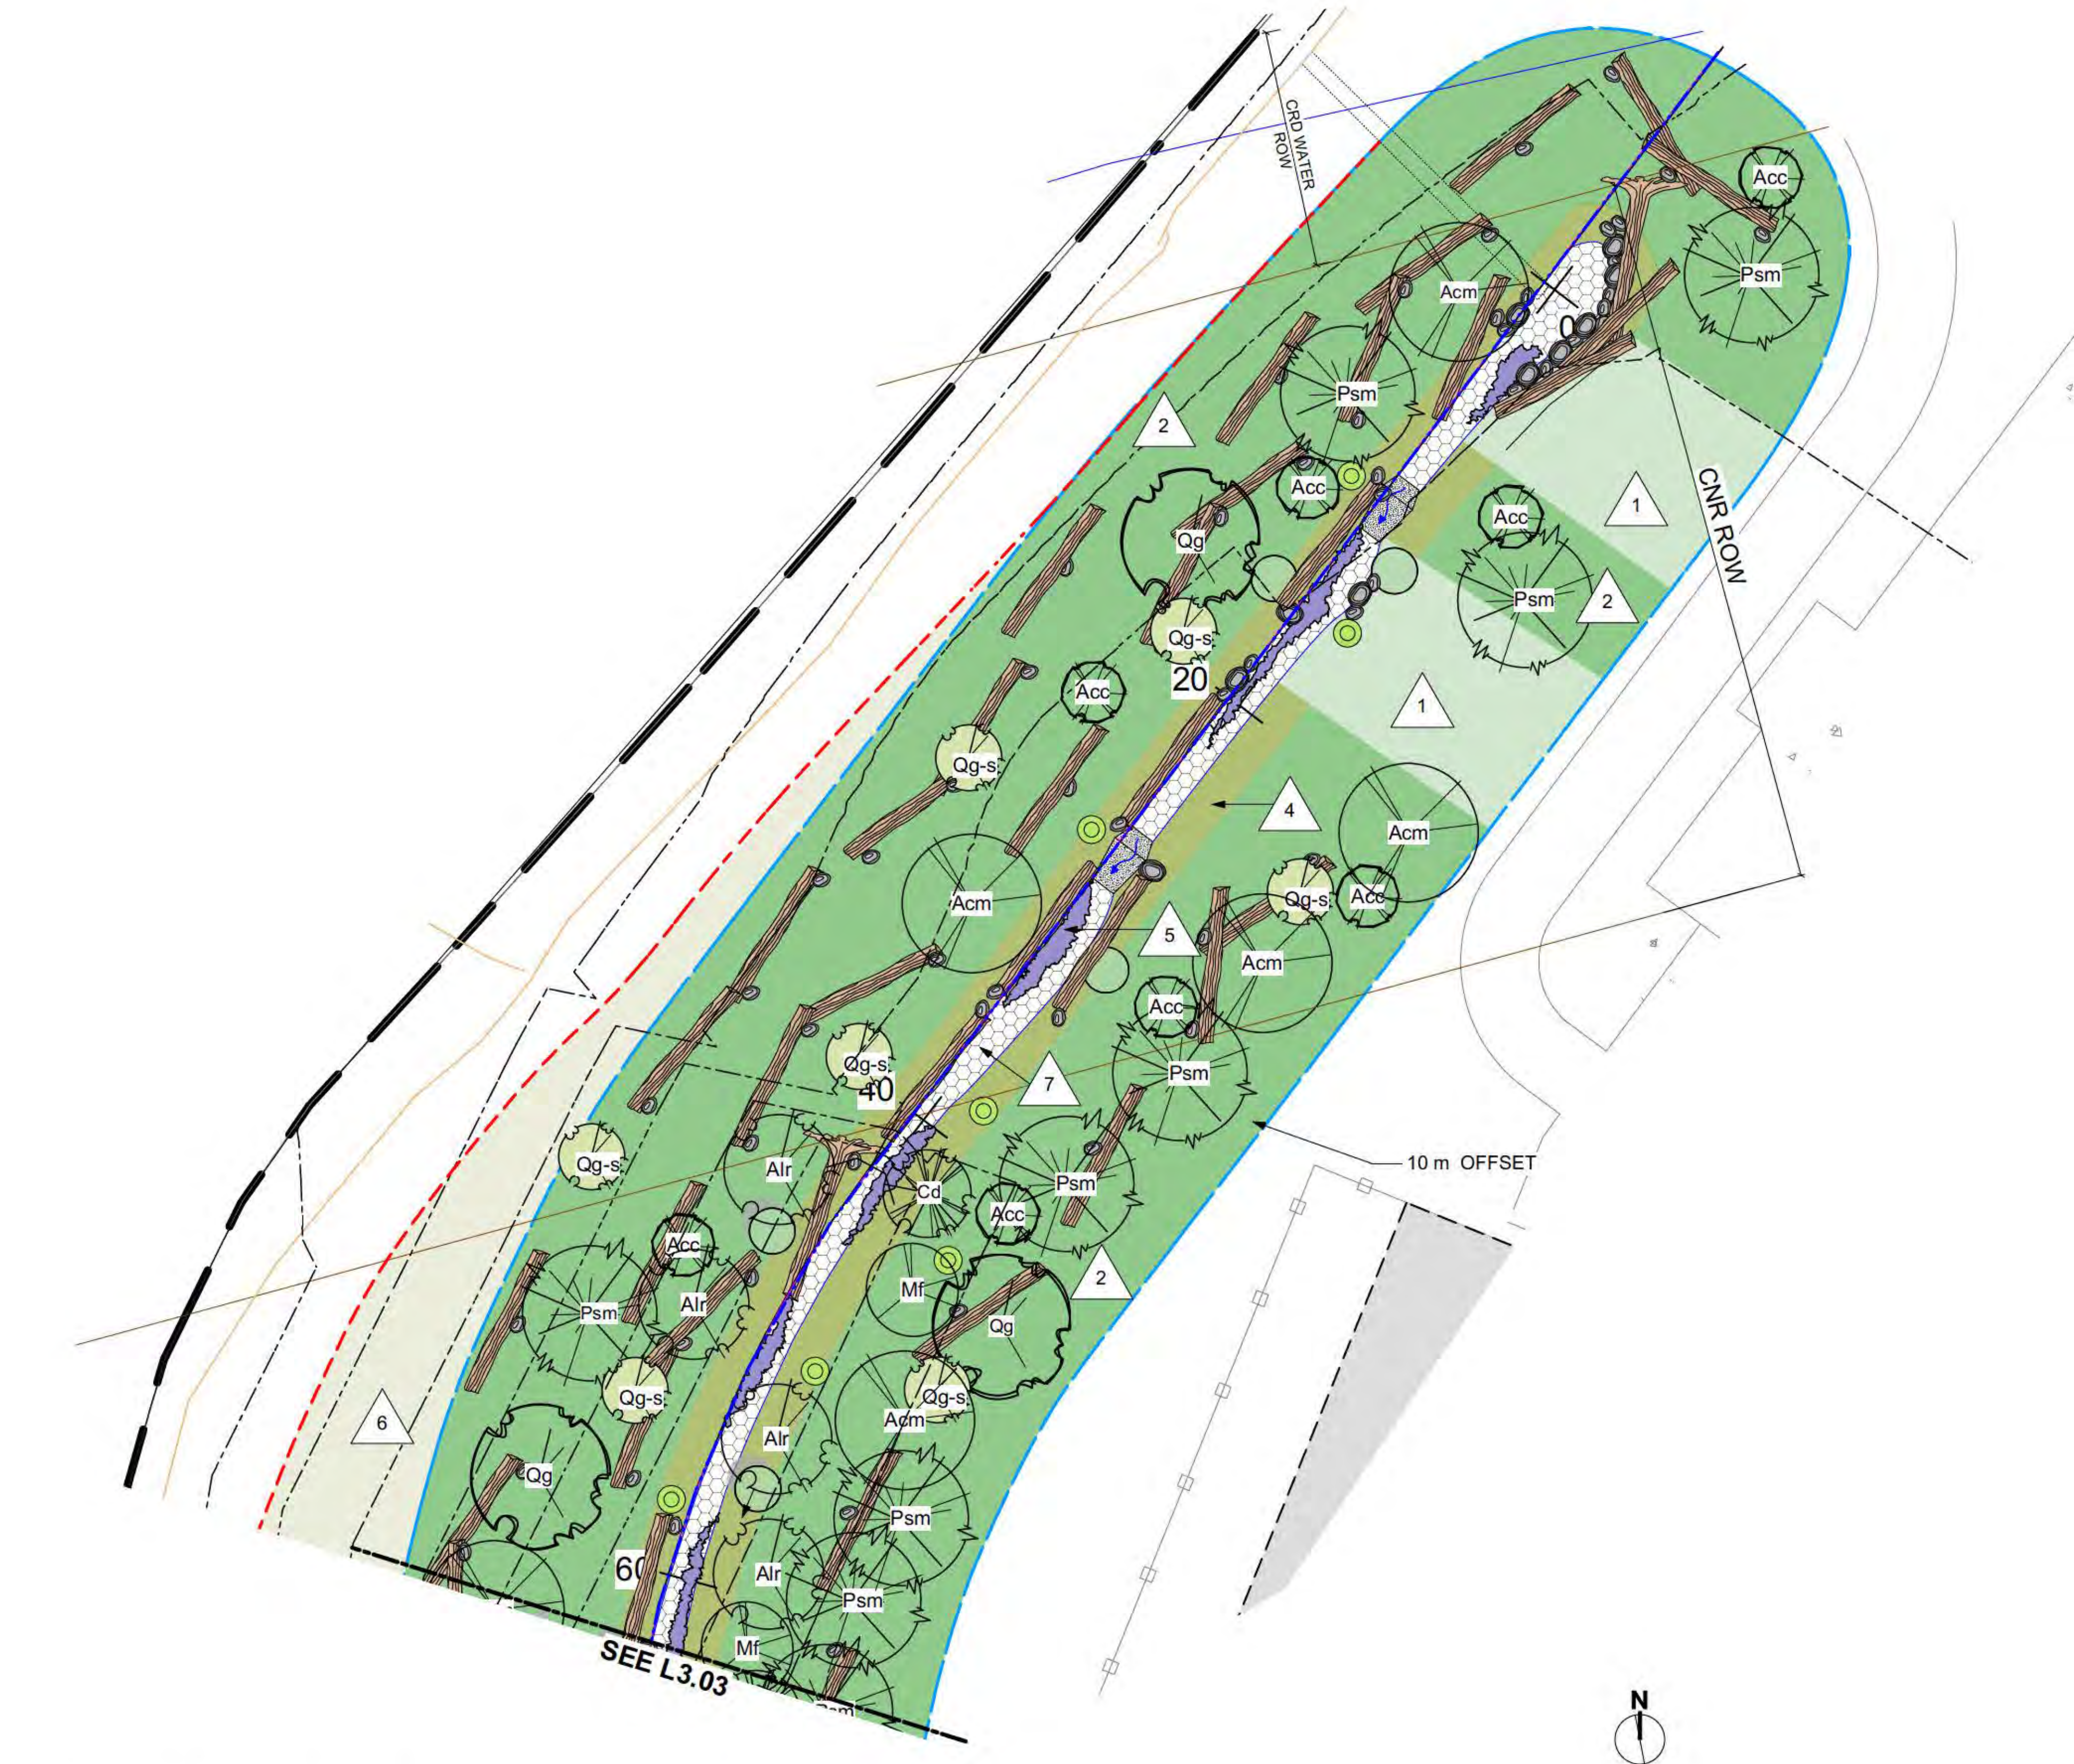
1 PLANTING PLAN - UPPER PORTION  
Scale: 1:150

SEE SHEET L3.01 FOR PLANT LIST
