**Riparian Areas Protection Regulation: Assessment Report**

The proposed development is the construction of a handyDART bus facility at the Site (the Project). To facilitate construction of the facility, the Project will require the realignment and subsequent infilling of Watercourse 2 which flows through the centre of the property. Construction of the Project will be broken into two stages. The first stage includes installing site access, grading the hill on the west side of the Site, construction of the Watercourse 2 realignment channel including a tie-in to Craigflower Creek, and wick drain installation (Figure 2).

Client/Project/Report  
 BC Transit  
 2401 Burnside Road HandyDART Facility  
 Riparian Areas Regulation Development Permit

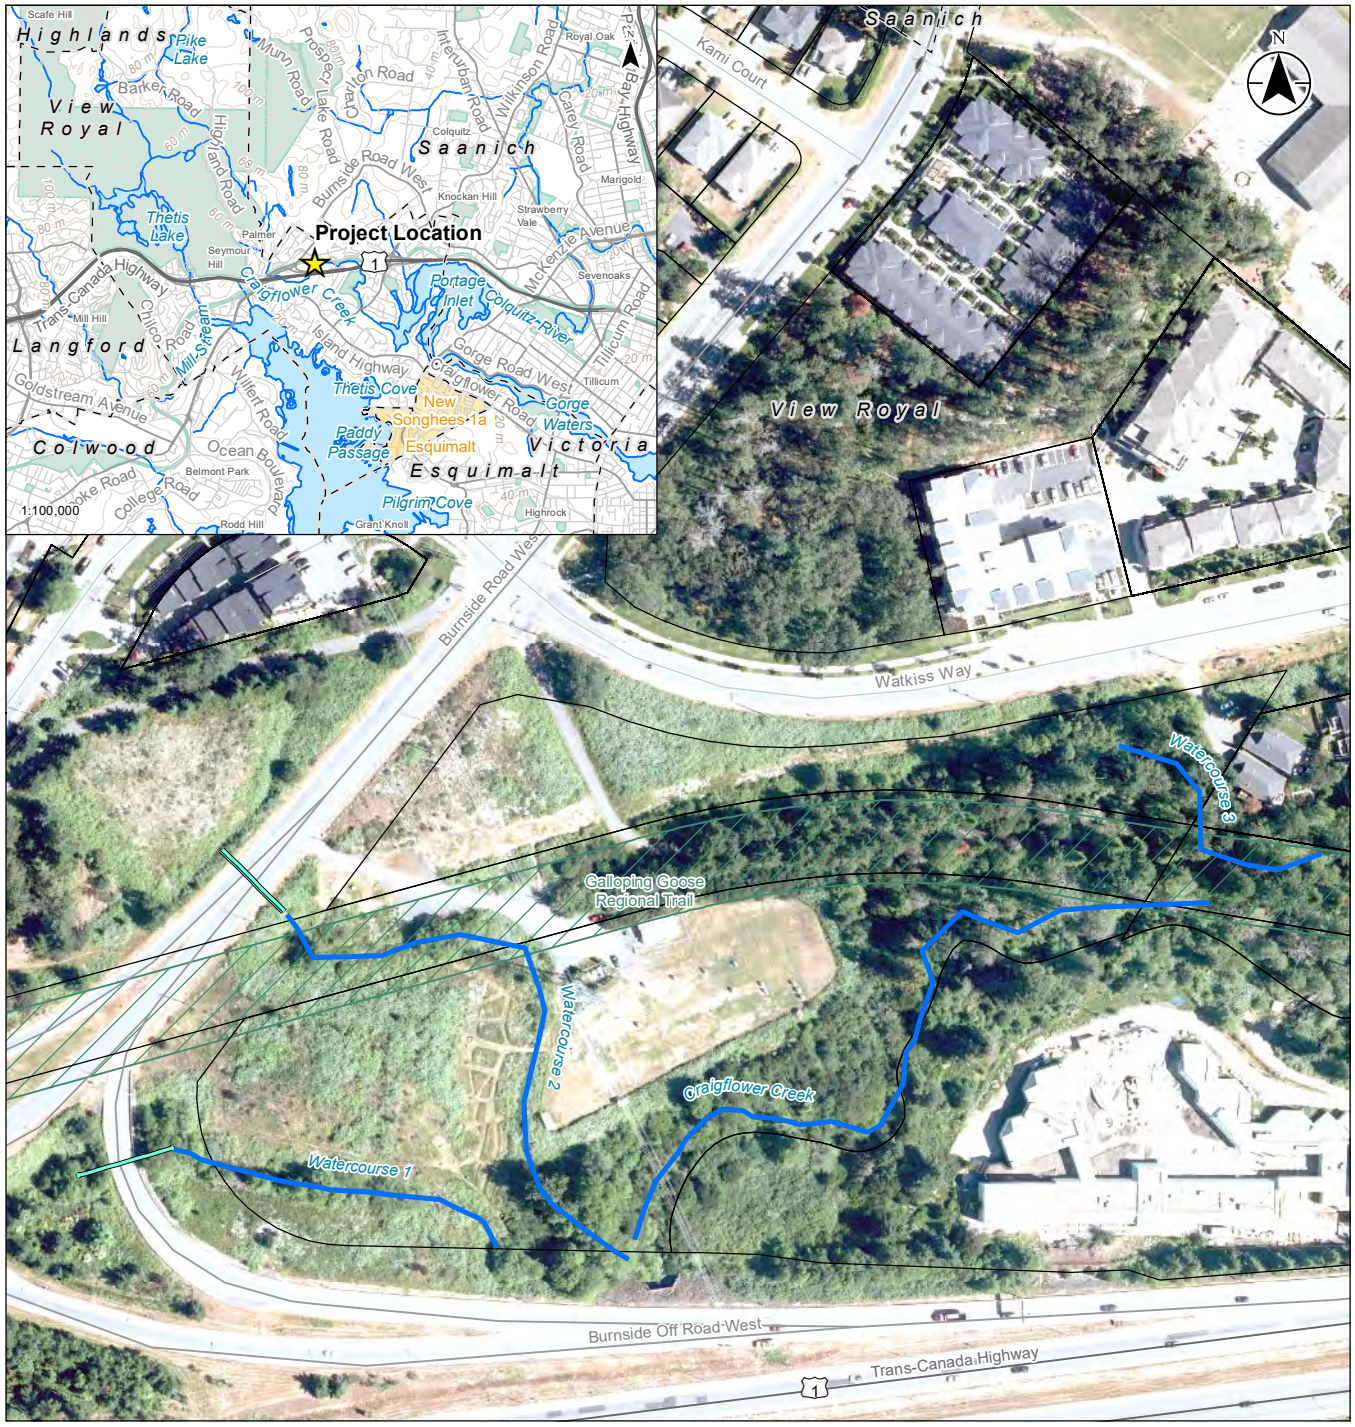
The site is located at 2401 Burnside Road in View Royal. The site is bounded by Highway 1 to the south, Burnside Road to the west, Watkiss Way along the north side, and private property off Talcott Road on the eastern property line. The property is currently used as an archery range by the Victoria Bowmen. The Galloping Goose Trail crosses the property towards the northern property line.

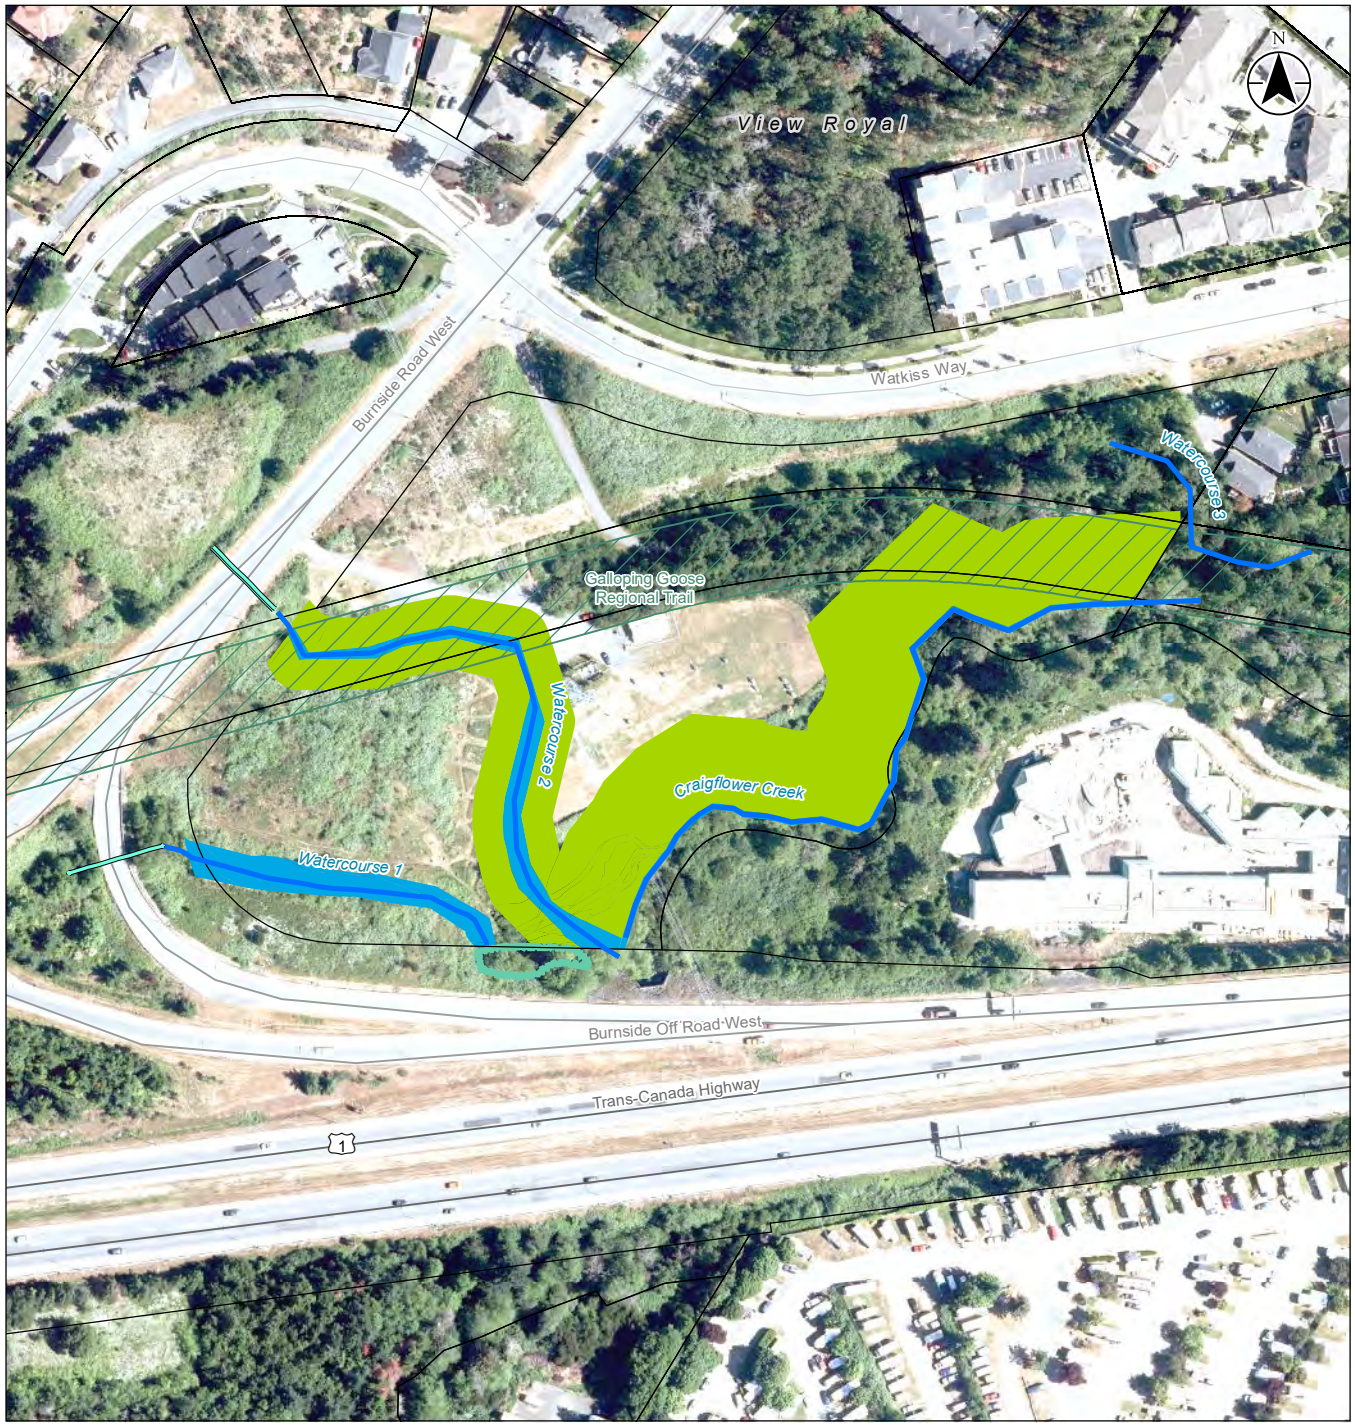
The following subsections summarize portions of the baseline (existing) fish and fish habitat descriptions supplemented by observations from 2020 reconnaissance surveys. Habitat types within the Project Area are characterized in Section 5.2 and existing watercourses are mapped in Figure 2.

There are four watercourses within the Project area including Craigflower Creek along the southeast boundary of the property and three unnamed watercourses: Watercourse 1 extends west to east on the southwest side of the property, Watercourse 2 extends west to east starting from a culvert on the west side of the property, and Watercourse 3 is a constructed drainage ditch that flows southeast from the north end of the property (Figure 2). The results of the watercourse assessments are summarized in Table 3 and described in the following sections.

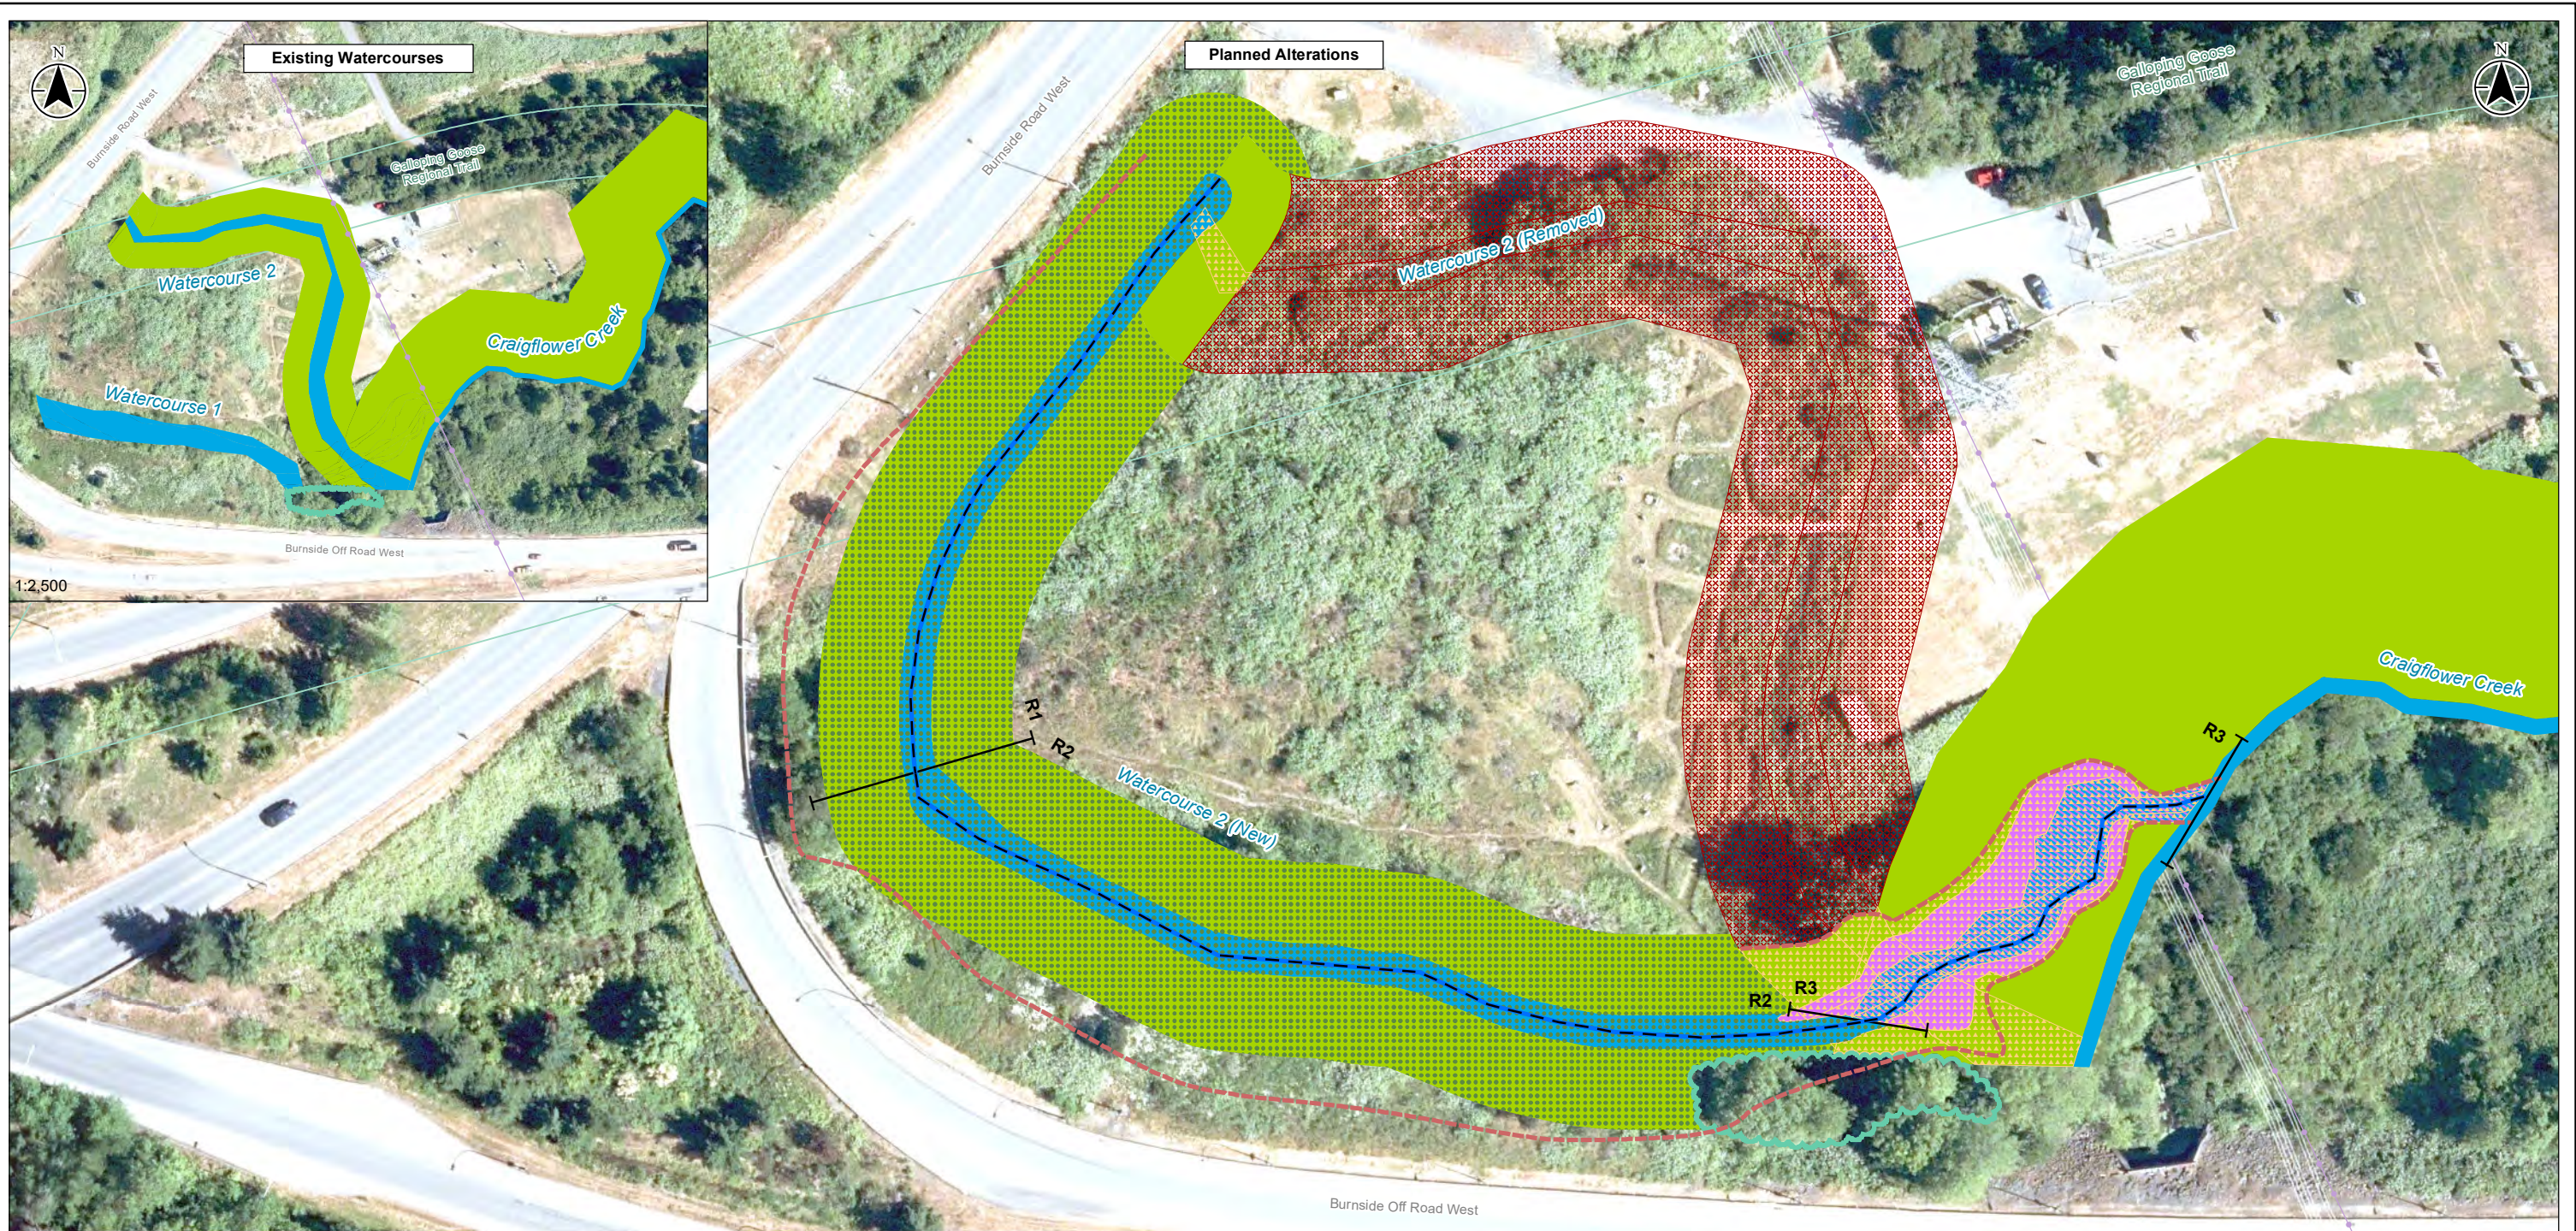
- Transmission Line
- Local Greenspace
- New Habitat**
- Pool
- Instream/Pool
- Instream
- Riparian
- Pooling Water
- Limit of Disturbance
- Alteration**
- Gain
- Alteration
- Loss

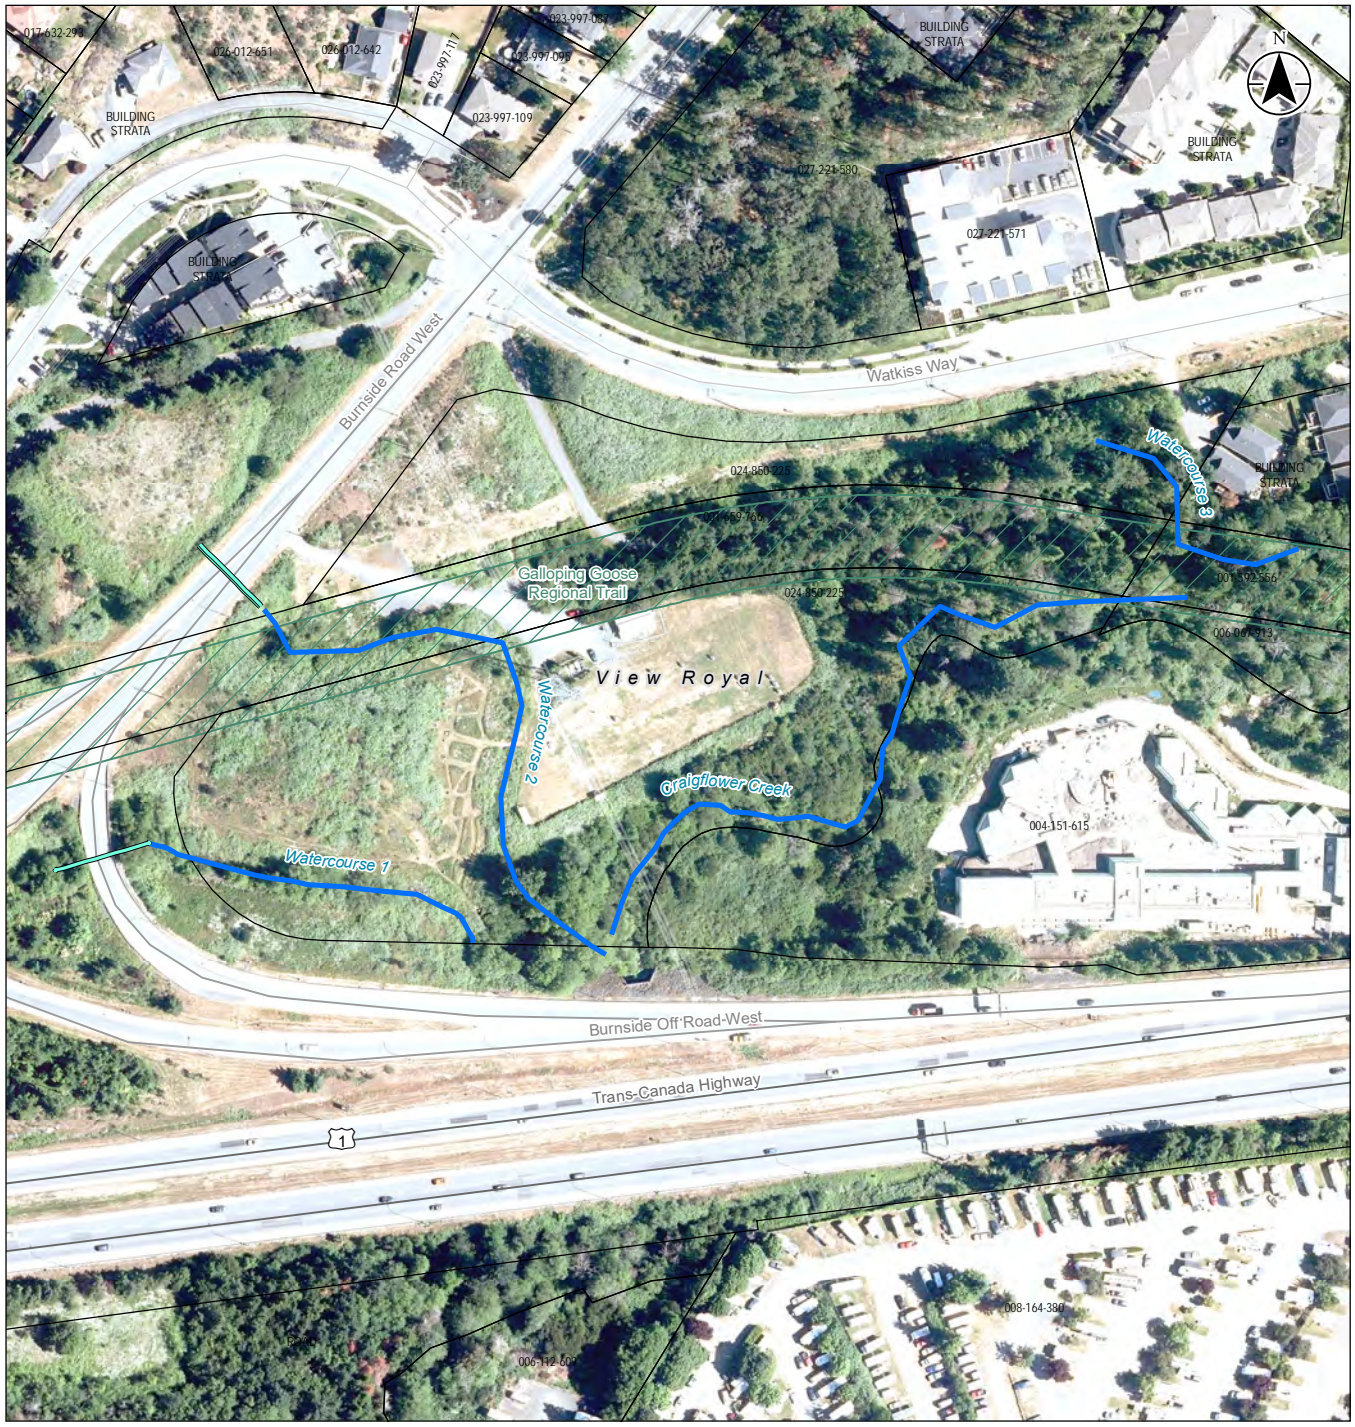
Stantec biologists completed a watercourse assessment at the property using the RAPR detailed assessment methods on April 23, 2020 (Figure 2). An arborist and a geotechnical engineer also visited the site on April 23, 2020 to fulfill requirements of the RAPR related to vegetation and slope stability. Weather during the site visit was partly cloudy with no rainfall recorded at the Victoria International Airport weather station on the day of the site visit; however, 13.2 mm of precipitation was recorded the previous day (April 22, 2020; ECCC 2020). Additional site visits were conducted on June 4, 2020 to assess Watercourse 3 and on September 2, 2020 to look at connectivity between an upstream ephemeral watercourse and Watercourse 2. Watercourse 1 extends along the south border of the property with Watercourse 2 extending approximately parallel to and 20 m from Watercourse 1. Watercourse 3 extends along the north side of the Galloping Goose Regional Trail, at the north end of the property. To the east, Craigflower Creek serves as the property line.

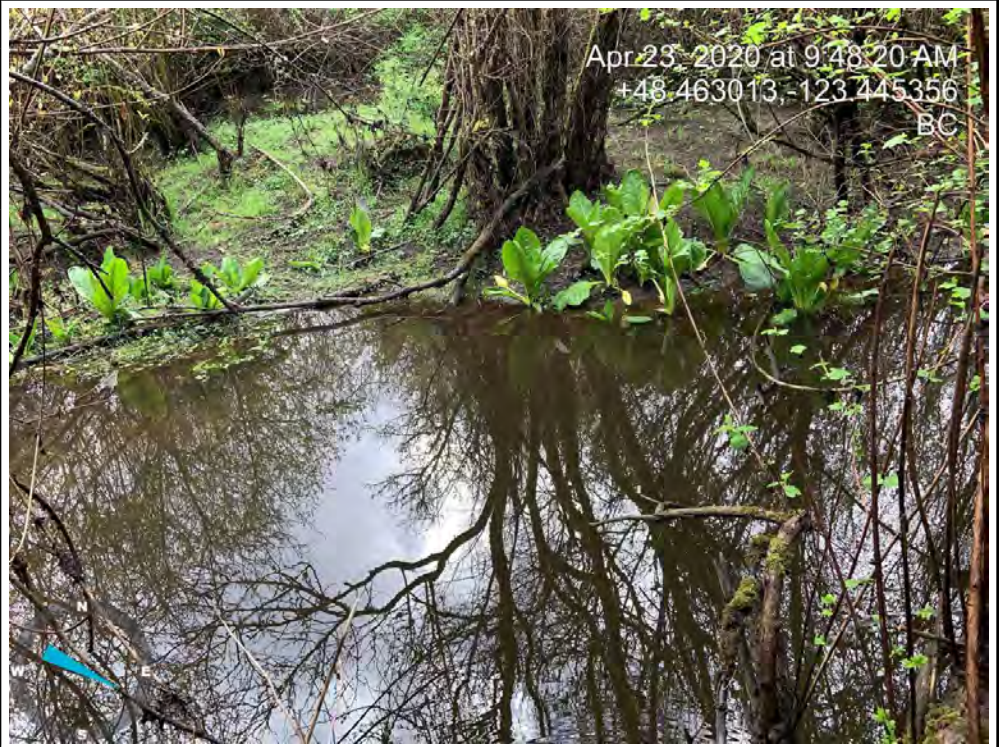
**Photograph ID: 2**

**Comments:**  
Typical photo of Craigflower Creek taken looking downstream.

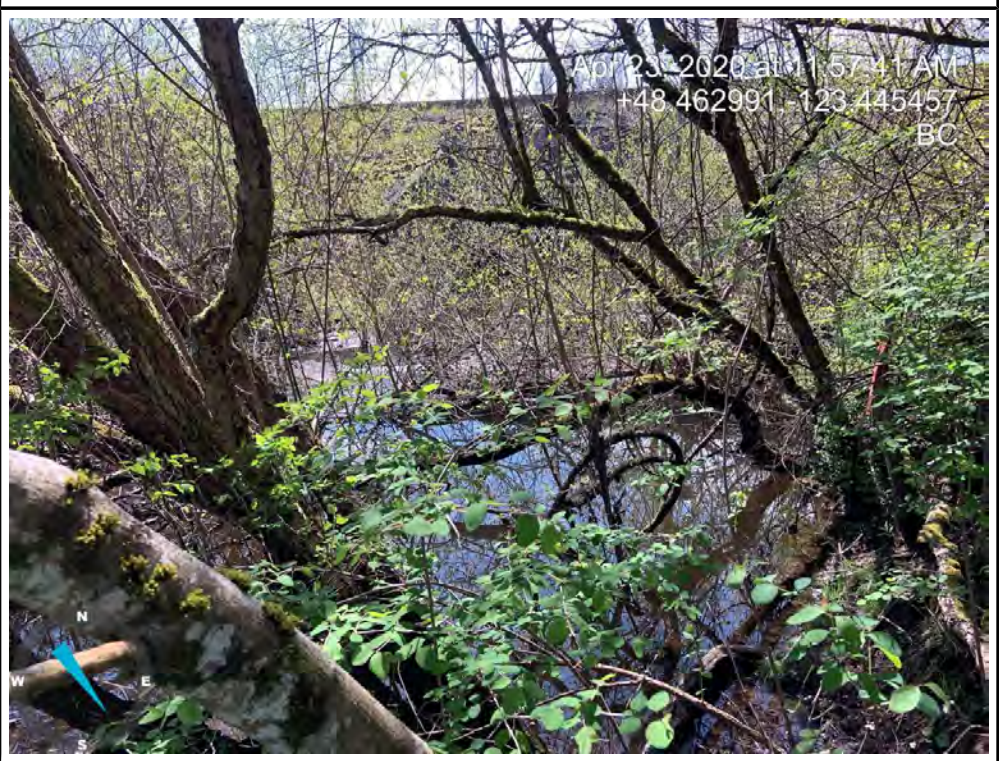
**Comments:**  
Typical photo of Craigflower Creek taken looking downstream.

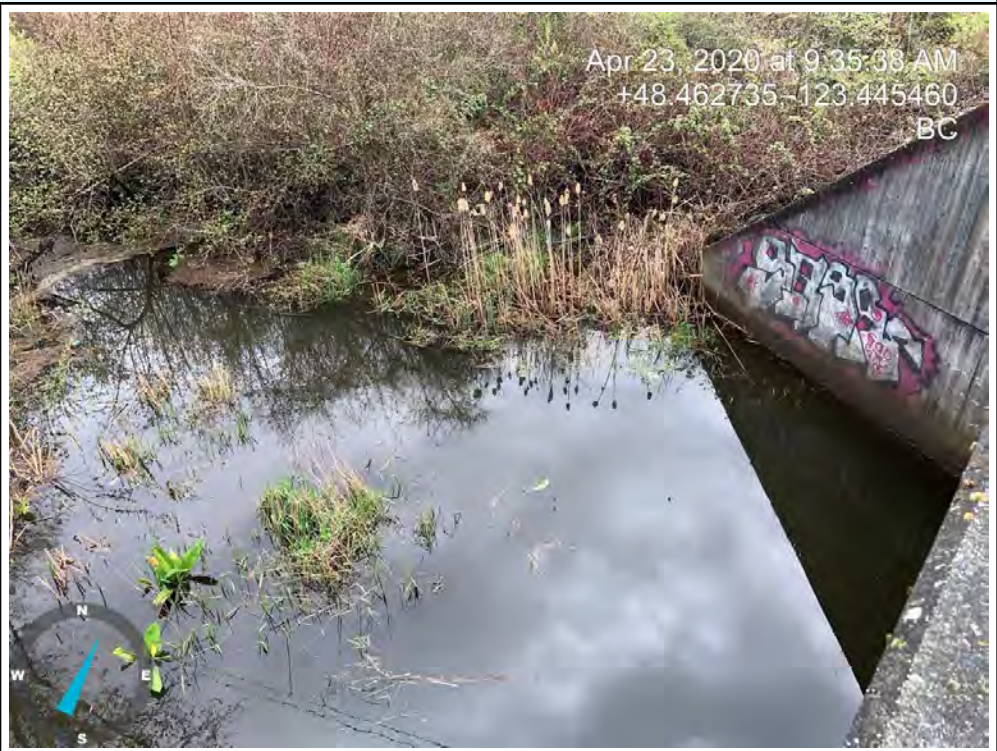
**Photograph ID:** 4

**Comments:**  
Pool downstream of Highway 1 culvert

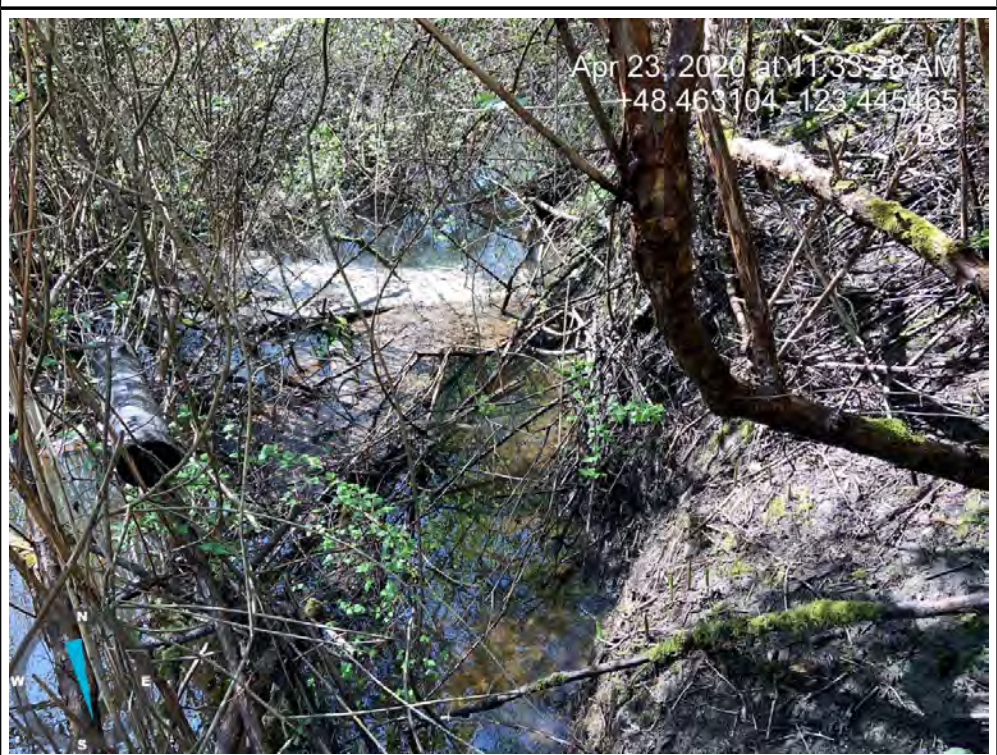
**Comments:**  
Looking upstream and showing rafted log in tree (left side centre) indicating high flow at times.

Stream flows were moderate at the time of assessment, though evidence of flood flows were present throughout the reach in the form of rafting and debris in trees above and beside the channel (Photo 3). Beaver activity was observed in the form of a small dam (Photo 4)

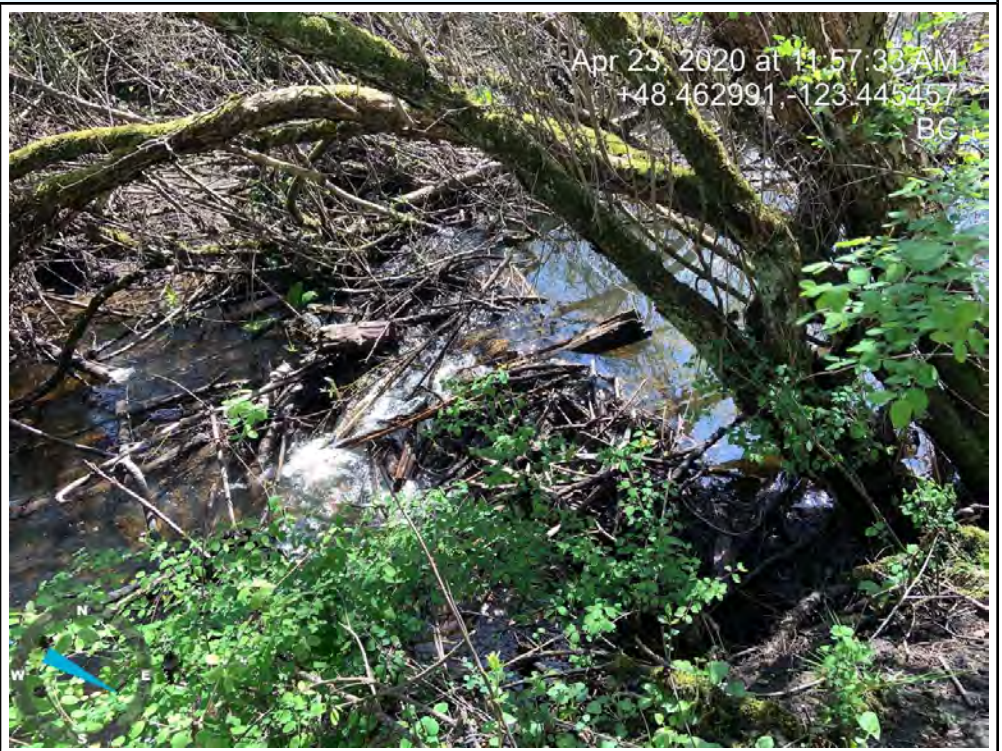
**Photograph ID:** 6

**Comments:**  
Beaver dam downstream of Highway 1 culvert.

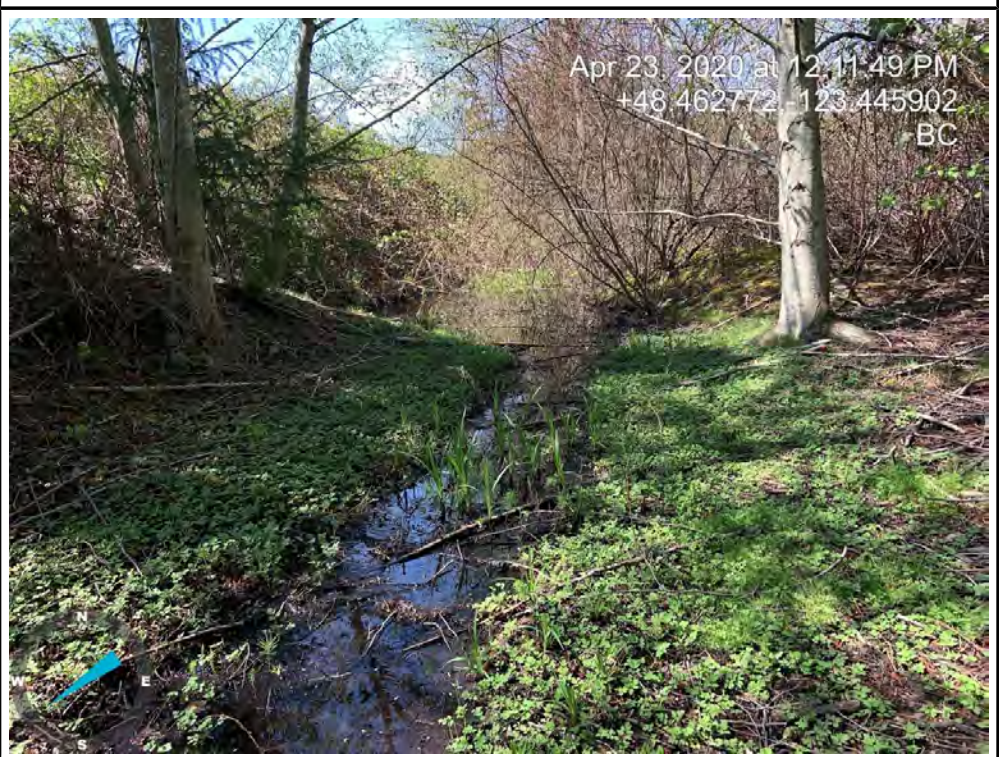
**Comments:**  
Looking upstream from the area where water pools

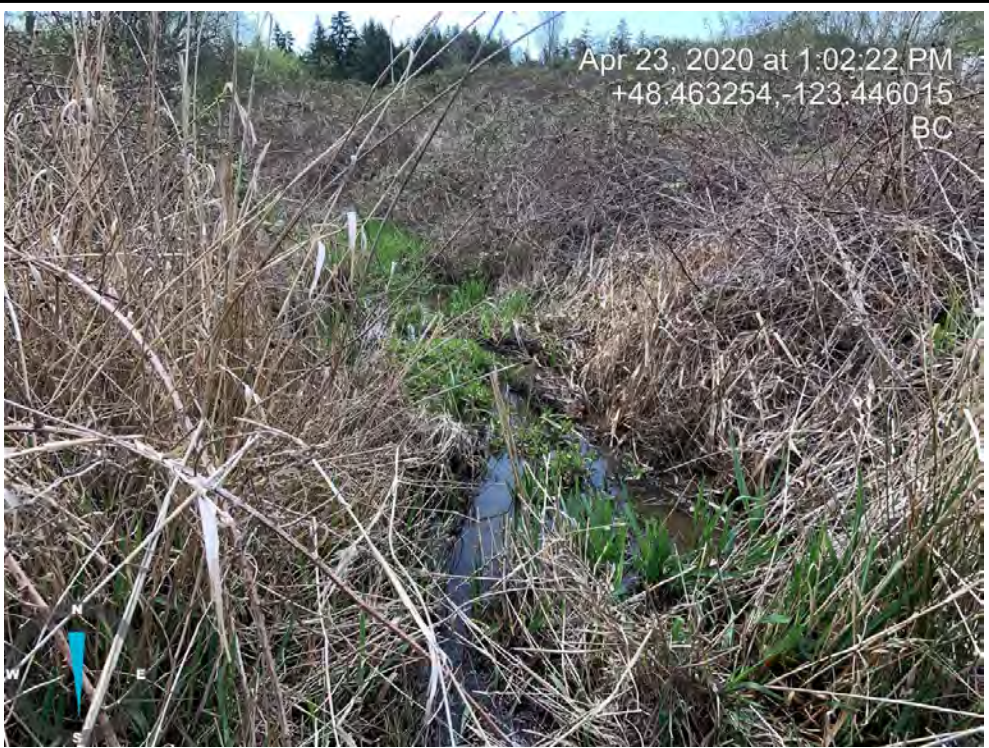
<b>Photograph ID:</b> 10

<b>Photo Location:</b> Watercourse 2	
<b>Survey Date:</b> 4/23/2020	
<b>Comments:</b> Looking upstream from within archery range. Channel had abundant reed canary grass and banks were overgrown with Himalayan blackberry.

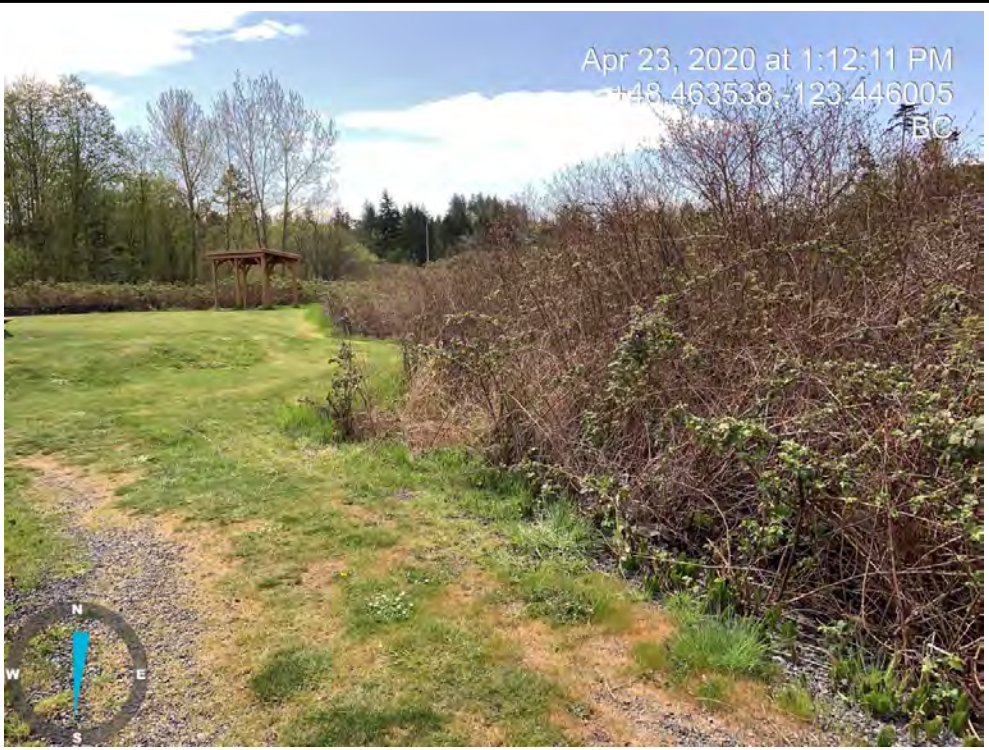
<b>Photograph ID:</b> 12	Apr 23, 2020 at 1:12:11 PM +48-463538-123-446005 BC
<b>Photo Location:</b> Watercourse 2	
<b>Survey Date:</b> 4/23/2020	
<b>Comments:</b> Looking downstream from within archery range. Watercourse is within area overgrown by Himalayan blackberry.

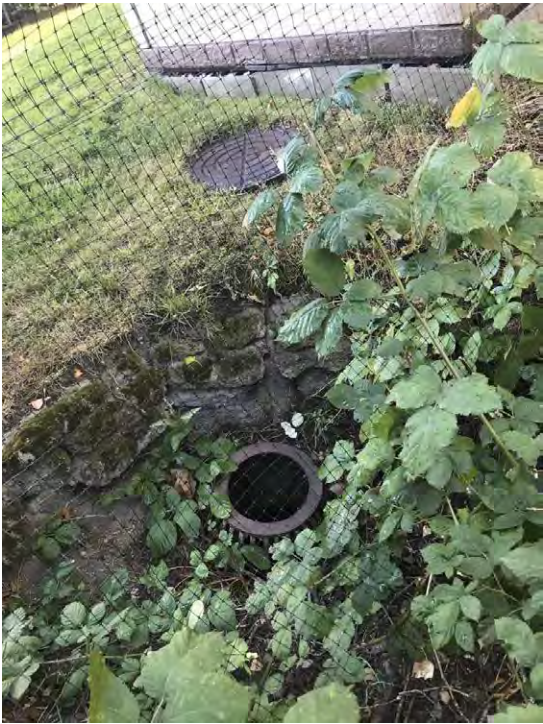
<b>Photo Location:</b> Watercourse North of Kami Court			
<b>Survey Date:</b> 9/2/2020			
<b>Comments:</b> Connection from Watercourse North of Kami Court to Watercourse 2.			
<b>Photograph ID:</b> 16

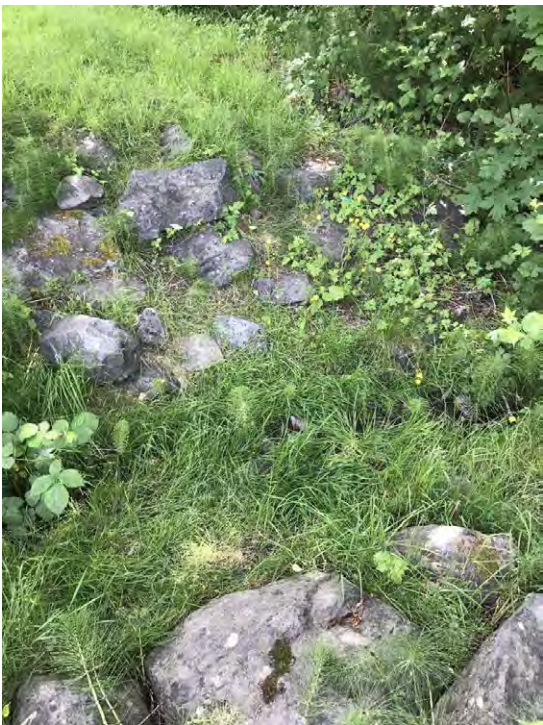
<b>Photo Location:</b> Watercourse 3			
<b>Survey Date:</b> 6/4/2020			
<b>Comments:</b> South of Watkiss Way showing rock armouring on banks.

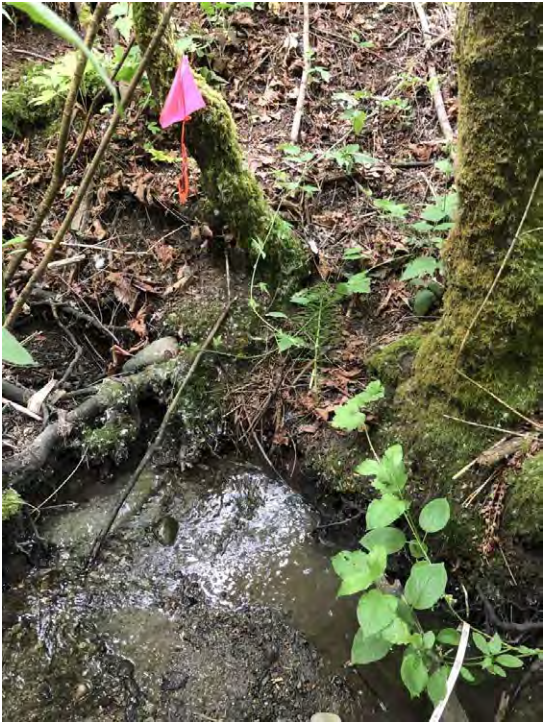
<b>Photo Location:</b> Watercourse 3	
<b>Survey Date:</b> 6/4/2020	
<b>Comments:</b> South of Watkiss Way showing area of channelization.

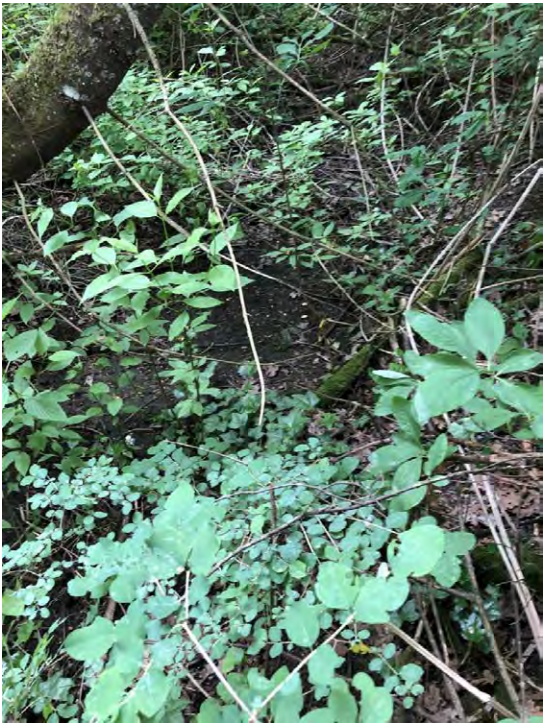
<b>Photo Location:</b> Watercourse 3			
<b>Survey Date:</b> 6/4/2020			
<b>Comments:</b> South of Watkiss Way showing dry patches in non-channelized areas.

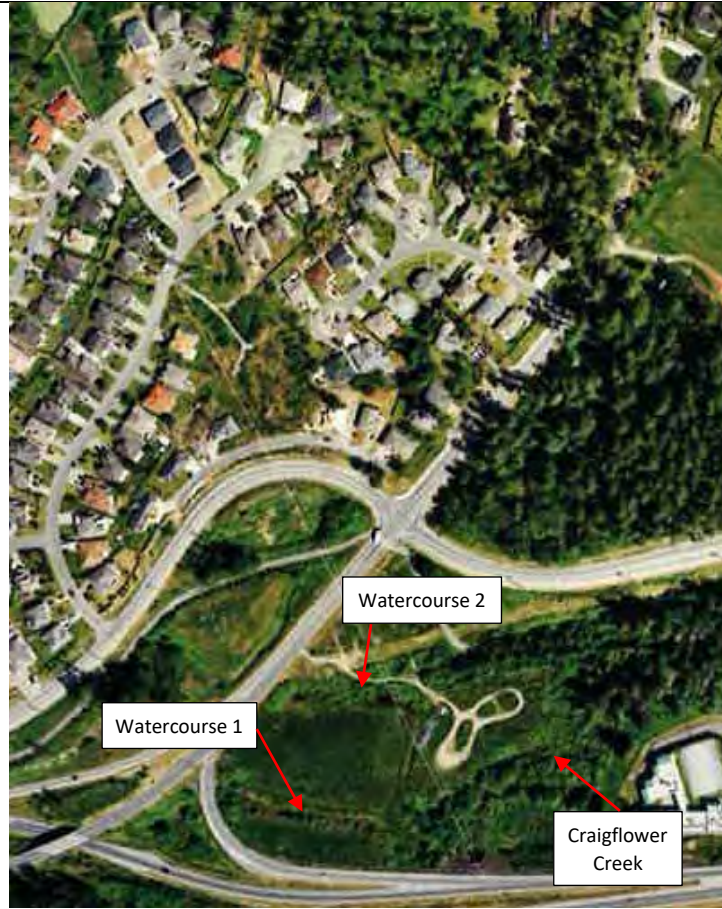
**Air Photo – 2005:** Site conditions after the construction of the Burnside Road offramp from Highway 1.

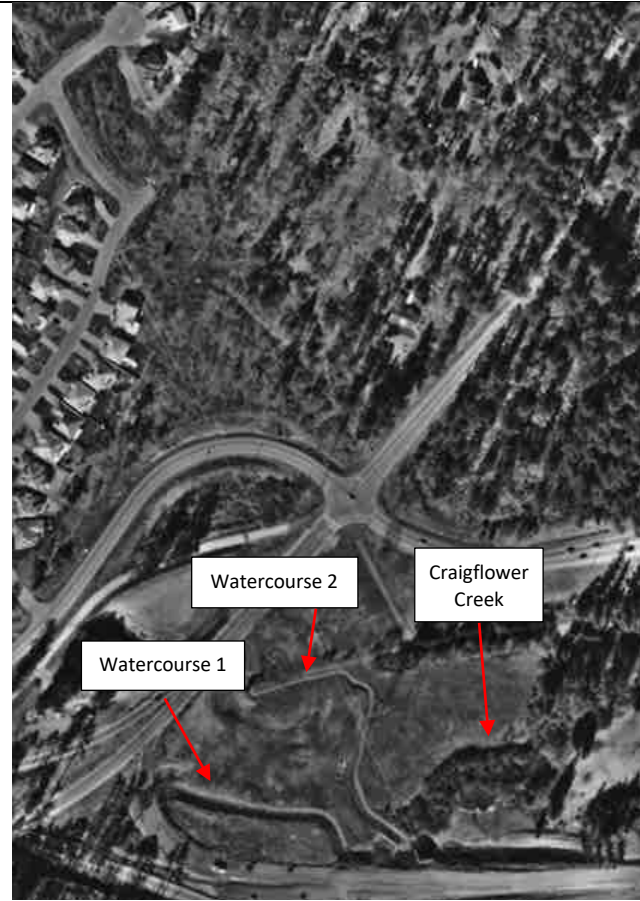
**Air Photo – 1997:** Site conditions during the construction of the Burnside Road offramp from Highway 1. The alignment of Watercourse 1 and Watercourse 2 are pronounced.

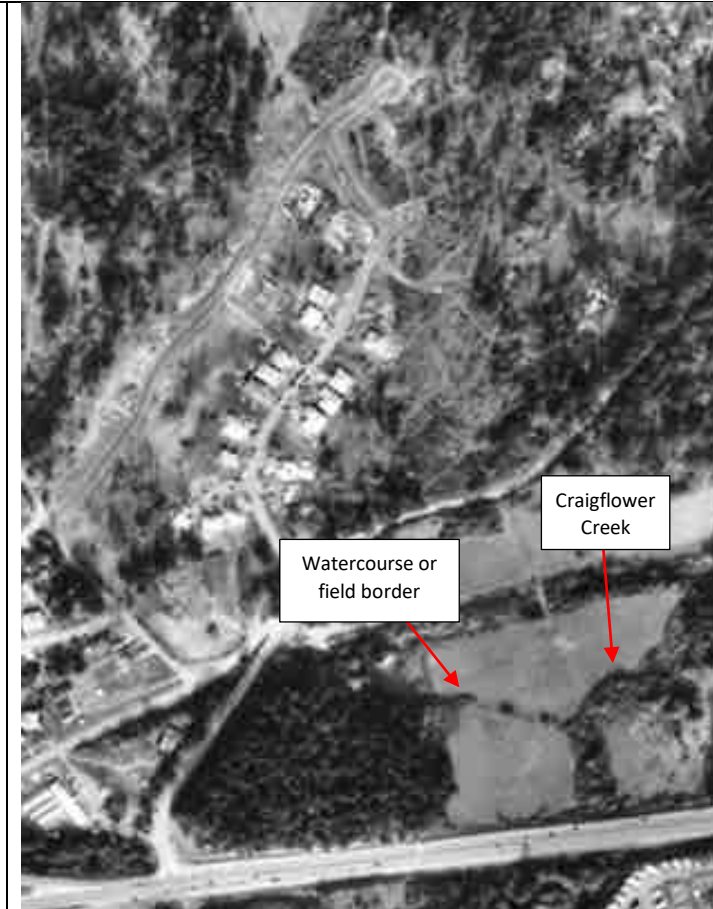
**Air Photo – 1992:** Site conditions prior to the construction of the Burnside Road offramp from Highway 1. Watercourse 1 does not appear to be present and a Watercourse or field border is present in a similar location as Watercourse 2 was previously.

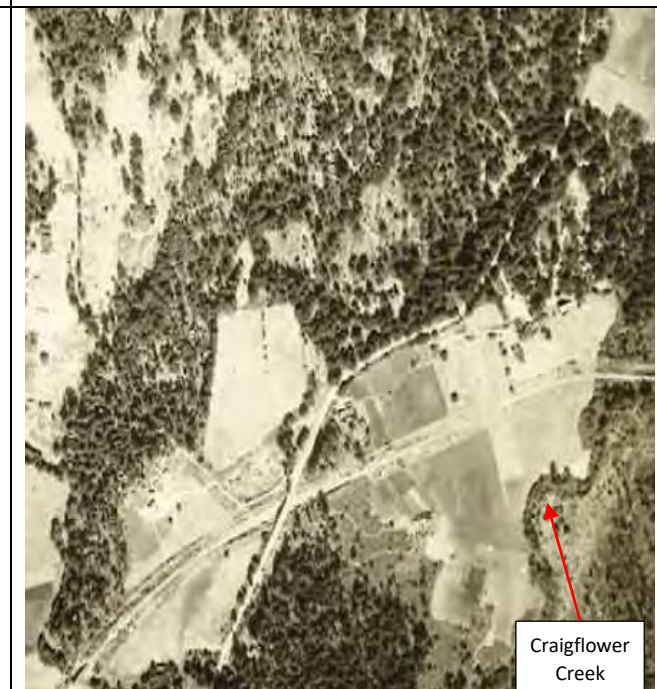
**Air Photo – 1926:** The watercourse / field border is no longer visible, though the area is cleared. No watercourses appear to flow into Craigflower Creek from the site.

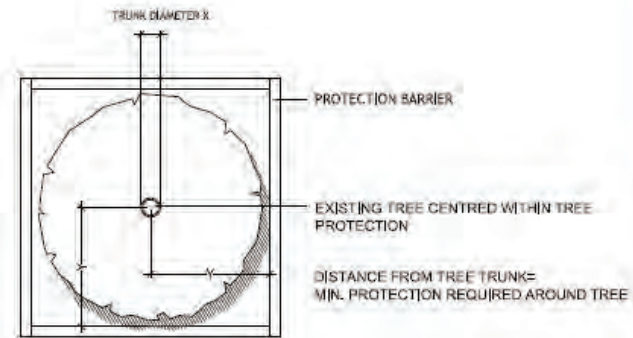
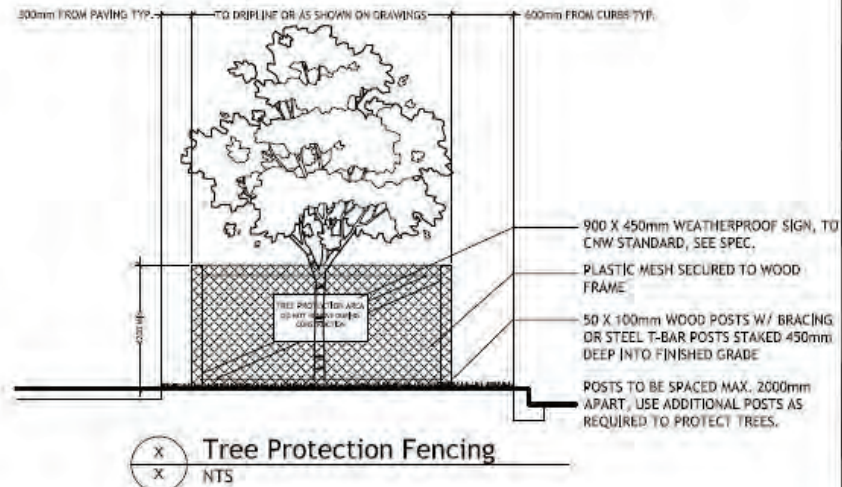
## **Tree Fencing Recommendation**

TRUNK DIAMETER X (cm)	MINIMUM PROTECTION REQUIRED AROUND TREE- DISTANCE FROM TRUNK Y (m)
20 cm	1.2 m
25 cm	1.5 m
30 cm	1.8 m
35 cm	2.1 m
40 cm	2.4 m
45 cm	2.7 m
50 cm	3.0 m
55 cm	3.3 m
60 cm	3.6 m
75 cm	4.5 m
90 cm	5.0 m
100 cm	6.0 m
