# **Hazardous Materials Investigation**

## **4206 Commerce Circle, Victoria, BC**

### **BC Transit – Handy Dart**

Island EHS Project #63922

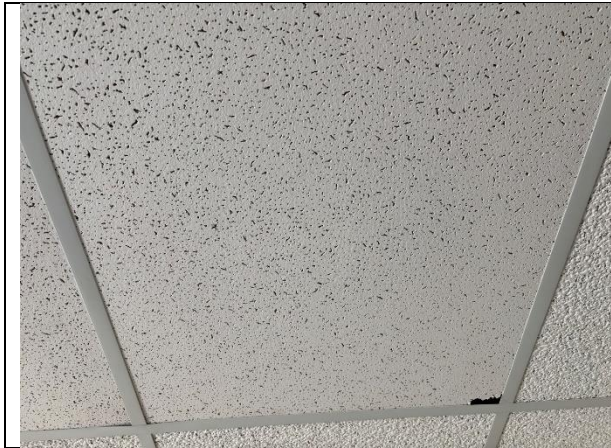
| Sample: | 63922-3 | Sample: | 63922-4 |

| Location: | Hallway | Location: | Hallway |
| Description: | Acoustic Ceiling Tile 1 | Description: | Acoustic Ceiling Tile 2 |
| Asbestos: | None Detected | Asbestos: | None Detected |

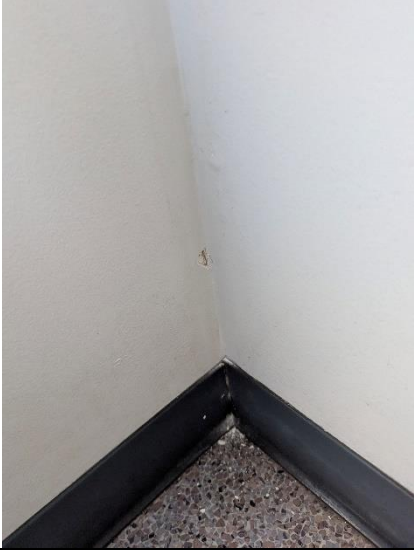
| Sample: | 63922-9 | Sample: | 63922-10 |

| Location: | Lunchroom | Location: | Men's Washroom |
| Description: | Drywall Joint Compound | Description: | Drywall Joint Compound |
| Asbestos: | None Detected | Asbestos: | None Detected |

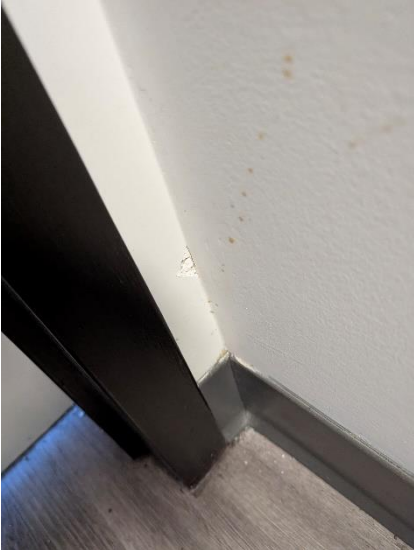
| Sample: | 63922-11 | Sample: | 63922-12 |

| Location: | Dispatch | Location: | Women's Washroom |
| Description: | Drywall Joint Compound | Description: | Drywall Joint Compound |
| Asbestos: | None Detected | Asbestos: | None Detected |

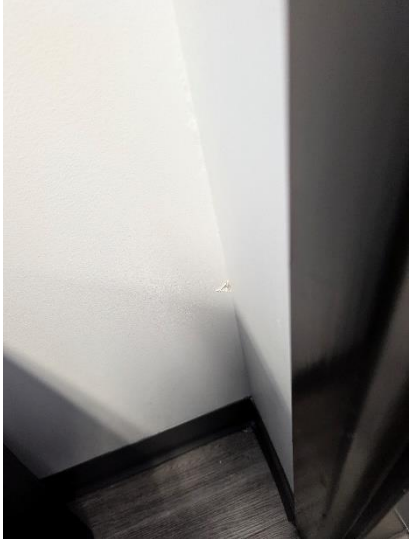
| Sample: | 63922-13 | Sample: | 63922-14 |

| Location: | Office | Location: | Loading Bay – Office |
| Description: | Drywall Joint Compound | Description: | Drywall Joint Compound |
| Asbestos: | None Detected | Asbestos: | None Detected |

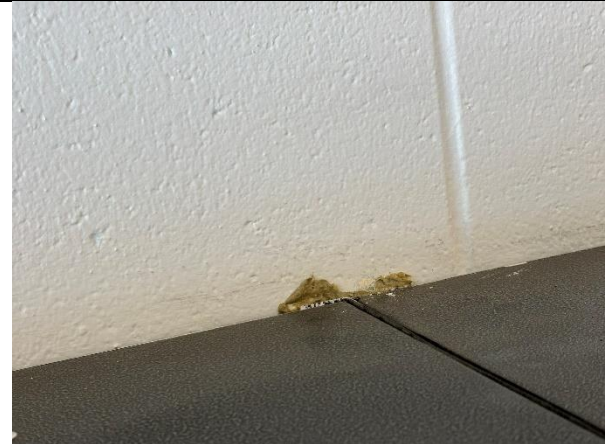
| Sample: | 63922-21 | Sample: | 63922-22 |

| Location: | Lunchroom – Behind Lockers | Location: | Lunchroom – Behind Lockers |
| Description: | Mastic | Description: | Mastic |
| Asbestos: | None Detected | Asbestos: | None Detected |

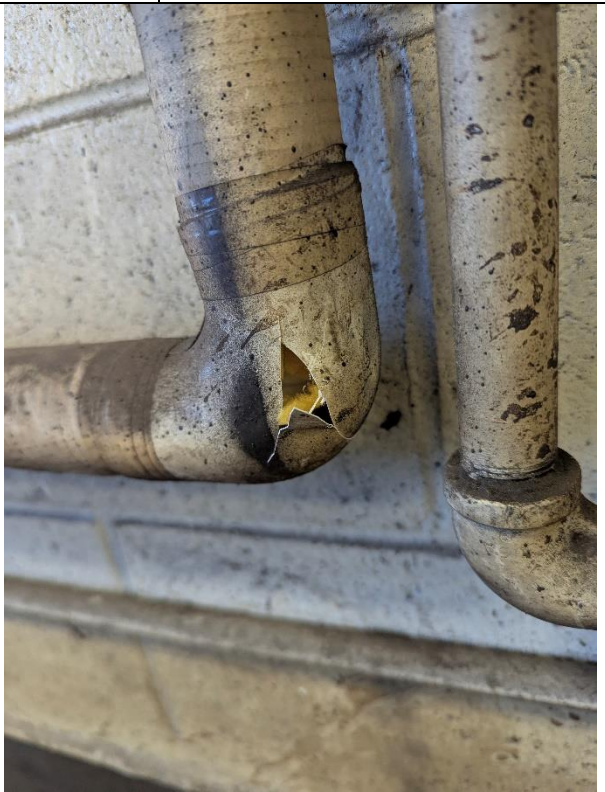
| Sample: | 63922-23 | Sample: | 63922-24 |

| Location: | Service Bay 2 – Run | Location: | Service Bay 2 – Elbow |
| Description: | Pipe Insulation | Description: | Pipe Insulation |
| Asbestos: | None Detected | Asbestos: | None Detected |

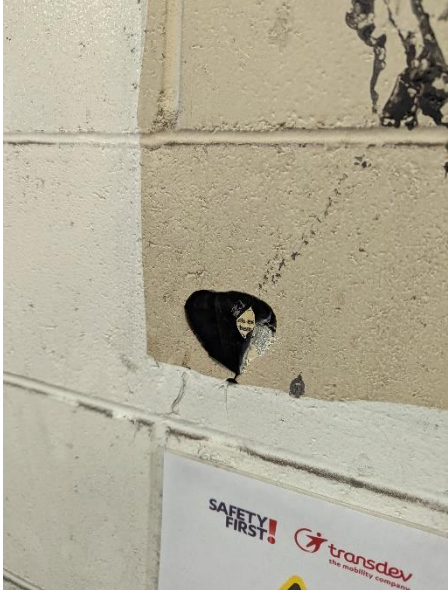
| <p>Sample: 63922-25<br/>Location: Service Bay 2 - Walls<br/>Description: Mastic<br/>Asbestos: None Detected</p> | <p>Sample: 63922-26<br/>Location: Service Bay 2 - Walls<br/>Description: Mastic<br/>Asbestos: None Detected</p> |

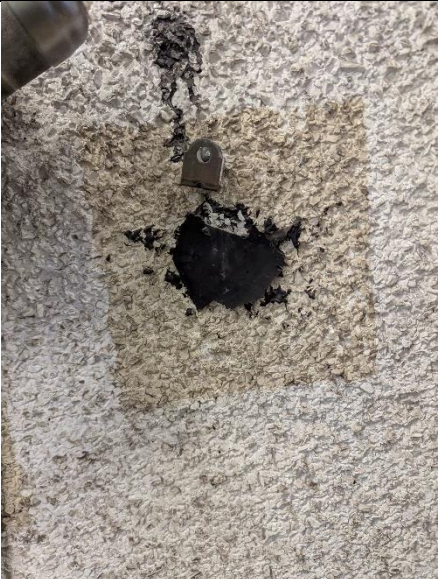
| <p>Sample: 63922-27<br/>Location: Service Bay 2 - Walls<br/>Description: Mastic<br/>Asbestos: None Detected</p> | <p>Sample: 63922-28<br/>Location: Exterior - Concrete Block<br/>Description: Mortar<br/>Asbestos: None Detected</p> |

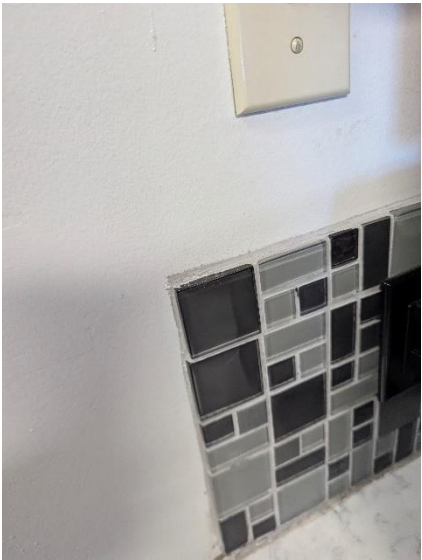
| Sample: | 63922-33 | Sample: | 63922-34 |

| Location: | Kitchen | Location: | Exterior – Siding |
| Description: | Grout | Description: | Stucco |
| Asbestos: | None Detected | Asbestos: | None Detected |

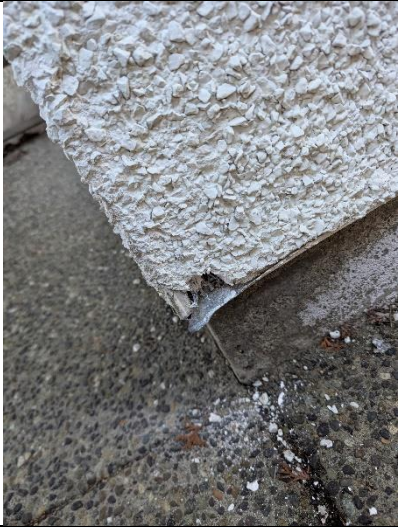
| Sample: | 63922-35 | Sample: | 63922-36 |

| Location: | Exterior – Siding | Location: | Exterior – Siding |
| Description: | Stucco | Description: | Stucco |
| Asbestos: | None Detected | Asbestos: | None Detected |

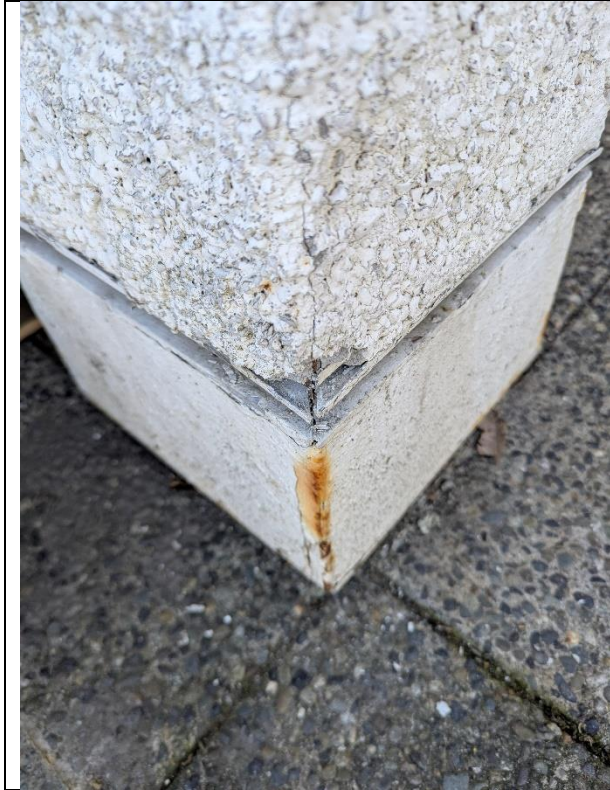
Sample: 63922-37  
 Location: Exterior – Siding  
 Description: Stucco  
 Asbestos: None Detected

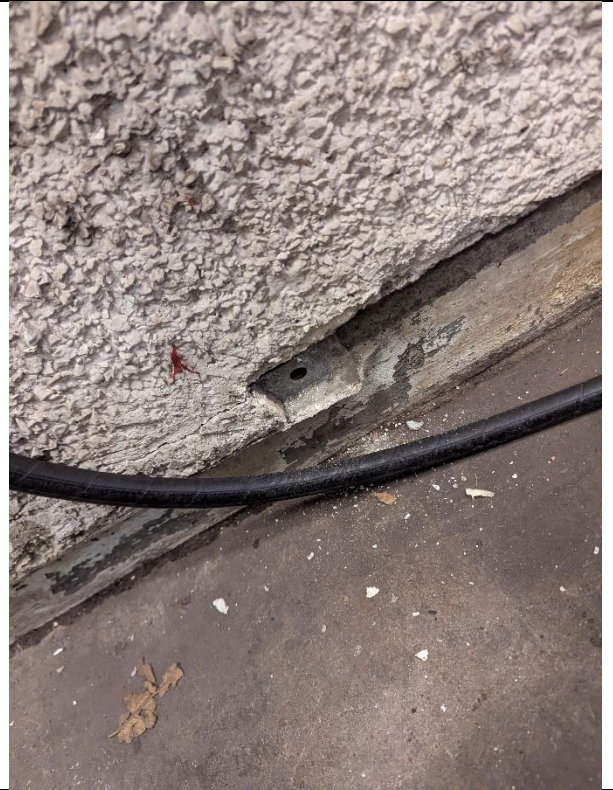
Sample: 63922-38  
 Location: Service Bay 2  
 Description: Stucco  
 Asbestos: None Detected

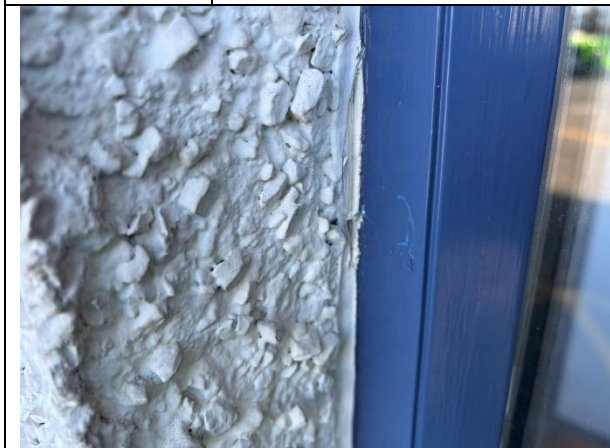
Sample: 63922-39  
 Location: Exterior – Window  
 Description: Caulking  
 Asbestos: None Detected

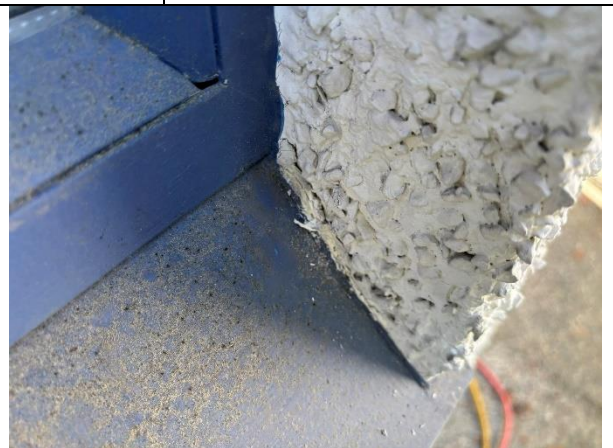
Sample: 63922-40  
 Location: Exterior – Window  
 Description: Caulking  
 Asbestos: None Detected

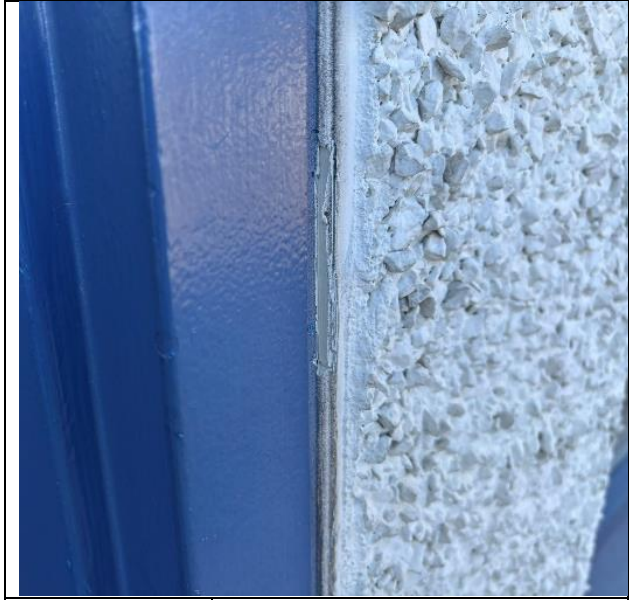
| Sample: | 63922-41 | Sample: | 63922-42 |

| Location: | Exterior - Door | Location: | Upper Roof |
| Description: | Caulking | Description: | Torch-on Asphalt |
| Asbestos: | None Detected | Asbestos: | None Detected |

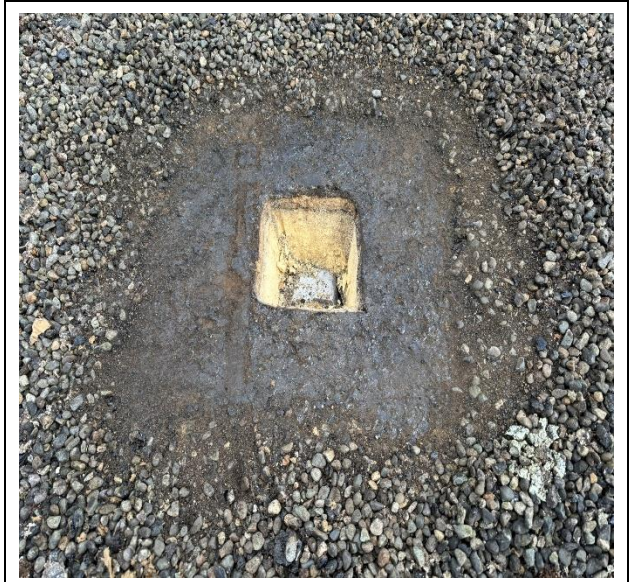
| Sample: | 63922-43 | Sample: | 63922-44 |

| Location: | Upper Roof | Location: | Upper Roof - HVAC |
| Description: | Tar & Gravel | Description: | Mastic |
| Asbestos: | None Detected | Asbestos: | None Detected |

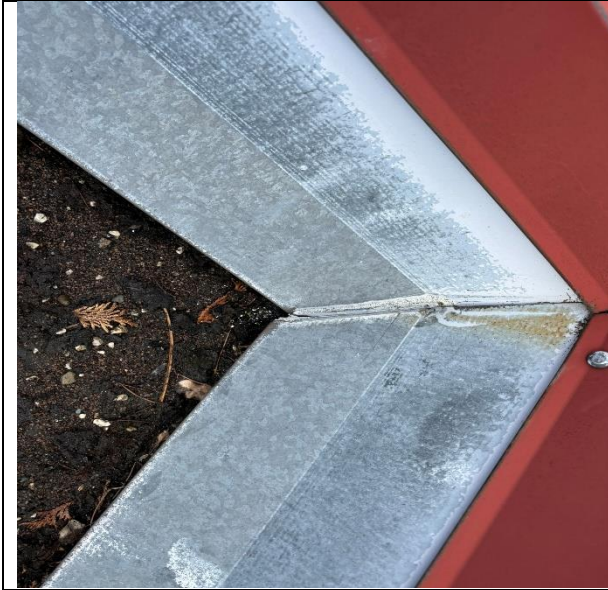
| Sample: | 63922-45 |

| Location: | Upper Roof – HVAC |
| Description: | Mastic |
| Asbestos: | None Detected |

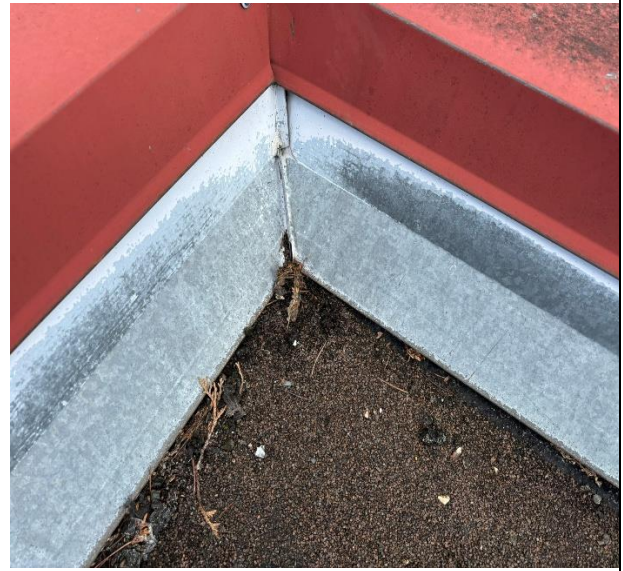
| Sample: | 63922-46 |

| Location: | Upper Roof – HVAC |

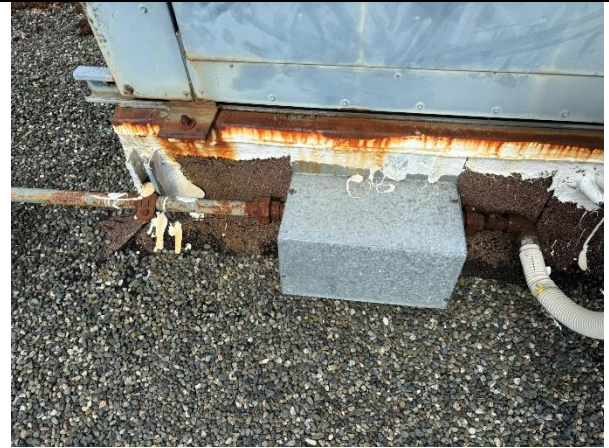
| Sample: | 63922-47 |

| Location: | Upper Roof – Flashing |
| Description: | Caulking – White |
| Asbestos: | None Detected |

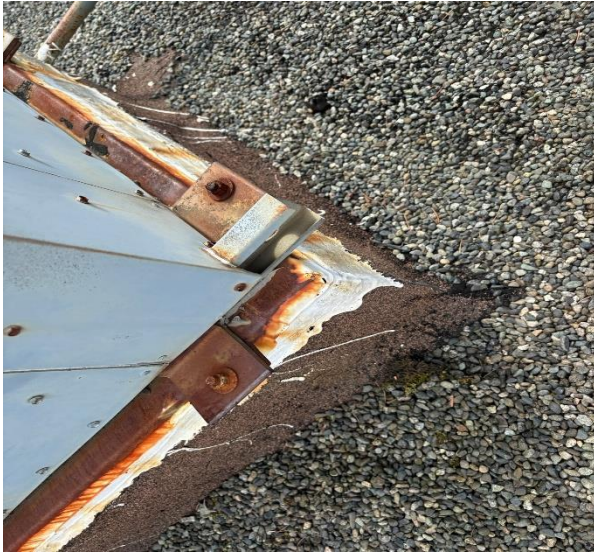
| Sample: | 63922-48 |

| Location: | Upper Roof – Flashing |
| Description: | Caulking – White |
| Asbestos: | None Detected |

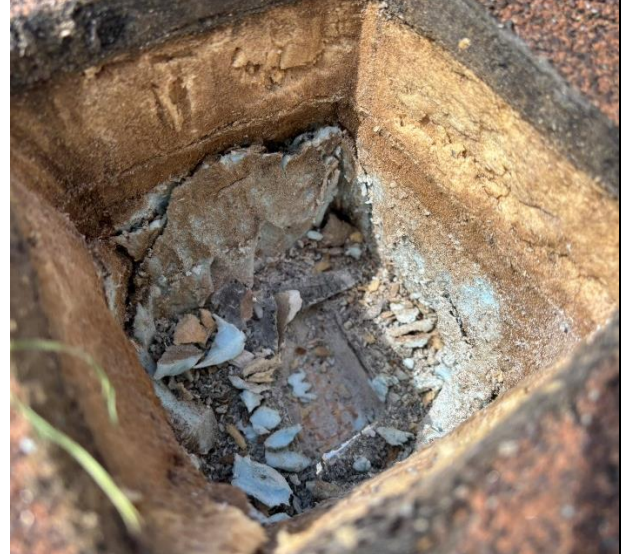
| Sample: | 63922-49 |

| Location: | Upper Roof – Flashing |
| Description: | Caulking – White |
| Asbestos: | None Detected |
