# **Hazardous Materials Investigation**

## **4212 Commerce Circle, Victoria, BC**

Island EHS Project #63920 (Rev02)

Original issue date April 2025  
Revised June 2025 (Rev01)  
September 2025 (Rev02)

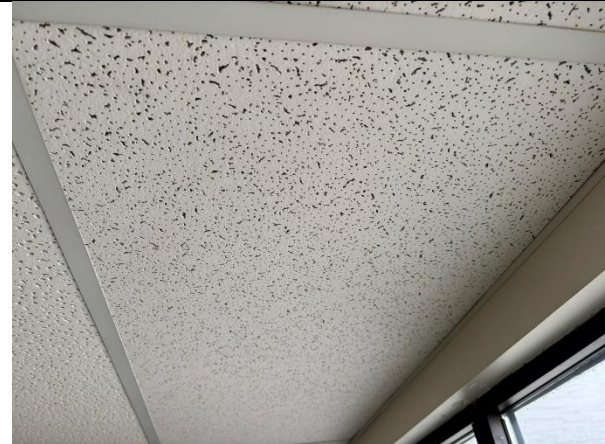
| Sample: | 63920-1 | Sample: | 63920-2 |

| Location: | 2 <sup>nd</sup> Floor – Break Room | Location: | 2 <sup>nd</sup> Floor – Open Office |
| Description: | Acoustic Ceiling Tile 1 | Description: | Acoustic Ceiling Tile 1 |
| Asbestos: | None Detected | Asbestos: | None Detected |

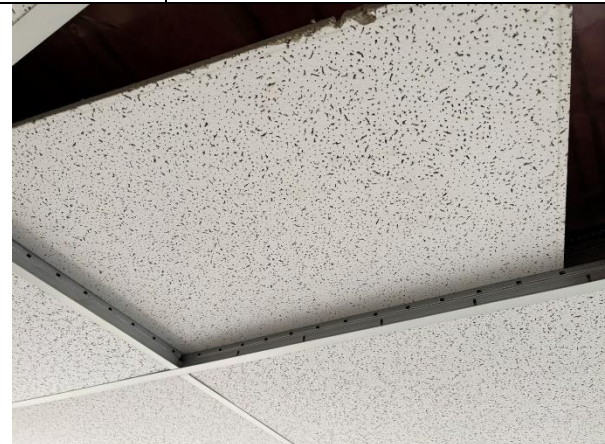
| Sample: | 63920-3 | Sample: | 63920-4 |

| Location: | 2 <sup>nd</sup> Floor – Office | Location: | 2 <sup>nd</sup> Floor – Break Room |
| Description: | Acoustic Ceiling Tile 1 | Description: | Acoustic Ceiling Tile 2 |
| Asbestos: | None Detected | Asbestos: | None Detected |

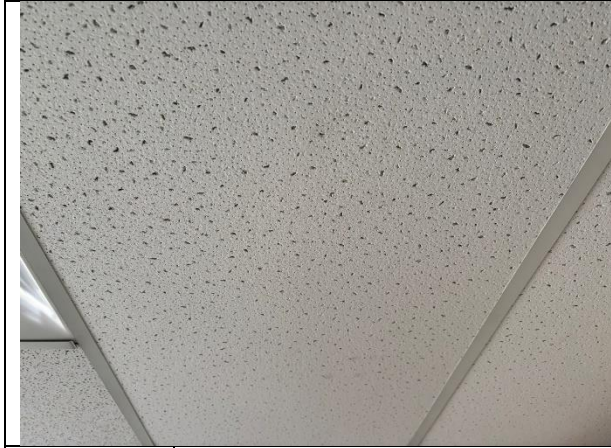
Sample: 63920-5  
 Location: 2<sup>nd</sup> Floor – Break Room  
 Description: Acoustic Ceiling Tile 2  
 Asbestos: None Detected

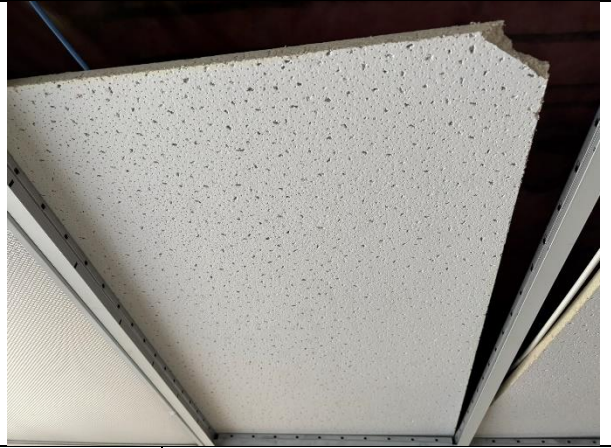
Sample: 63920-6  
 Location: 2<sup>nd</sup> Floor – Break Room  
 Description: Acoustic Ceiling Tile 2  
 Asbestos: None Detected

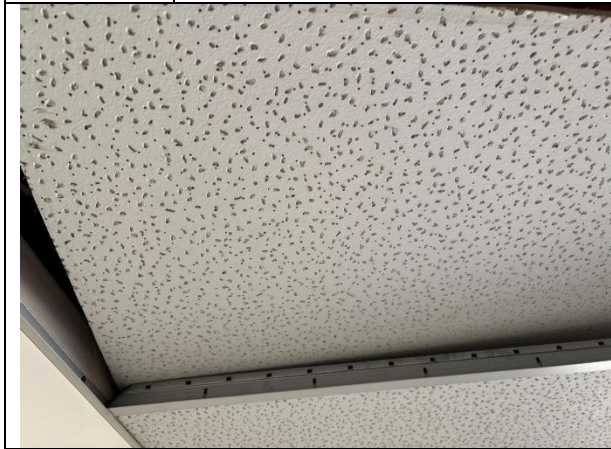
Sample: 63920-7  
 Location: 2<sup>nd</sup> Floor – Break Room  
 Description: Acoustic Ceiling Tile 3  
 Asbestos: None Detected

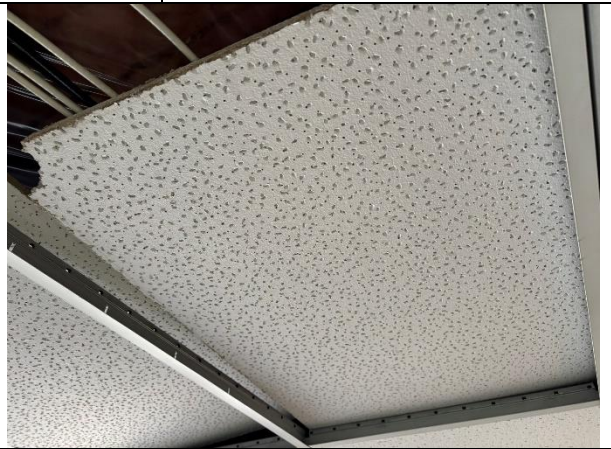
Sample: 63920-8  
 Location: 2<sup>nd</sup> Floor – Break Room  
 Description: Acoustic Ceiling Tile 3  
 Asbestos: None Detected

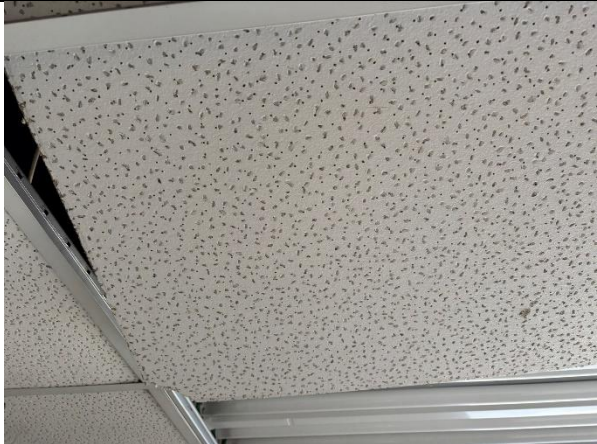
| Sample: | 63920-9 | Sample: | 63920-10 |

| Location: | 2 <sup>nd</sup> Floor – Break Room | Location: | 2 <sup>nd</sup> Floor – Washroom |
| Description: | Acoustic Ceiling Tile 3 | Description: | Drywall Joint Compound |
| Asbestos: | None Detected | Asbestos: | None Detected |

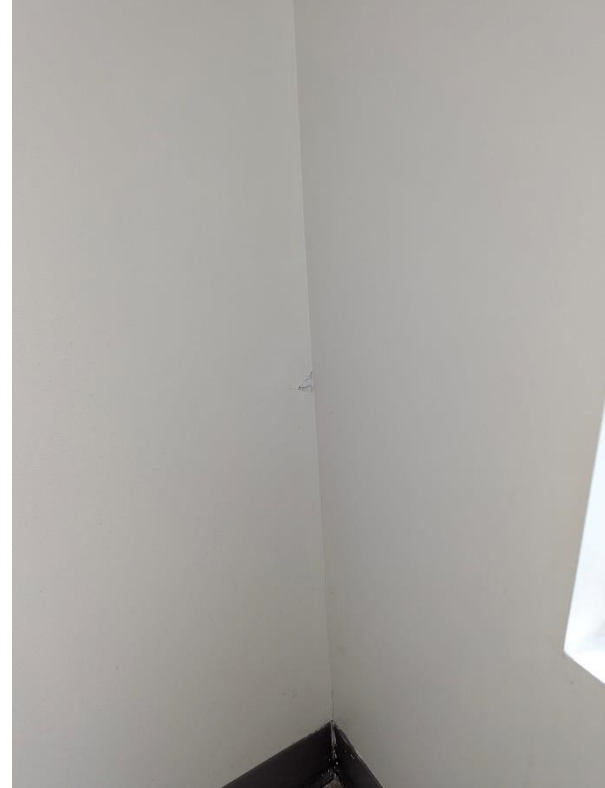
| Sample: | 63920-11 | Sample: | 63920-12 |

| Location: | 2 <sup>nd</sup> Floor – Open Office | Location: | 2 <sup>nd</sup> Floor - Office |
| Description: | Drywall Joint Compound | Description: | Drywall Joint Compound |
| Asbestos: | None Detected | Asbestos: | None Detected |

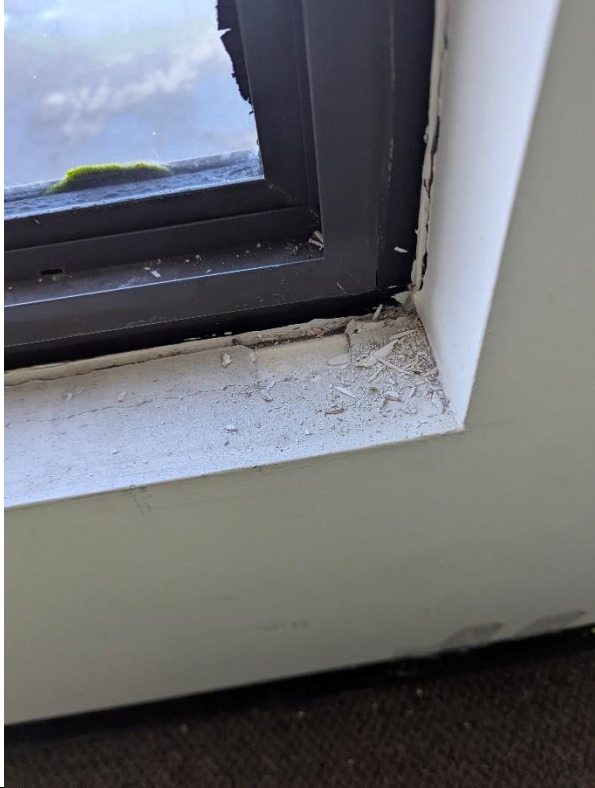
| Sample: | 63920-13 | Sample: | 63920-14 |

| Location: | 2 <sup>nd</sup> Floor – Office | Location: | 2 <sup>nd</sup> Floor – Break Room |
| Description: | Drywall Joint Compound | Description: | Drywall Joint Compound |
| Asbestos: | None Detected | Asbestos: | None Detected |

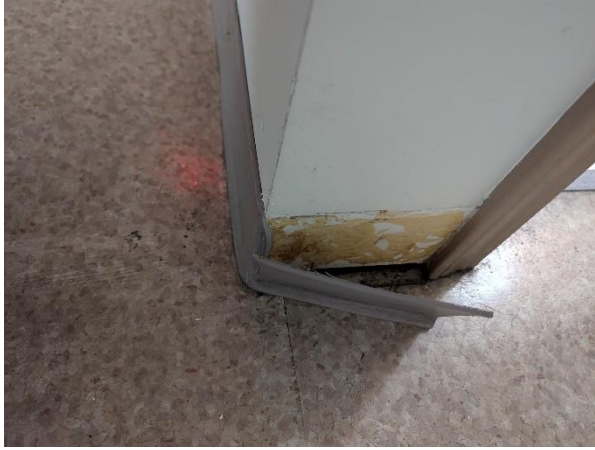
| Sample: | 63920-15 | Sample: | 63920-16 |

| Location: | 2 <sup>nd</sup> Floor – Office, Baseboards | Location: | 2 <sup>nd</sup> Floor – Office, Baseboards |
| Description: | Adhesive | Description: | Adhesive |
| Asbestos: | None Detected | Asbestos: | None Detected |

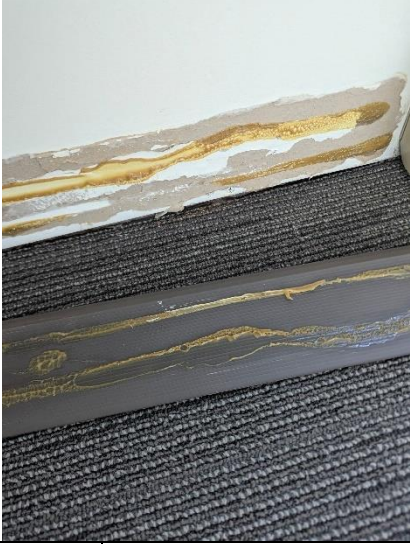
| Sample: | 63920-17 | Sample: | 63920-18 |

| Location: | 2 <sup>nd</sup> Floor – Office, Baseboards | Location: | 2 <sup>nd</sup> Floor – Break Room |
| Description: | Adhesive | Description: | Acoustic Ceiling Tile 4 |
| Asbestos: | None Detected | Asbestos: | None Detected |

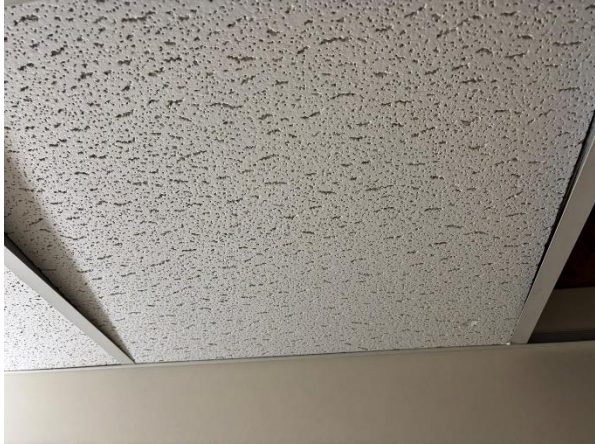
| Sample: | 63920-19 | Sample: | 63920-20 |

| Location: | 2 <sup>nd</sup> Floor – Women's Washroom | Location: | 2 <sup>nd</sup> Floor – Open Office |
| Description: | Acoustic Ceiling Tile 4 | Description: | Acoustic Ceiling Tile 4 |
| Asbestos: | None Detected | Asbestos: | None Detected |

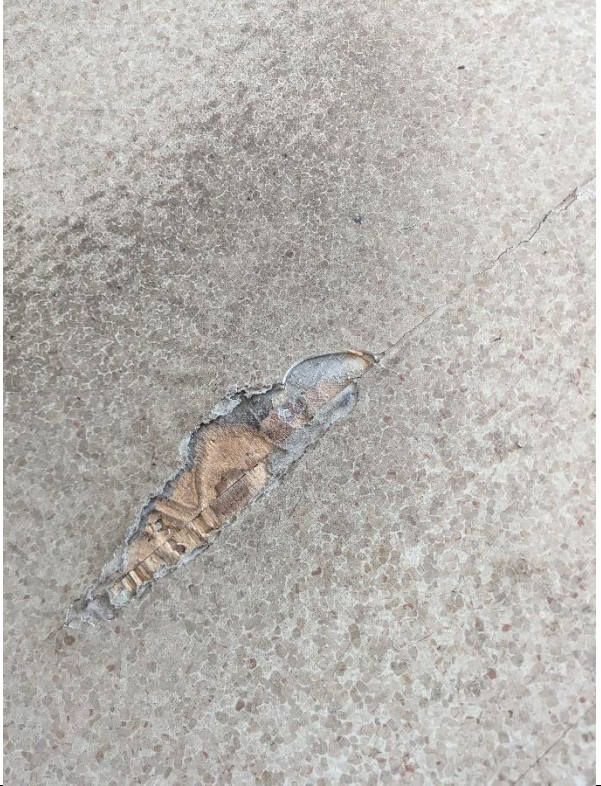
| Sample: | 63920-21 | Sample: | 63920-22 |

| Location: | 2 <sup>nd</sup> Floor – Break Room, Sink | Location: | 2 <sup>nd</sup> Floor |
| Description: | Mastic | Description: | Vinyl Sheet Flooring |
| Asbestos: | None Detected | Asbestos: | None Detected |

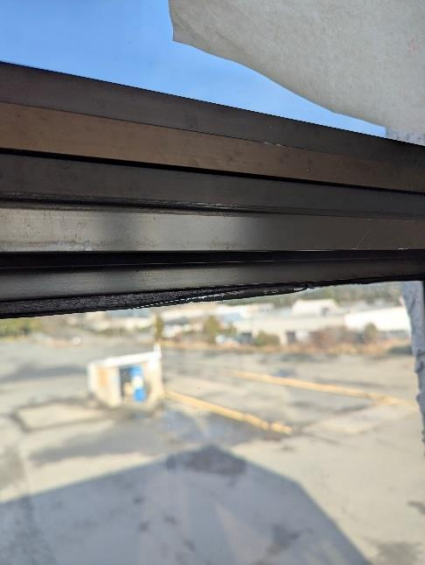
| Sample: | 63920-23 | Sample: | 63920-24 |

| Location: | 2 <sup>nd</sup> Floor – Office, Deck | Location: | 2 <sup>nd</sup> Floor - Windows |
| Description: | Vinyl Deck Membrane | Description: | Putty |
| Asbestos: | None Detected | Asbestos: | None Detected |

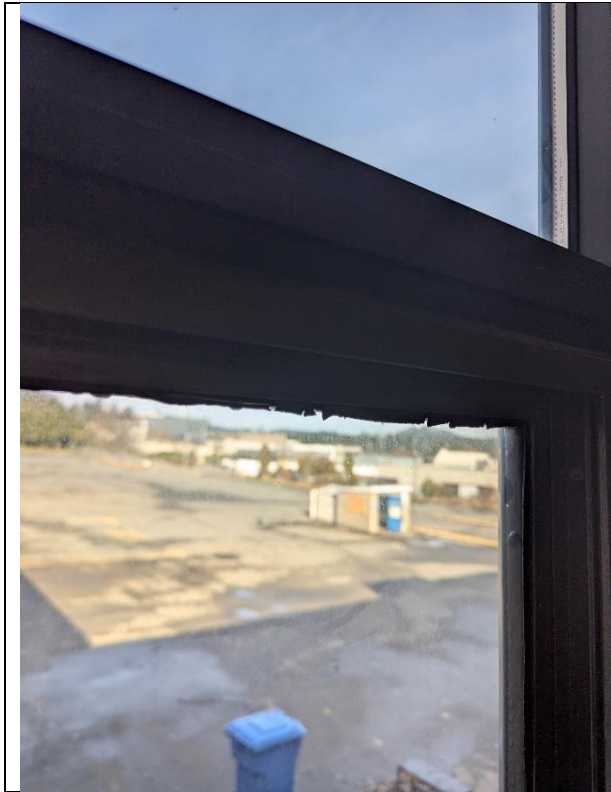
Sample: 63920-25  
Location: 2<sup>nd</sup> Floor - Windows  
Description: Putty  
Asbestos: None Detected

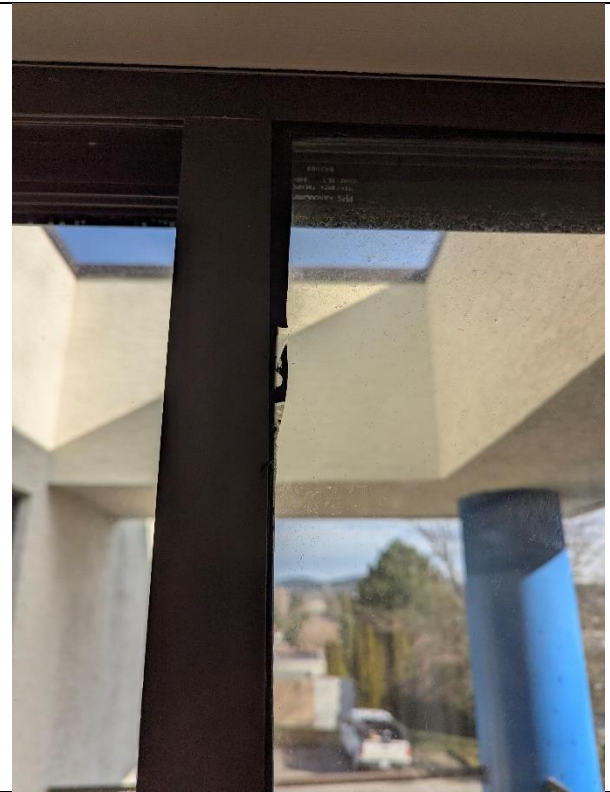
Sample: 63920-26  
Location: 2<sup>nd</sup> Floor - Windows  
Description: Putty  
Asbestos: None Detected

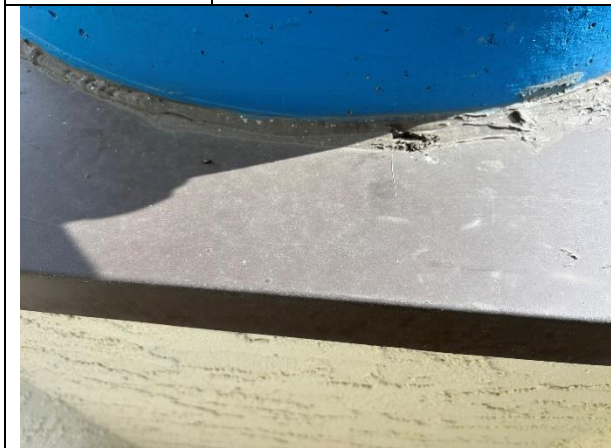
Sample: 63920-27  
Location: 2<sup>nd</sup> Floor – Balcony – Flashing  
Description: Caulking – Brown  
Asbestos: None Detected

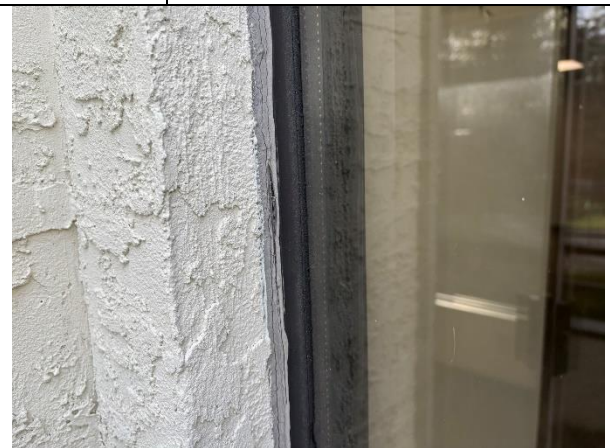
Sample: 63920-28  
Location: 2<sup>nd</sup> Floor – Balcony – Window  
Description: Caulking – Brown  
Asbestos: None Detected

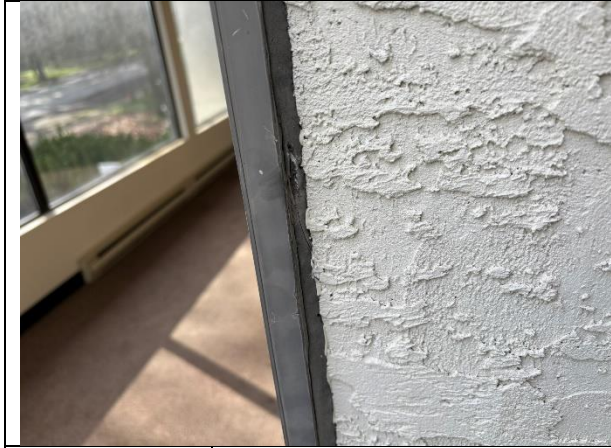
Sample: 63920-29  
 Location: 2<sup>nd</sup> Floor – Balcony – Door  
 Description: Caulking – Brown  
 Asbestos: None Detected

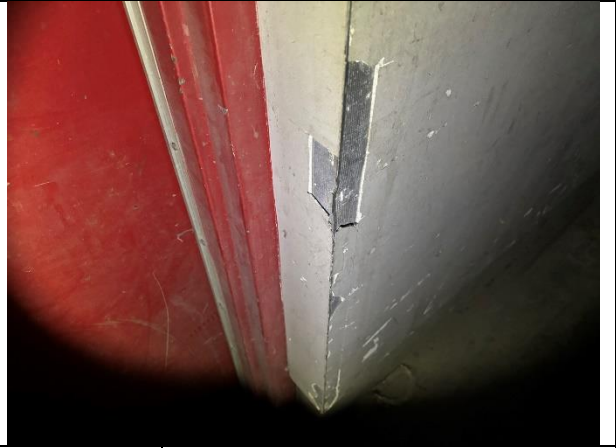
Sample: 63920-30  
 Location: 1<sup>st</sup> Floor – Loading Bay  
 Description: Drywall Joint Compound  
 Asbestos: None Detected

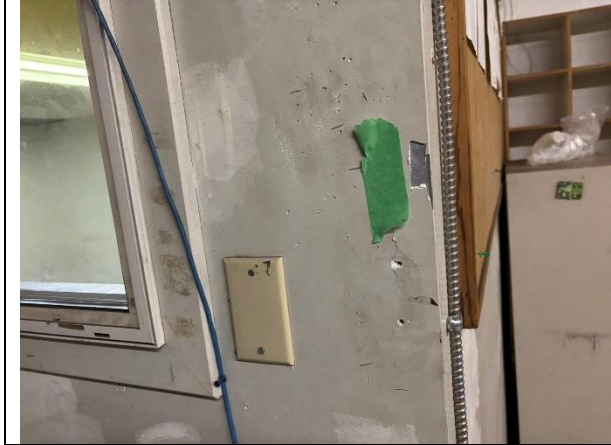
Sample: 63920-31  
 Location: 1<sup>st</sup> Floor – Parts  
 Description: Drywall Joint Compound  
 Asbestos: None Detected

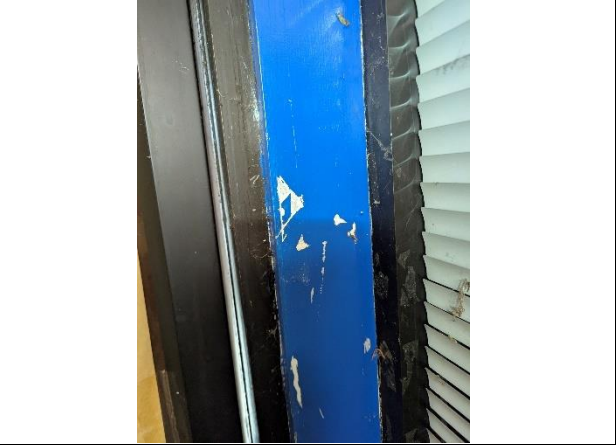
Sample: 63920-32  
 Location: 1<sup>st</sup> Floor - Reception  
 Description: Drywall Joint Compound  
 Asbestos: None Detected

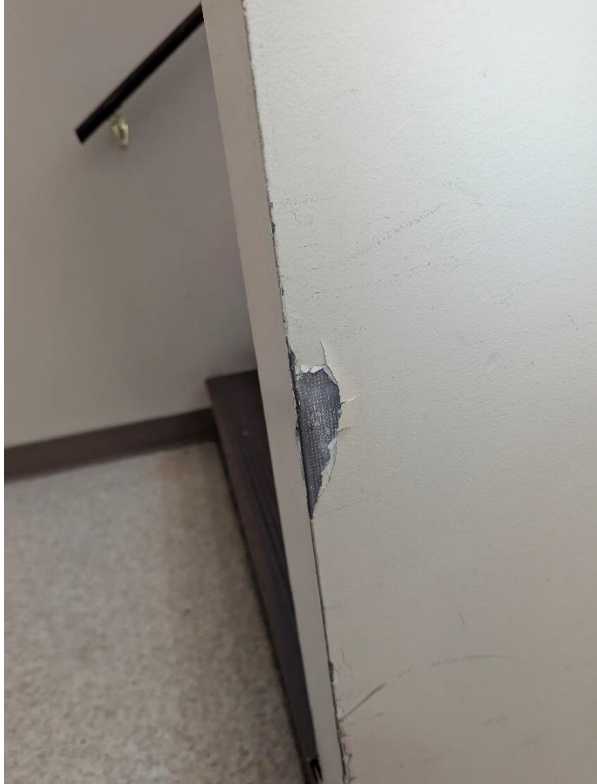
| Sample: | 63920-33 | Sample: | 63920-34 |

| Location: | 1 <sup>st</sup> Floor – Stairwell | Location: | 1 <sup>st</sup> Floor – Mail Room |
| Description: | Drywall Joint Compo | Description: | Drywall Joint |
| Asbestos: | None Detected | Asbestos: | None Detected |

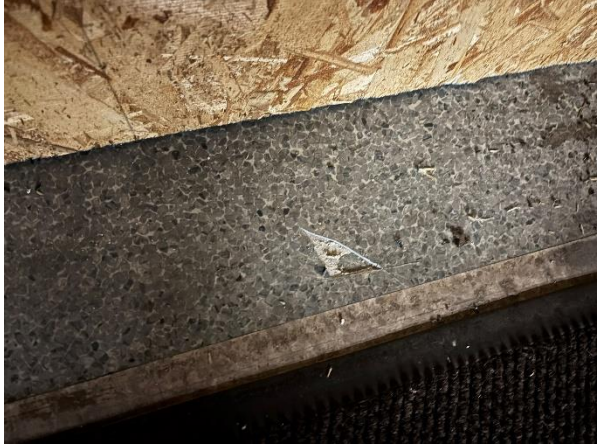
| Sample: | 63920-35 | Sample: | 63920-36 |

| Location: | 1 <sup>st</sup> Floor - Office | Location: | 1 <sup>st</sup> Floor - Parts |
| Description: | Vinyl Sheet Flooring | Description: | Concrete Block Mortar |
| Asbestos: | None Detected | Asbestos: | None Detected |

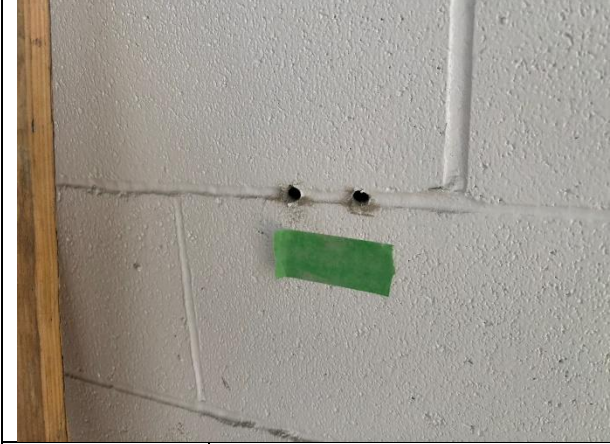
| Sample: | 63920-37 | Sample: | 63920-38 |

| Location: | 1 <sup>st</sup> Floor – Loading Bay #1 | Location: | 1 <sup>st</sup> Floor – Loading Bay #2 |
| Description: | Concrete Block Mortar | Description: | Concrete Block Mortar |
| Asbestos: | None Detected | Asbestos: | None Detected |

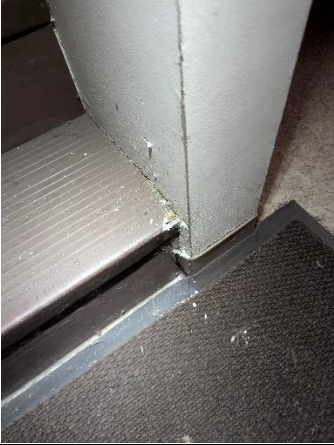
| Sample: | 63920-39 | Sample: | 63920-40 |

| Location: | 1 <sup>st</sup> Floor – Stairwell | Location: | 1 <sup>st</sup> Floor – Reception |
| Description: | Stair Tread | Description: | Acoustic Ceiling Tile 1 |
| Asbestos: | None Detected | Asbestos: | None Detected |

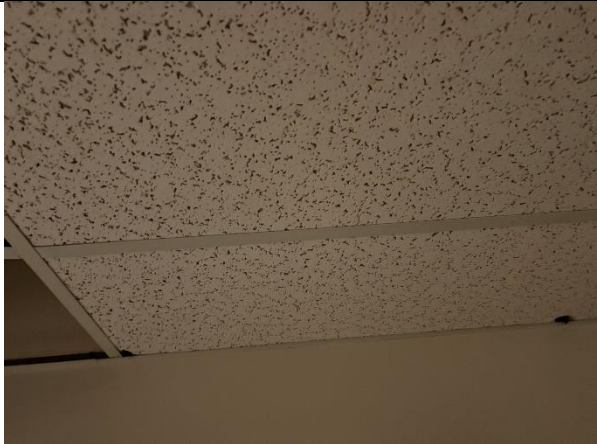
| Sample: | 63920-41 | Sample: | 63920-42 |

| Location: | 1 <sup>st</sup> Floor – Mail Room | Location: | 1 <sup>st</sup> Floor – Washroom |

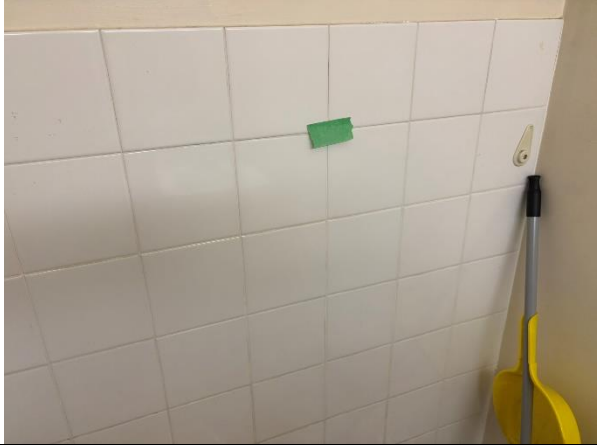
| Description: | Acoustic Ceiling Tile 1 | Description: | Grout |
| Asbestos: | None Detected | Asbestos: | None Detected |

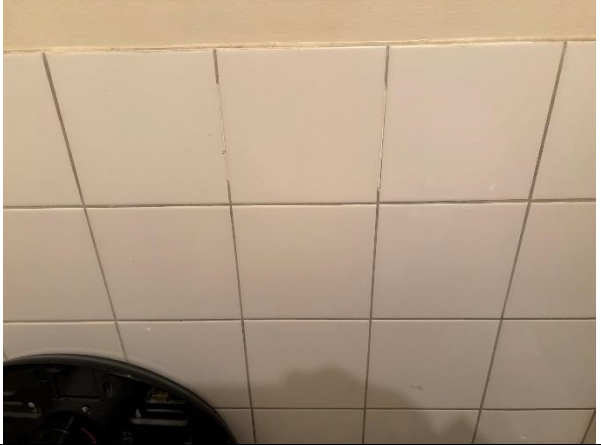
| Sample: | 63920-43 | Sample: | 63920-44 |

| Location: | 1 <sup>st</sup> Floor – Washroom | Location: | 1 <sup>st</sup> Floor – Washroom |
| Description: | Grout | Description: | Grout |
| Asbestos: | None Detected | Asbestos: | None Detected |

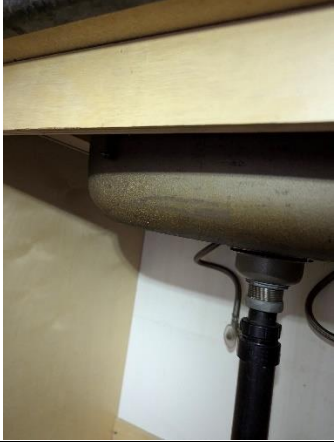
| Sample: | 63920-45 | Sample: | 63920-46 |

| Location: | Mezzanine – Break Room, Sink | Location: | Exterior |
| Description: | Mastic | Description: | Stucco |
| Asbestos: | <b>Chrysotile 1%</b> | Asbestos: | None Detected |

| Material | Description | Location and Quantity Estimates | Recommendation |
|---|---|---|---|
| Asbestos | Sink Mastic | 1 sink in the 2 <sup>nd</sup> floor staff room | <b>Moderate risk asbestos abatement work procedures</b><br><br>If unidentified materials are encountered, work must stop until the material is identified and assessed |

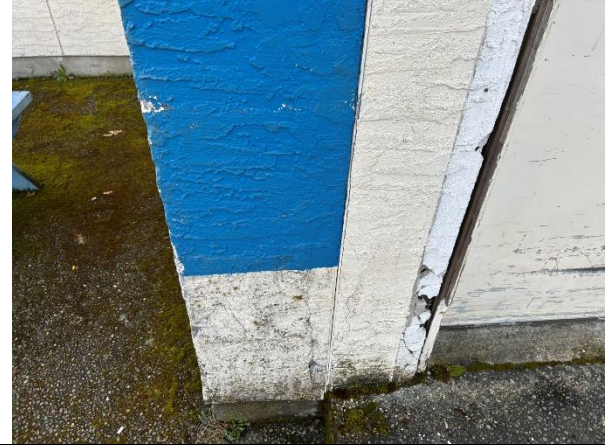
| Sample: | 63920-47 | Sample: | 63920-48 |

| Location: | Exterior | Location: | Exterior |
| Description: | Stucco | Description: | Stucco |
| Asbestos: | None Detected | Asbestos: | None Detected |

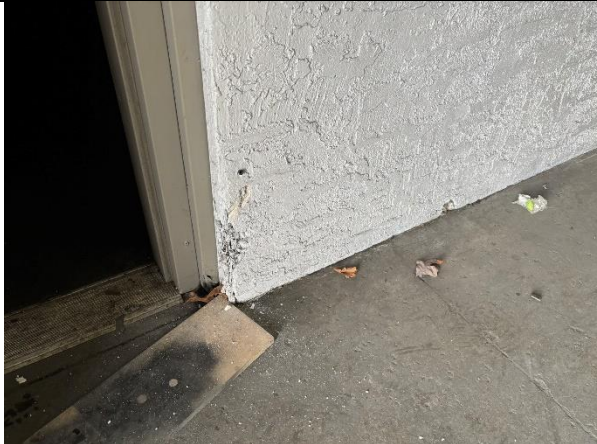
| Sample: | 63920-49 | Sample: | 63920-50 |

| Location: | Loading Bay #3 | Location: | Exterior |
| Description: | Stucco | Description: | Stucco |
| Asbestos: | None Detected | Asbestos: | None Detected |

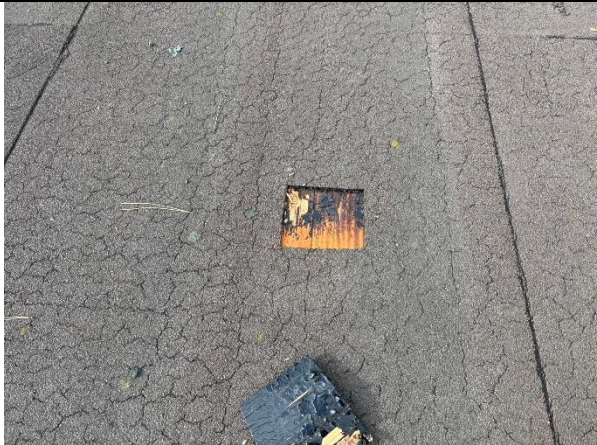
| Sample: | 63920-51 | Sample: | 63920-52 |

| Location: | Roof - West Side | Location: | Roof - East Side |
| Description: | Torch-on Asphalt | Description: | Torch-on Asphalt |
| Asbestos: | None Detected | Asbestos: | None Detected |

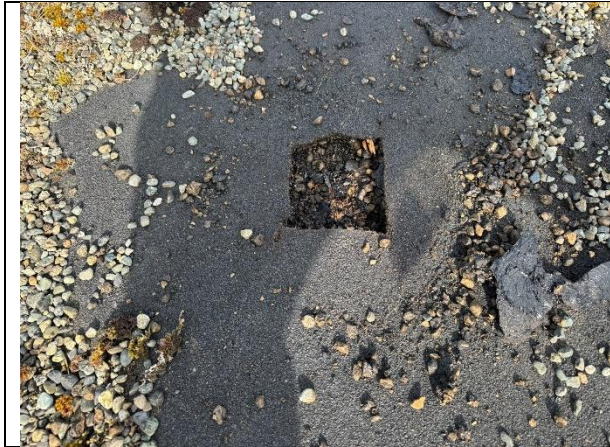
Sample: 63920-53  
 Location: Roof - Central  
 Description: Tar & Gravel  
 Asbestos: None Detected

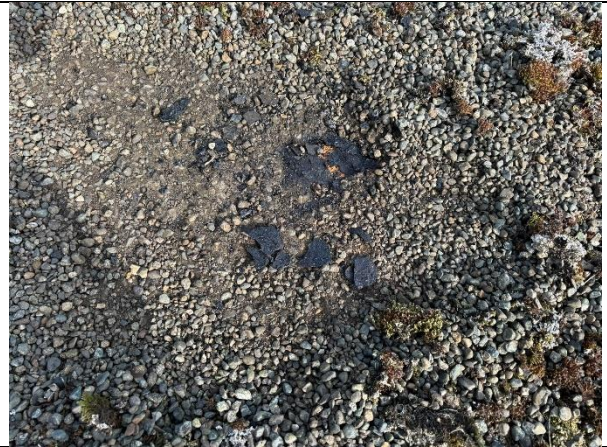
Sample: 63920-54  
 Location: Roof - Central  
 Description: Tar & Gravel  
 Asbestos: None Detected

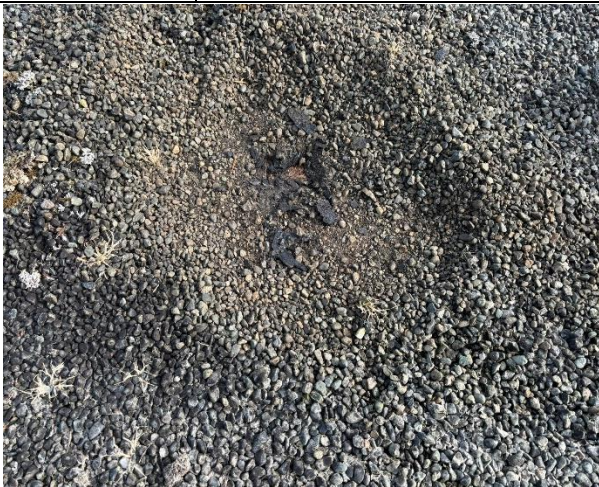
Sample: 63920-55  
 Location: Roof - Central  
 Description: Tar & Gravel  
 Asbestos: None Detected

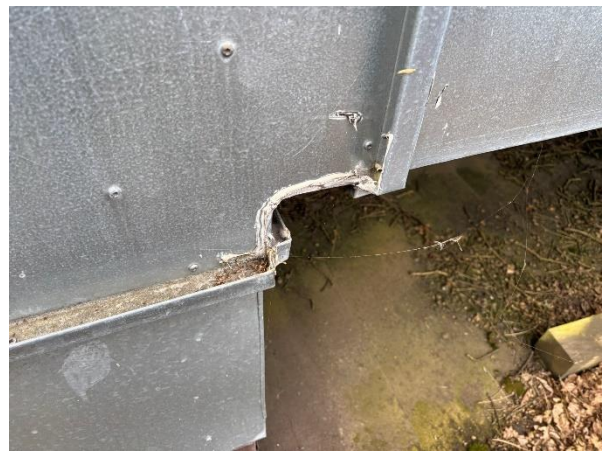
Sample: 63920-56  
 Location: Roof - HVAC - West Side  
 Description: Caulking White  
 Asbestos: None Detected

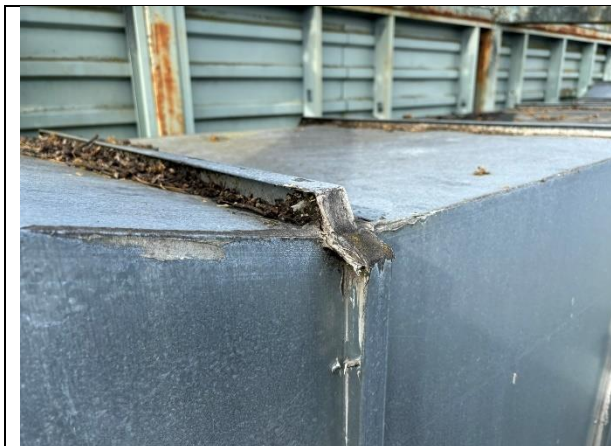
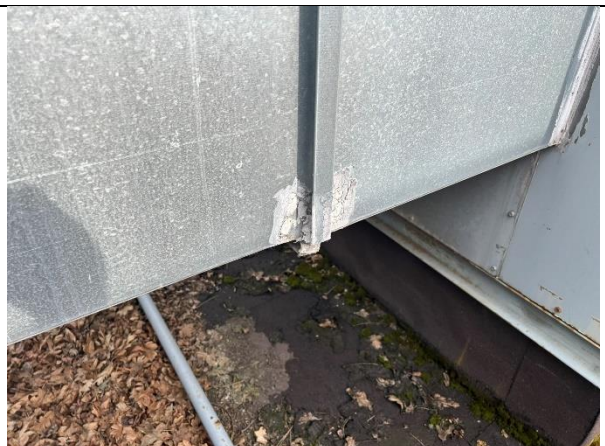
| Sample: | 63920-57 |

| Location: | Roof - HVAC - West Side |

| Description: | Caulking White |
| Asbestos: | None Detected |

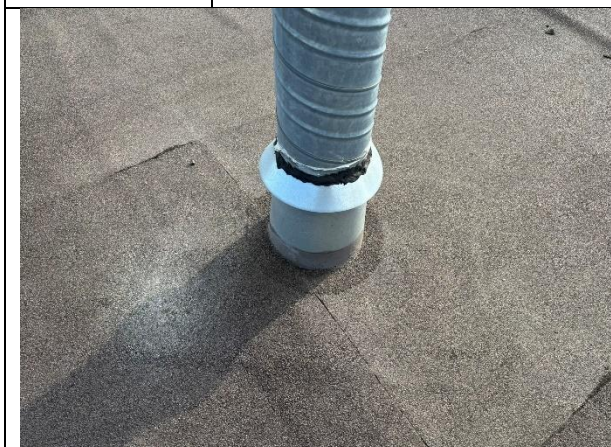
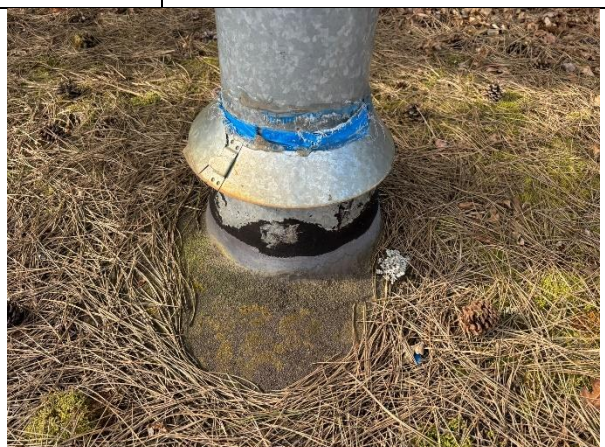
| Sample: | 63920-59 |

| Location: | Roof - Vents |

| Description: | Mastic - Black |
| Asbestos: | None Detected |

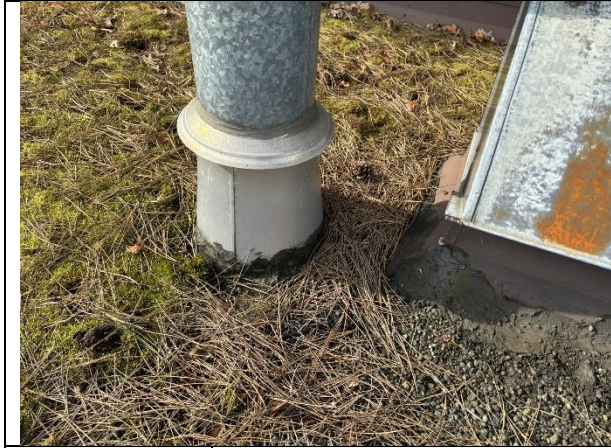
| Sample: | 63920-61 |

| Location: | Roof - Vents |
| Description: | Mastic - Black |
| Asbestos: | None Detected |

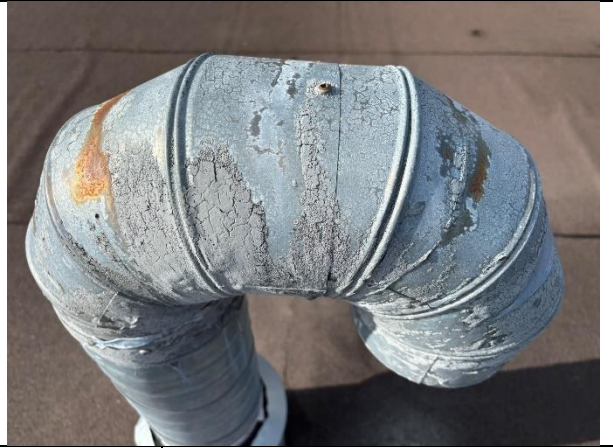
| Sample: | 63920-62 |

| Location: | Roof - Vents |
| Description: | Mastic - Grey |
| Asbestos: | None Detected |

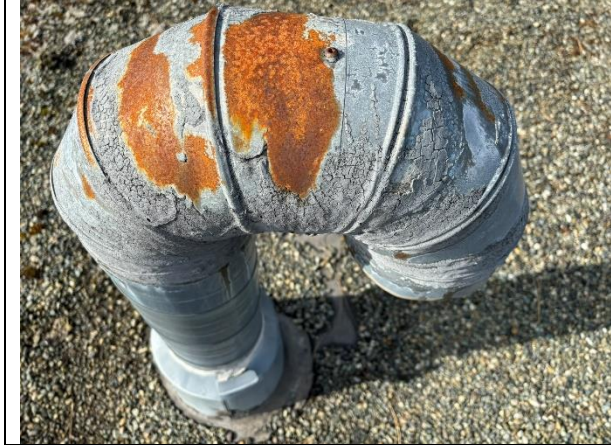
| Sample: | 63920-63 |

| Location: | Roof - Vents |
| Description: | Mastic - Grey |
| Asbestos: | None Detected |

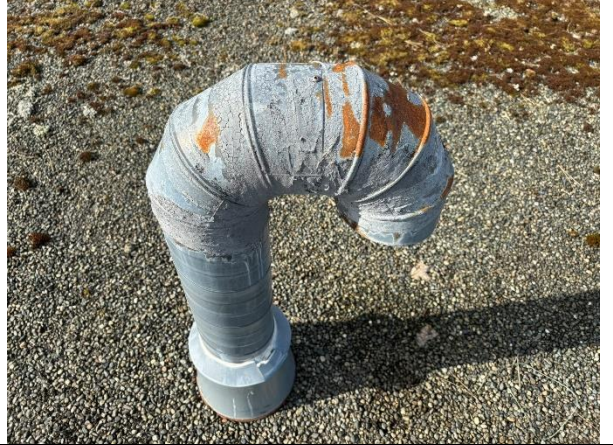
| Sample: | 63920-64 |

| Location: | Roof - Vents |
| Description: | Mastic - Grey |
| Asbestos: | None Detected |

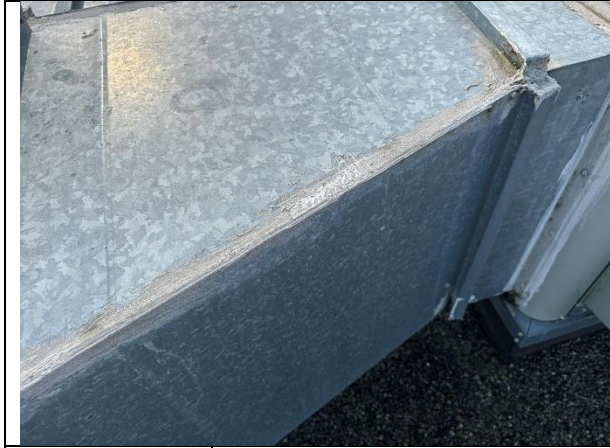
Sample: 63920-65  
 Location: Roof - HVAC - East Side  
 Description: Mastic - Grey  
 Asbestos: None Detected

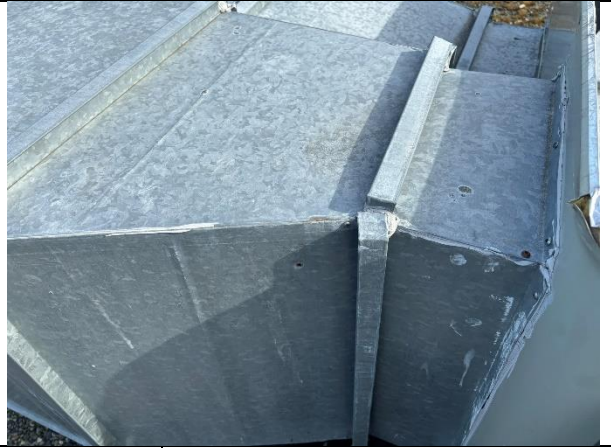
Sample: 63920-66  
 Location: Roof - HVAC - East Side  
 Description: Mastic - Grey  
 Asbestos: None Detected

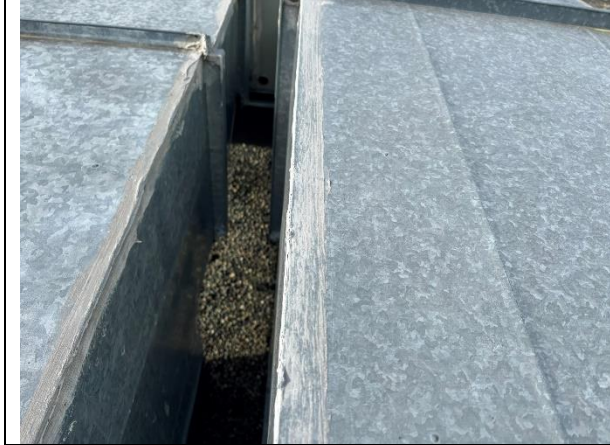
Sample: 63920-67  
 Location: Roof - HVAC - East Side  
 Description: Mastic - Grey  
 Asbestos: None Detected

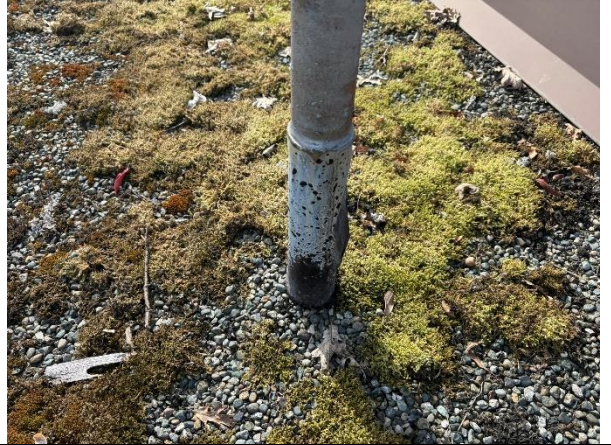
Sample: 63920-68  
 Location: Roof - HVAC  
 Description: Tar - Black  
 Asbestos: None Detected

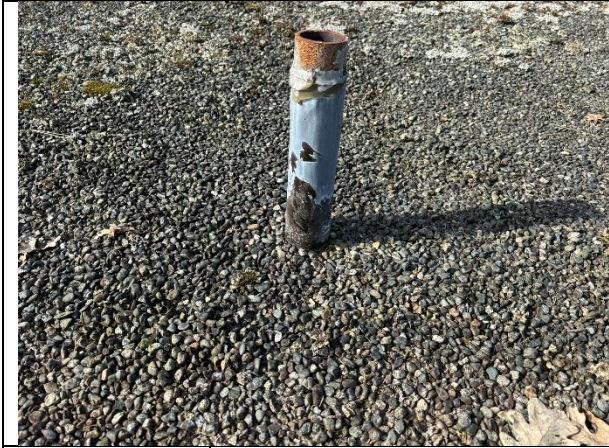
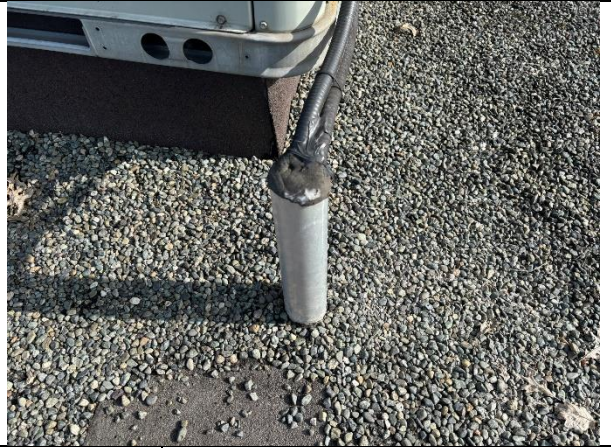
| Sample: | 63920-69 | Sample: | 63920-70 |

| Location: | Roof - HVAC | Location: | Roof - HVAC |
