# **Hazardous Materials Investigation**

## **4216 Glanford Avenue, Victoria, BC**

Island EHS Project #63918

Original issue date April 2025  
Revised July 2025 (Rev01)  
September 2025 (Rev02)

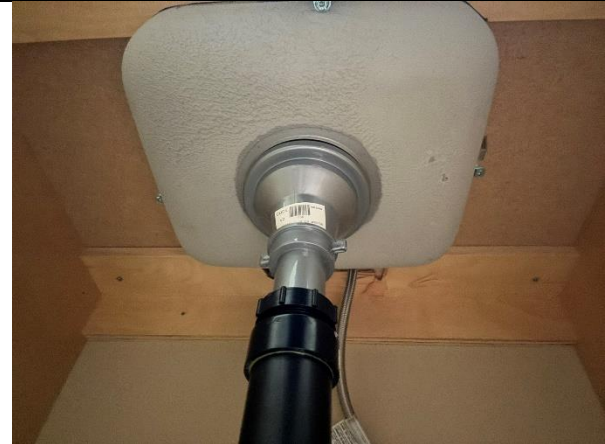
| Sample: | 63918-9 | Sample: | 63918-10 |

| Location: | Main Foyer – Closet (Sink) | Location: | West Storage Bay |
| Description: | Mastic | Description: | Drywall Joint Filler Compound |
| Asbestos: | None Detected | Asbestos: | None Detected |

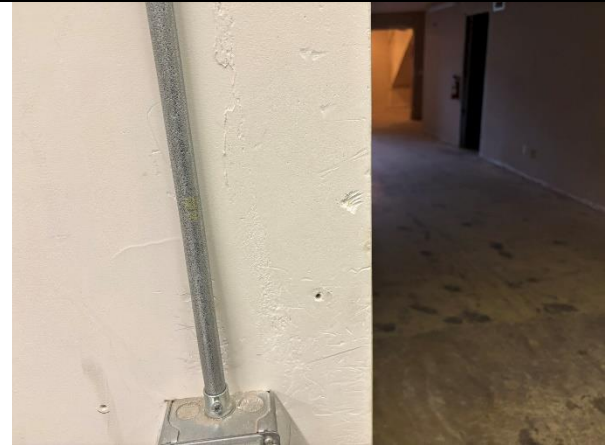
| Sample: | 63918-11 | Sample: | 63918-12 |

| Location: | West Storage Bay | Location: | West Storage Bay |
| Description: | Drywall Joint Filler Compound | Description: | Drywall Joint Filler Compound |
| Asbestos: | None Detected | Asbestos: | None Detected |

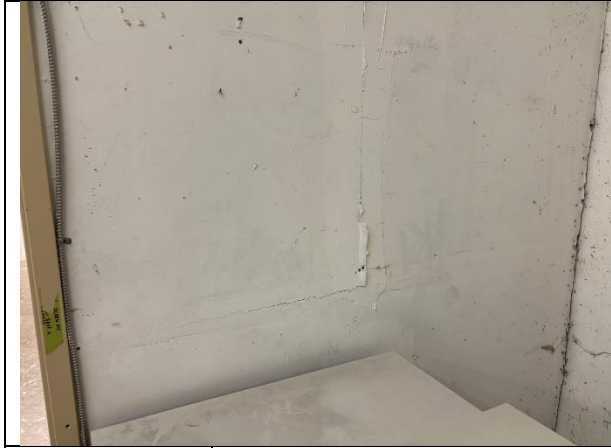
| Sample: | 63918-13 |

| Location: | West Storage Bay |
| Description: | Drywall Joint Filler Compound |
| Asbestos: | None Detected |

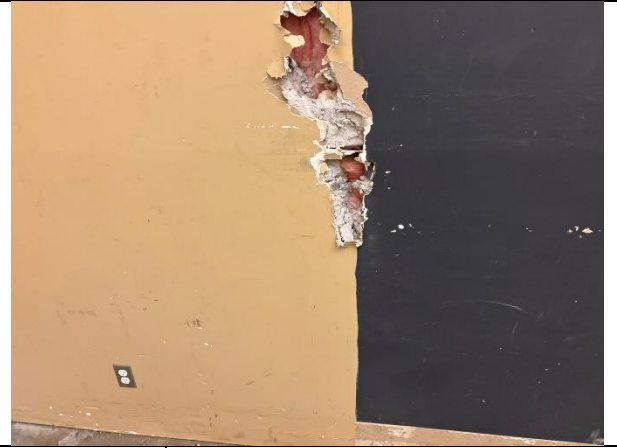
| Sample: | 63918-14 |

| Location: | Flood Room |
| Description: | Drywall Joint Filler Compound |
| Asbestos: | None Detected |

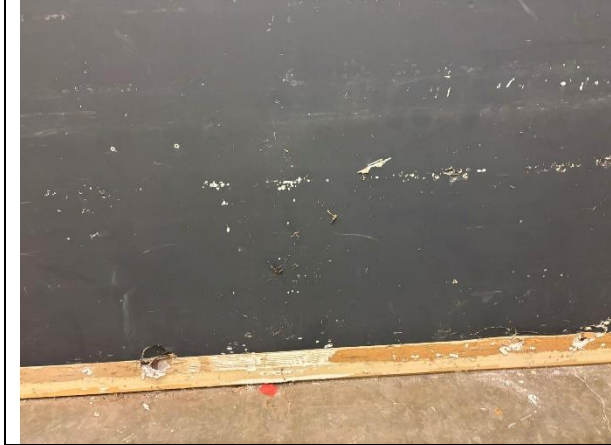
| Sample: | 63918-15 |

| Location: | Flood Room |
| Description: | Drywall Joint Filler Compound |
| Asbestos: | None Detected |

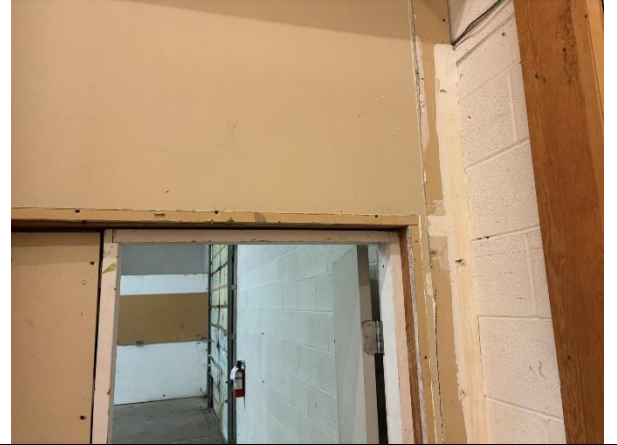
| Sample: | 63918-16 |

| Location: | Flood Room |
| Description: | Drywall Joint Filler Compound |
| Asbestos: | None Detected |

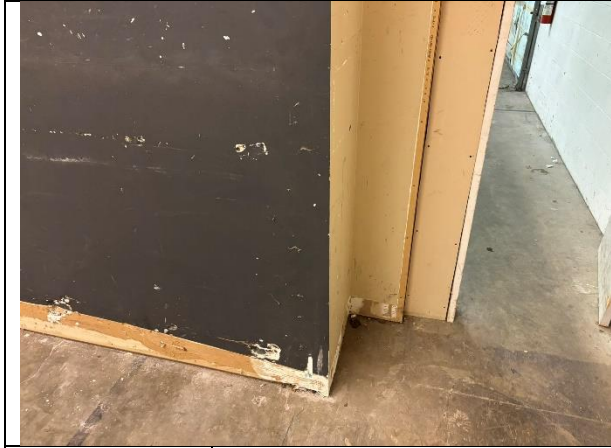
Sample: 63918-17  
 Location: Flood Room  
 Description: Drywall Joint Filler Compound  
 Asbestos: None Detected

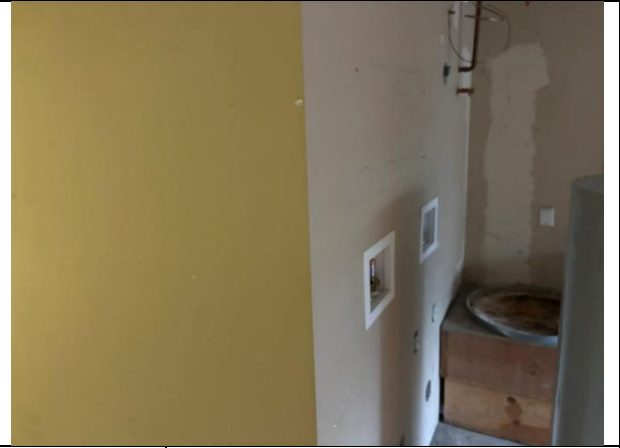
Sample: 63918-18  
 Location: Cleaning Shop  
 Description: Drywall Joint Filler Compound  
 Asbestos: None Detected

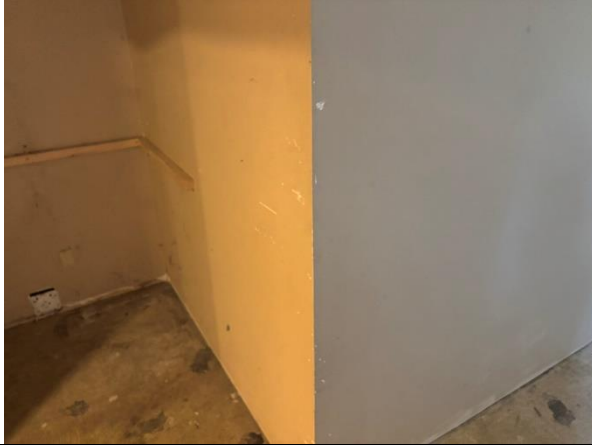
Sample: 63918-19  
 Location: Cleaning Shop  
 Description: Drywall Joint Filler Compound  
 Asbestos: None Detected

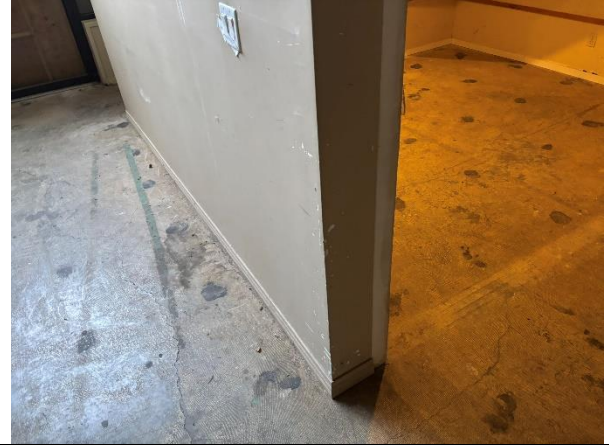
Sample: 63918-20  
 Location: Cleaning Shop  
 Description: Drywall Joint Filler Compound  
 Asbestos: None Detected

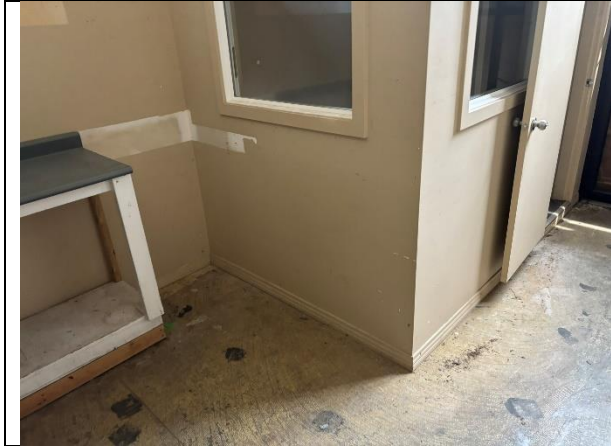
| Sample: | 63918-21 |

| Location: | Cleaning Shop |

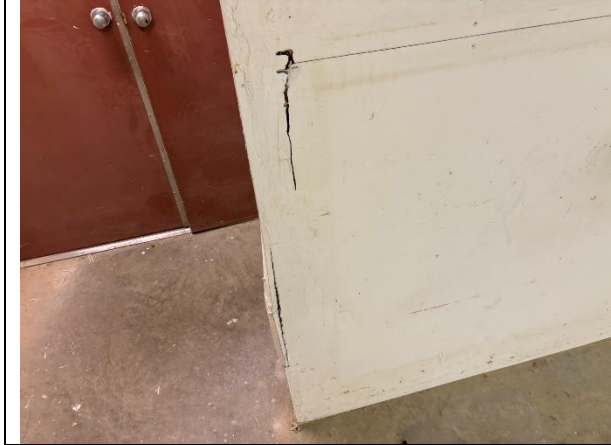
| Sample: | 63918-23 |

| Location: | Carpentry Shop |
| Description: | Drywall Joint Filler Compound |
| Asbestos: | None Detected |

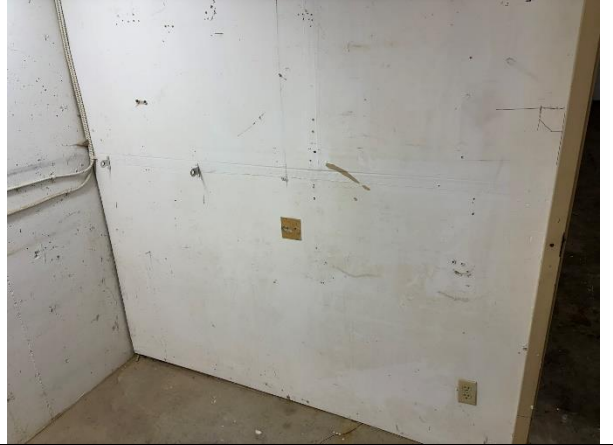
| Sample: | 63918-24 |

| Location: | Carpentry Shop |
| Description: | Drywall Joint Filler Compound |
| Asbestos: | None Detected |

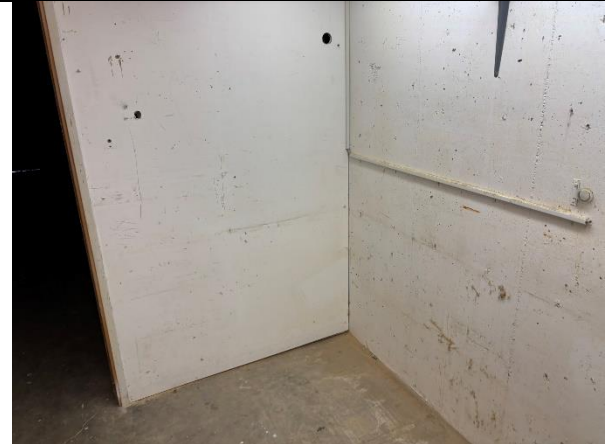
| Sample: | 63918-25 | Sample: | 63918-26 |

| Location: | Carpentry Shop | Location: | Carpentry Shop |
| Description: | Drywall Joint Filler Compound | Description: | Drywall Joint Filler Compound |
| Asbestos: | None Detected | Asbestos: | None Detected |

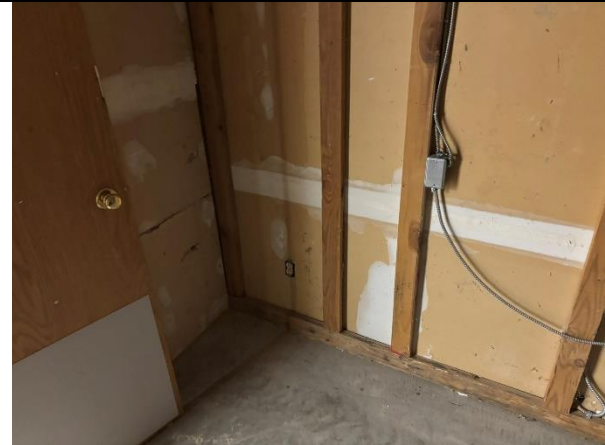
| Sample: | 63918-27 | Sample: | 63918-28 |

| Location: | Carpentry Shop | Location: | Main Floor – Washrooms |
| Description: | Drywall Joint Filler Compound | Description: | Vinyl Sheet Flooring |
| Asbestos: | None Detected | Asbestos: | None Detected |

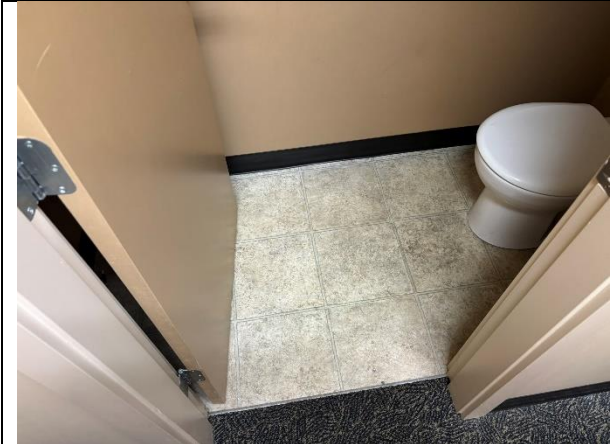
| Sample: | 63918-29 | Sample: | 63918-30 |

| Location: | Main Floor – Washroom | Location: | 2 <sup>nd</sup> Floor – Board Room |
| Description: | Vinyl Sheet Flooring | Description: | Textured Ceiling (type 1) |
| Asbestos: | None Detected | Asbestos: | None Detected |

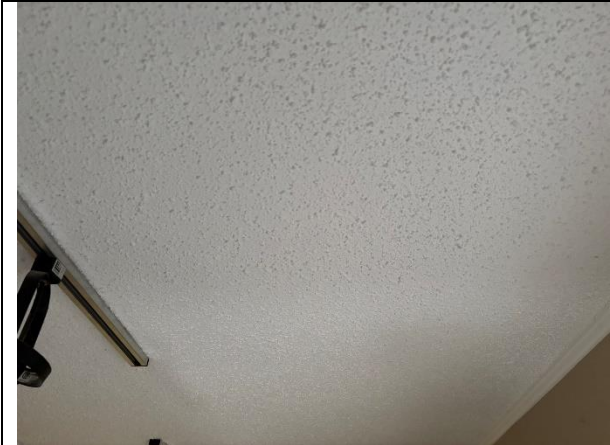
| Sample: | 63918-31 | Sample: | 63918-32 |

| Location: | 2 <sup>nd</sup> Floor – Centre | Location: | 2 <sup>nd</sup> Floor - Centre |
| Description: | Textured Ceiling (type 1) | Description: | Textured Ceiling (type 1) |
| Asbestos: | None Detected | Asbestos: | None Detected |

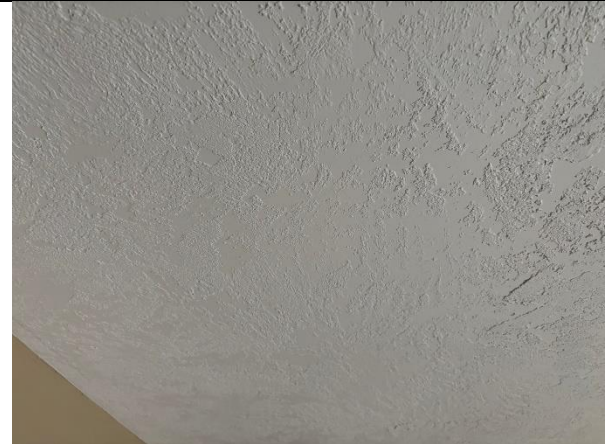
| Sample: | 63918-33 | Sample: | 63918-34 |

| Location: | 2 <sup>nd</sup> Floor – Westend | Location: | 2 <sup>nd</sup> Floor – Kitchen |
| Description: | Textured Ceiling (type 2) | Description: | Drywall Joint Filler Compound |
| Asbestos: | None Detected | Asbestos: | None Detected |

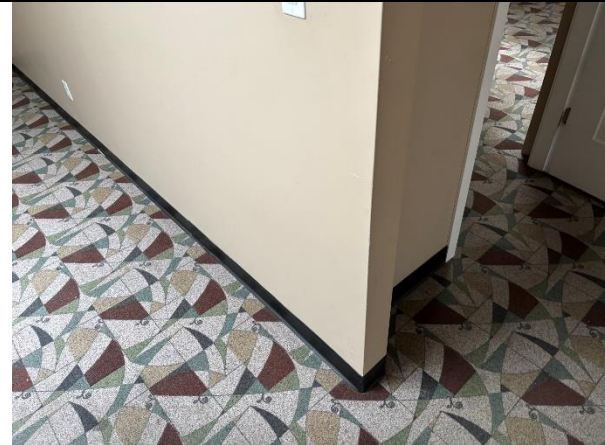
| Sample: | 63918-35 | Sample: | 63918-36 |

| Location: | 2 <sup>nd</sup> Floor – Kitchen | Location: | 2 <sup>nd</sup> Floor – Kitchen |
| Description: | Drywall Joint Filler Compound | Description: | Drywall Joint Filler Compound |
| Asbestos: | None Detected | Asbestos: | None Detected |

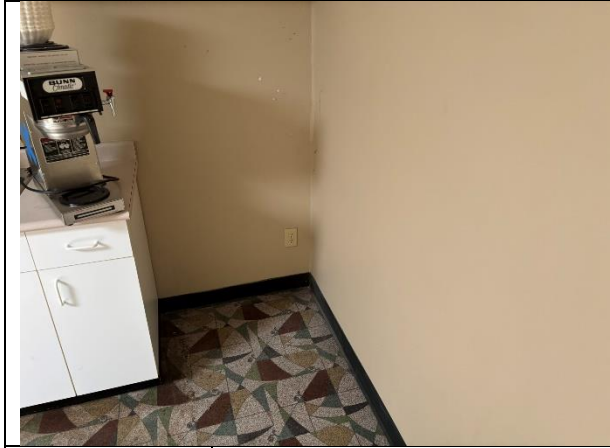
Sample: 63918-37  
 Location: 2<sup>nd</sup> Floor – Kitchen  
 Description: Drywall Joint Filler Compound  
 Asbestos: None Detected

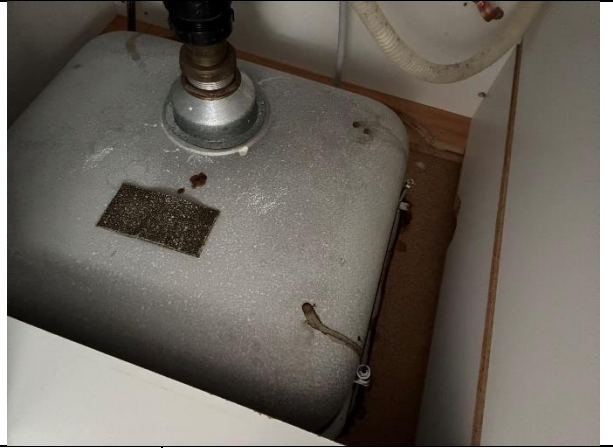
Sample: 63918-38  
 Location: 2<sup>nd</sup> Floor – Kitchen (Sink)  
 Description: Mastic  
 Asbestos: None Detected

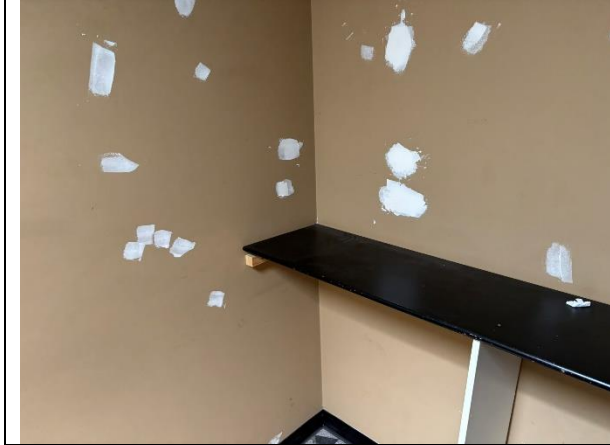
Sample: 63918-39  
 Location: 2<sup>nd</sup> Floor – West Offices  
 Description: Drywall Joint Filler Compound  
 Asbestos: None Detected

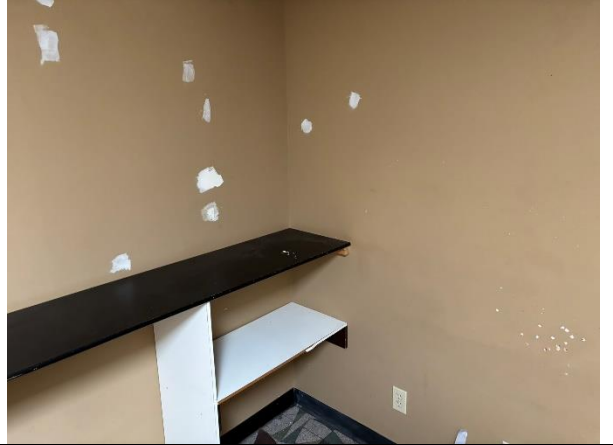
Sample: 63918-40  
 Location: 2<sup>nd</sup> Floor – West Offices  
 Description: Drywall Joint Filler Compound  
 Asbestos: None Detected

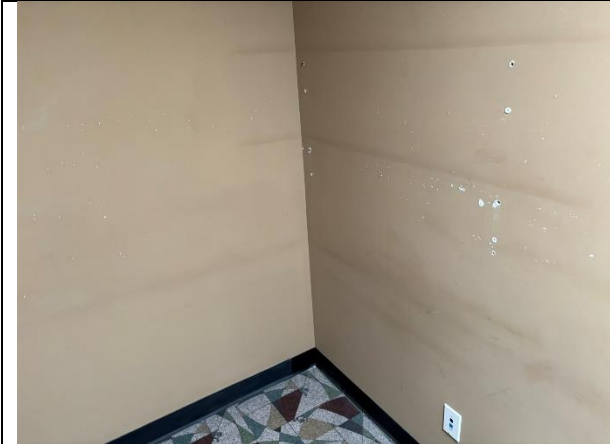
| Sample: | 63918-41 | Sample: | 63918-42 |

| Location: | 2 <sup>nd</sup> Floor – West Offices | Location: | 2 <sup>nd</sup> Floor – West Offices |
| Description: | Drywall Joint Filler Compound | Description: | Drywall Joint Filler Compound |
| Asbestos: | None Detected | Asbestos: | None Detected |

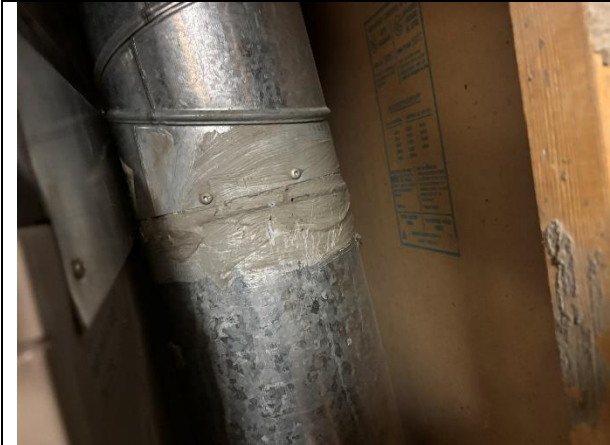
| Sample: | 63918-43 | Sample: | 63918-44 |

| Location: | Fan Unit 2 | Location: | Fan Unit 2 |
| Description: | Duct Caulking | Description: | Duct Caulking |
| Asbestos: | None Detected | Asbestos: | None Detected |

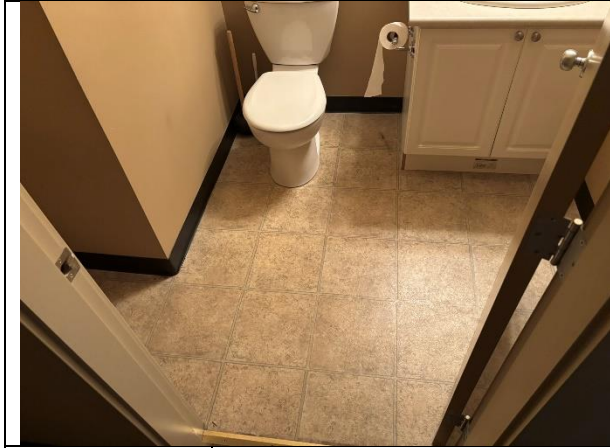
| Sample: | 63918-45 |

| Location: | 2 <sup>nd</sup> Floor – Women's Bathroom |
| Description: | Vinyl Sheet Flooring |
| Asbestos: | None Detected |

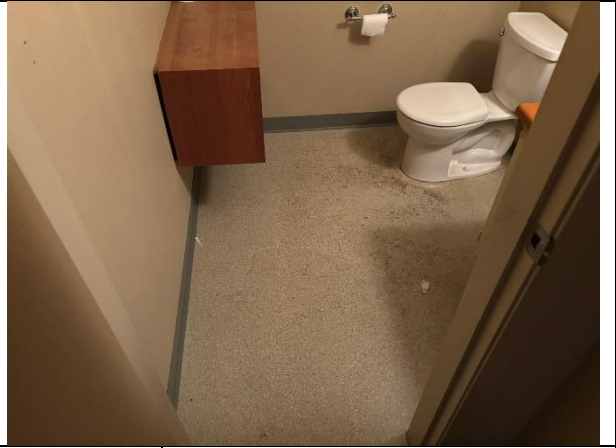
| Sample: | 63918-46 |

| Location: | 2 <sup>nd</sup> Floor – Men's Bathroom |
| Description: | Vinyl Sheet Flooring |
| Asbestos: | None Detected |

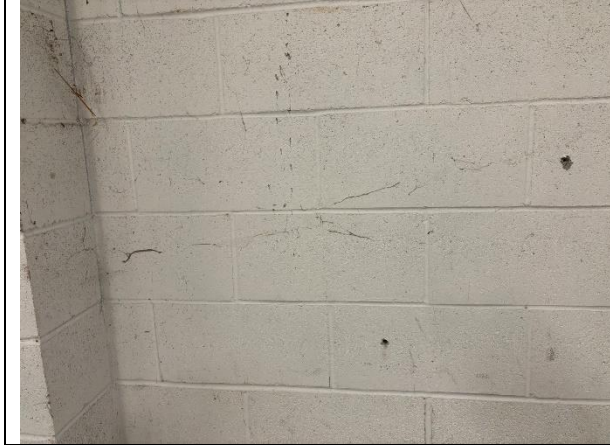
| Sample: | 63918-47 |

| Location: | Concrete Block (Exterior) |
| Description: | Mortar |
| Asbestos: | None Detected |

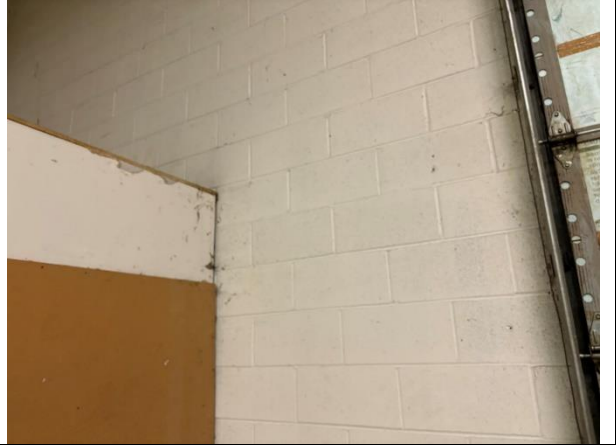
| Sample: | 63918-48 |

| Location: | Concrete Block (Exterior) |

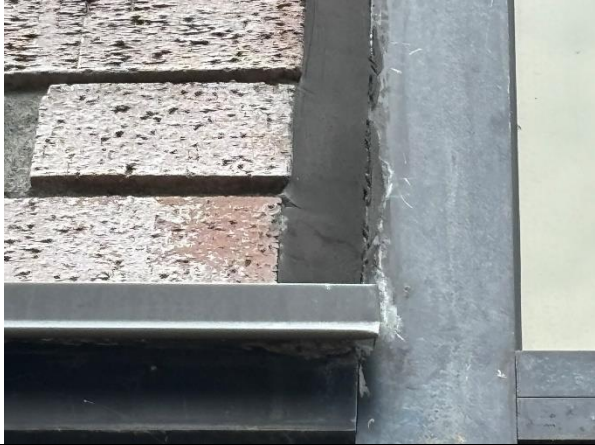
Sample: 63918-55  
 Location: Exterior at Windows  
 Description: Caulking  
 Asbestos: None Detected

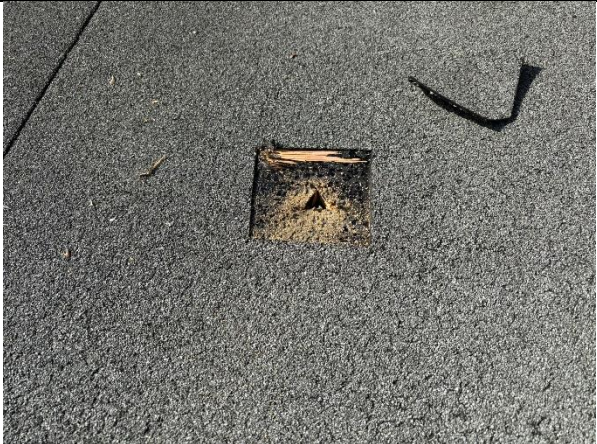
| Sample: | 63918-57 | Sample: | 63918-58 |
| Location: | Roof | Location: | Roof |
| Description: | Torch-on Asphalt | Description: | Torch-on Asphalt |
| Asbestos: | None Detected | Asbestos: | None Detected |

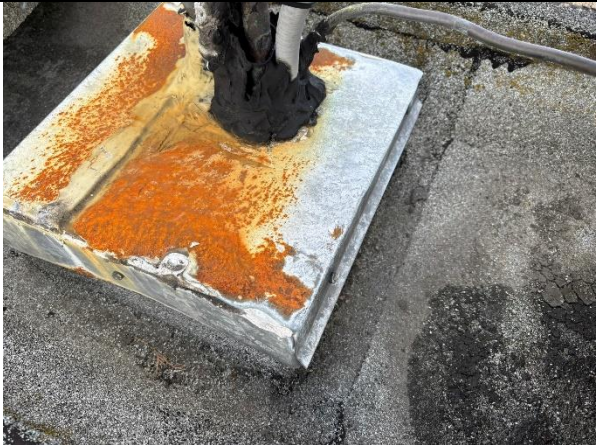
| Sample: | 63918-59 | Sample: | 63918-60 |
| Location: | Roof | Location: | Roof |

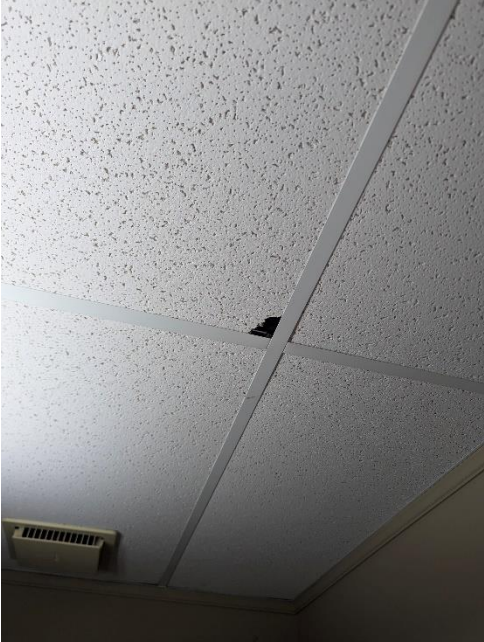
| Sample: | 63918-65 | Sample: | 63918-66 |
| Location: | Room Off Main Foyer | Location: | Room Off Cleaning Shop |
| Description: | Lay in ceiling panel | Description: | Duct caulking |
| Asbestos: | None Detected | Asbestos: | None Detected |

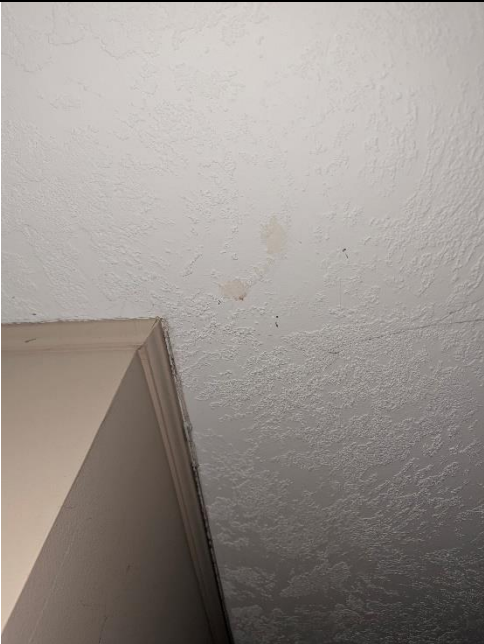
| Sample: | 63918-67 | Sample: | 63918-68 |
| Location: | 2 <sup>nd</sup> Floor – Centre | Location: | 2 <sup>nd</sup> Floor – East End, Office |
| Description: | Ceiling texture (2) | Description: | Ceiling texture (2) |
| Asbestos: | None Detected | Asbestos: | None Detected |

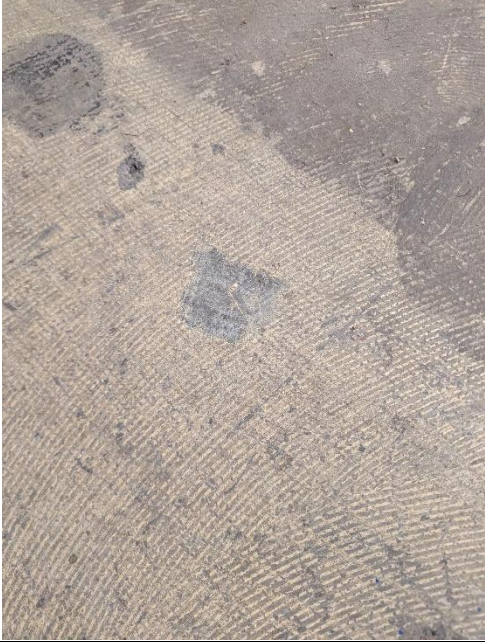
| Sample: | 63918-69 | Sample: | 63918-70 |
| Location: | Cleaning Shop - Floor | Location: | Cleaning Shop - Floor |

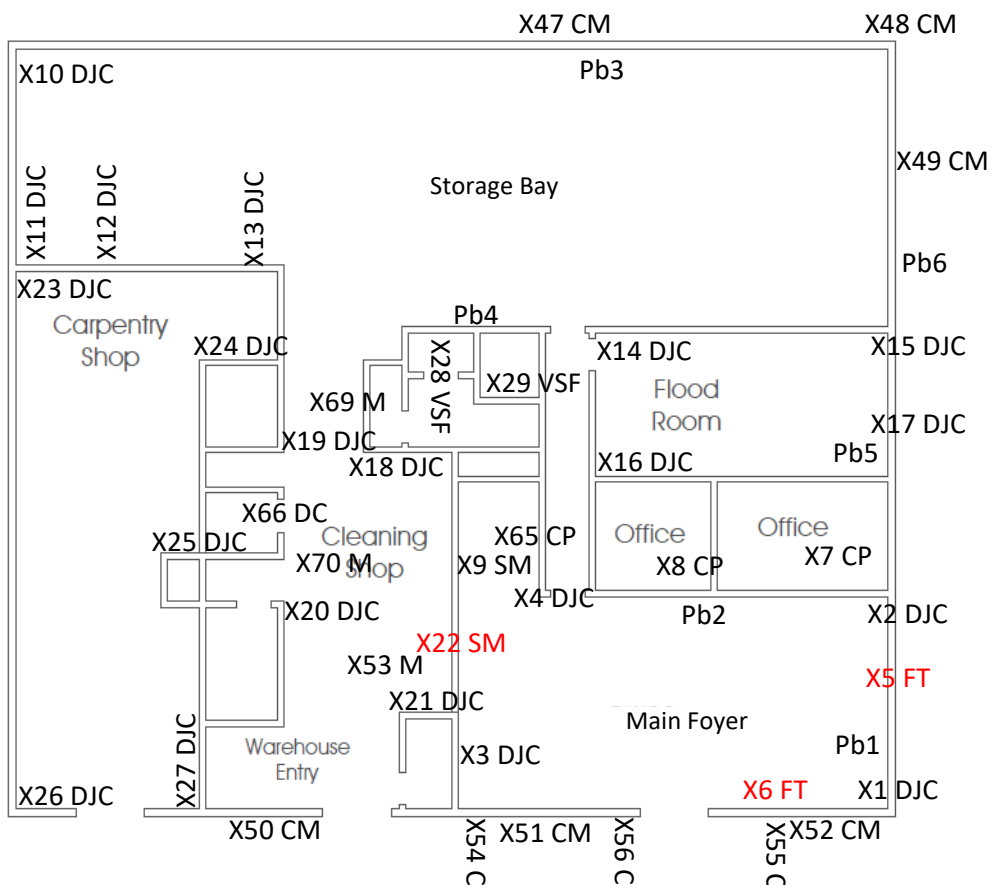
# MAIN FLOOR PLAN

Hazardous Materials Investigation  
 Sample Locations  
 Site: 4216 Glanford Avenue, Victoria, BC

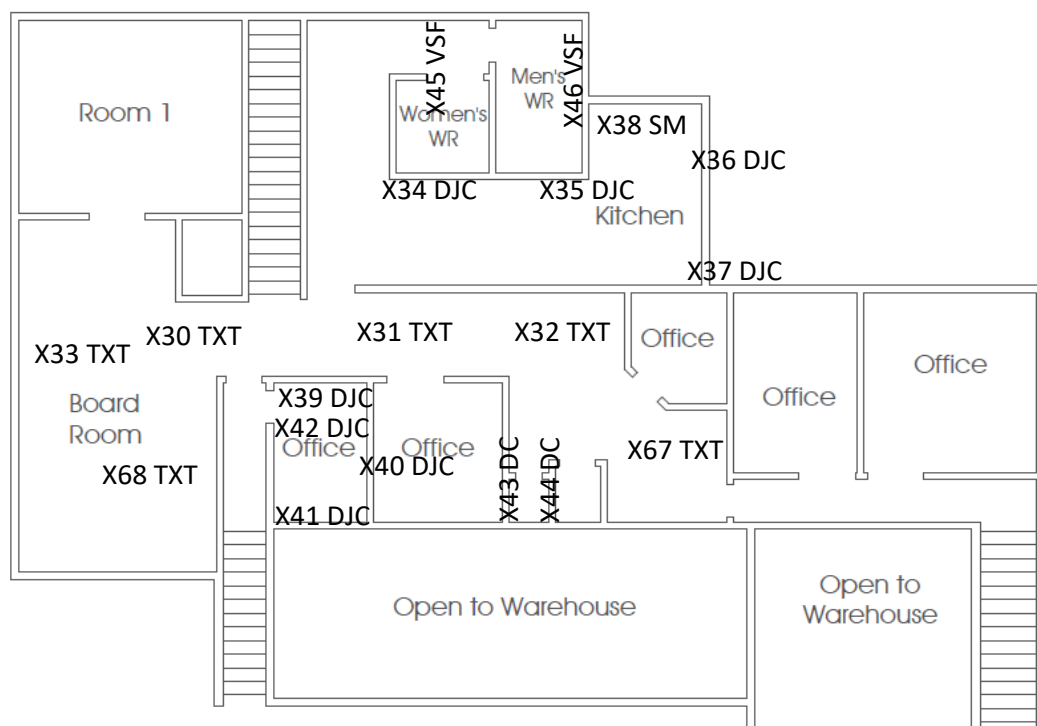
# UPPER FLOOR PLAN

Hazardous Materials Investigation  
Sample Locations  
Site: 4216 Glanford Avenue, Victoria, BC
